**SERVICE BULLETIN**

**APPLICABILITY:** 2015 and 2016MY WRX and STI Models

**NUMBER:** 12-201-16R

**SUBJECT:** Paint Chipping between Hood Grille (Scoop) and Hood

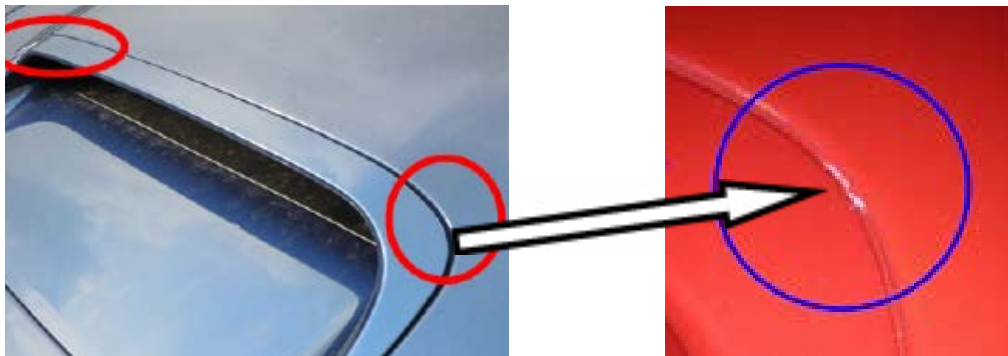
This new bulletin replaces TSB 12-186-15 and announces a new repair procedure to address customer concerns of the hood scoop scrubbing the finish of the hood panel in the areas shown in the photo below. Due to different expansion rates between the metal hood panel and the resin material used for the hood scoop, the edges of the scoop's rear corners may come in contact with the hood panel and abrade the finish.
