SERVICE BULLETIN

APPLICABILITY: 2015-2017MY Legacy and Outback
SUBJECT: Sticking Secondary Hood Latch

NUMBER: 12-219-17
DATE: 04-10-17

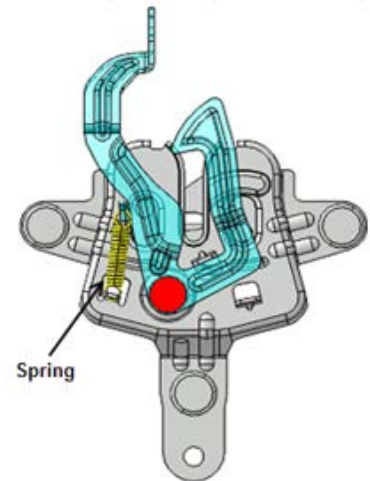
This bulletin provides new part information and an identification procedure to address a small number of vehicles identified with a sticking secondary hood latch mechanism. The hood latch mechanism is exposed to foreign materials during normal use which can accumulate and cause the secondary portion to not operate properly. The spring-loaded secondary latch is manually released (after pulling the inside hood release lever to operate the primary latch mechanism) by the operator to open the hood. If faulty, the spring may not have enough force to return the lever back to its original position while the hood is open. Once the hood is closed, the secondary latch is forced into the closed position by design.

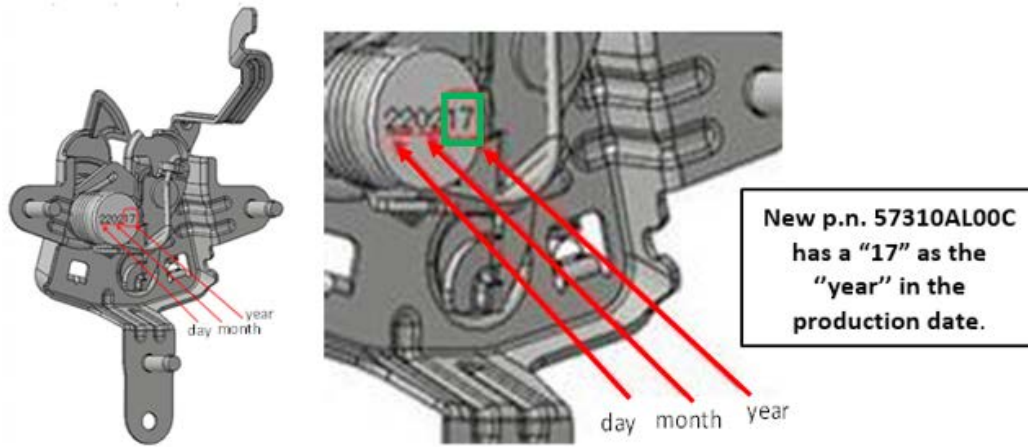
The part number for the new hood latch assembly is **57310AL00C**. If the condition as described above is verified and the VIN is close to the supplied starting VIN, inspect the date code found on the latch as shown below. Latches with the last 2 digits “16” or before require replacement when this condition is identified. Those with “17” as the last 2 digits are the enhanced parts.

If after inspection, replacement is required, follow the procedure in the applicable Service Manual.
