Service Bulletin

PRELIMINARY INFORMATION

Subject: Front Suspension Squeak/Creak/Rumble/Rattle/Clunk/Thump/Click/Tick/Knock Type Noise Over Bumps

Models: 2015-2016 Cadillac Escalade Models
2015-2016 Chevrolet Tahoe LTZ, Suburban LTZ
2015-2016 GMC Sierra Denali 1500 and Yukon Denali Models
With Magnetic Ride Control Suspension (RPO Z95)
Vehicles Built Before 6/27/2016

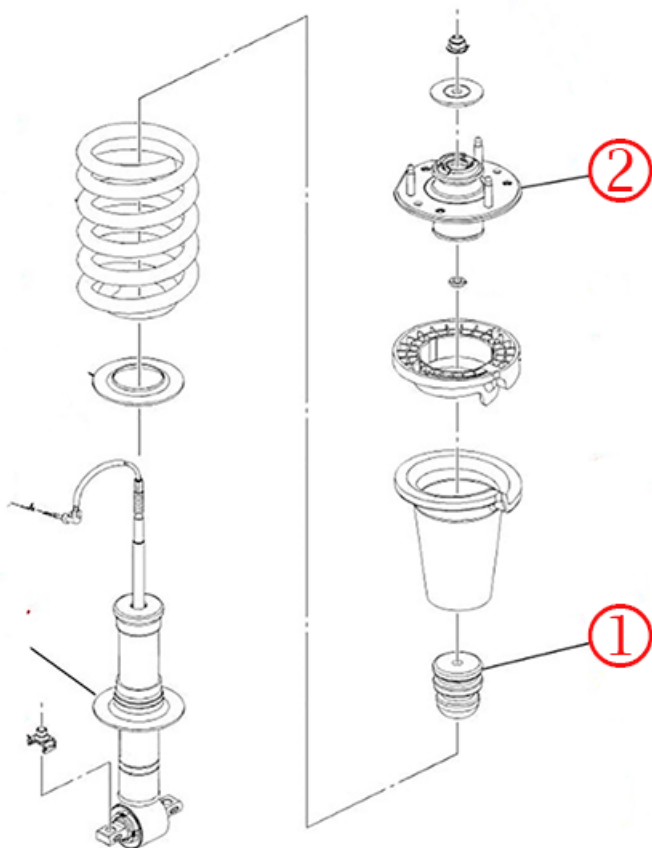
This condition may be caused by a slip/stick condition between the front strut jounce bumper ID and piston rod.

7. Remove the jounce bumper (1) from the top mount assembly (2).
8. Install the jounce bumper to the top mount assembly. NOTE: Ensure that the jounce bumper is secure to the top mount.
9. Assemble the coil spring and top mount to each strut. Refer to Shock Absorber, Shock Absorber Component, or Spring Replacement in SI.
10. Install the LH and RH strut assemblies to the vehicle. Refer to Shock Absorber and Spring Removal and Installation in SI.
11. Test drive the vehicle under the same conditions to verify the repair.
