Bulletin No.: PIT5538

Service Bulletin

Subject: Park Brake Lever Contacts Rear Hub Flange After Rear Wheel Bearing Replacement

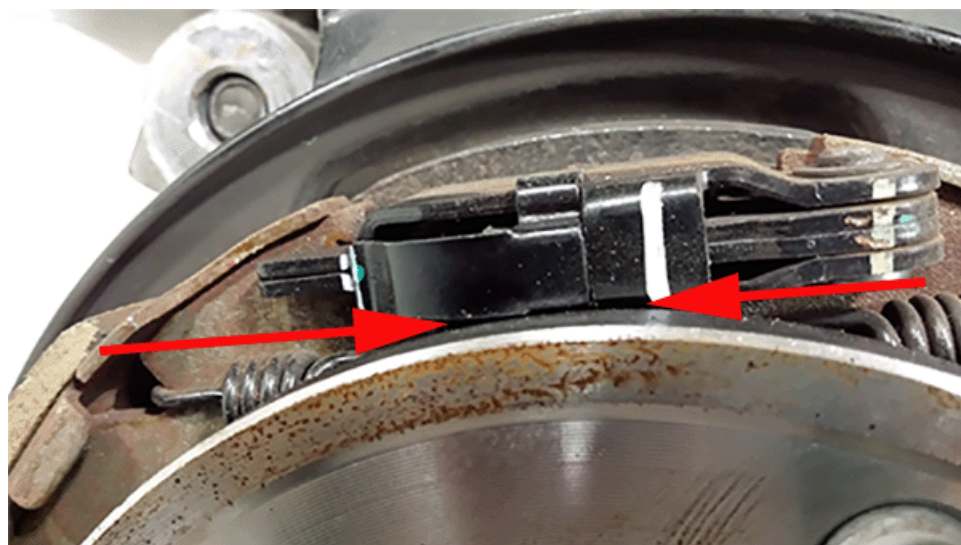
Before:

| Condition | Park brake lever contacts rear hub flange after rear bearing replacement. |
| Cause | Replacement Rear Bearing assemblies have a thicker hub flange that can cause an interference between the hub flange and park brake lever. |

Showing incorrect gap

Loosen park brake lever and move lever away from flange enough to create a gap

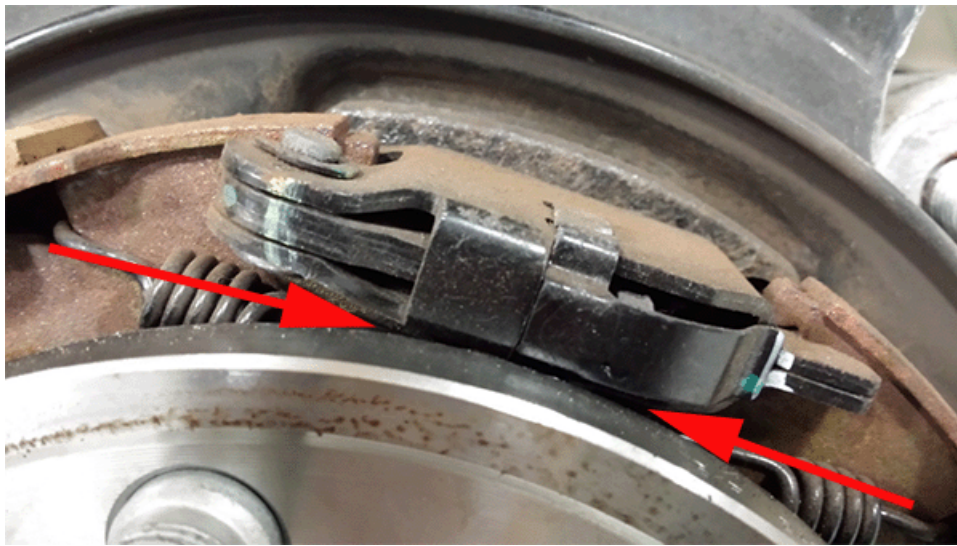
After:

Showing corrected gap
