# Service Bulletin

**Subject:** Cold Air Blowing From Wireless Charging Dock Area

Brand:	Model:	Model Year:		VIN:		Engine:	Transmission:
		from	to	from	to		
Chevrolet	Impala	2016	2017	All	All	All	All

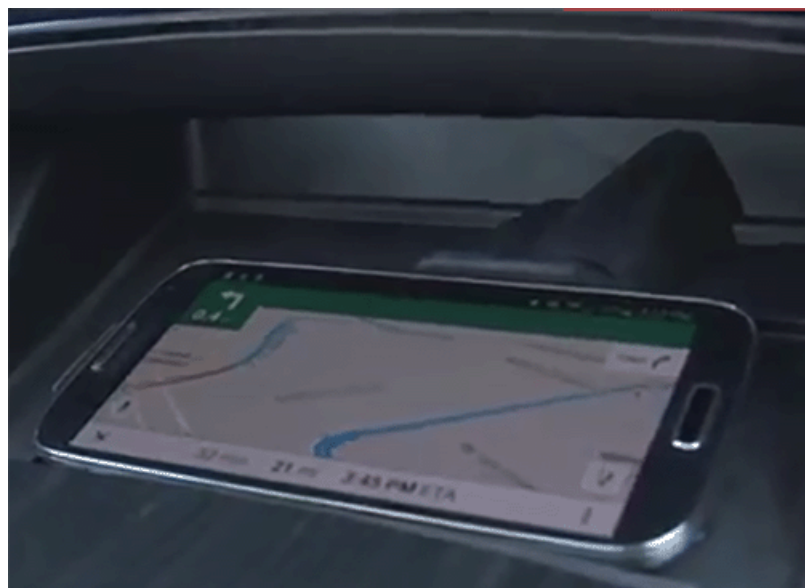
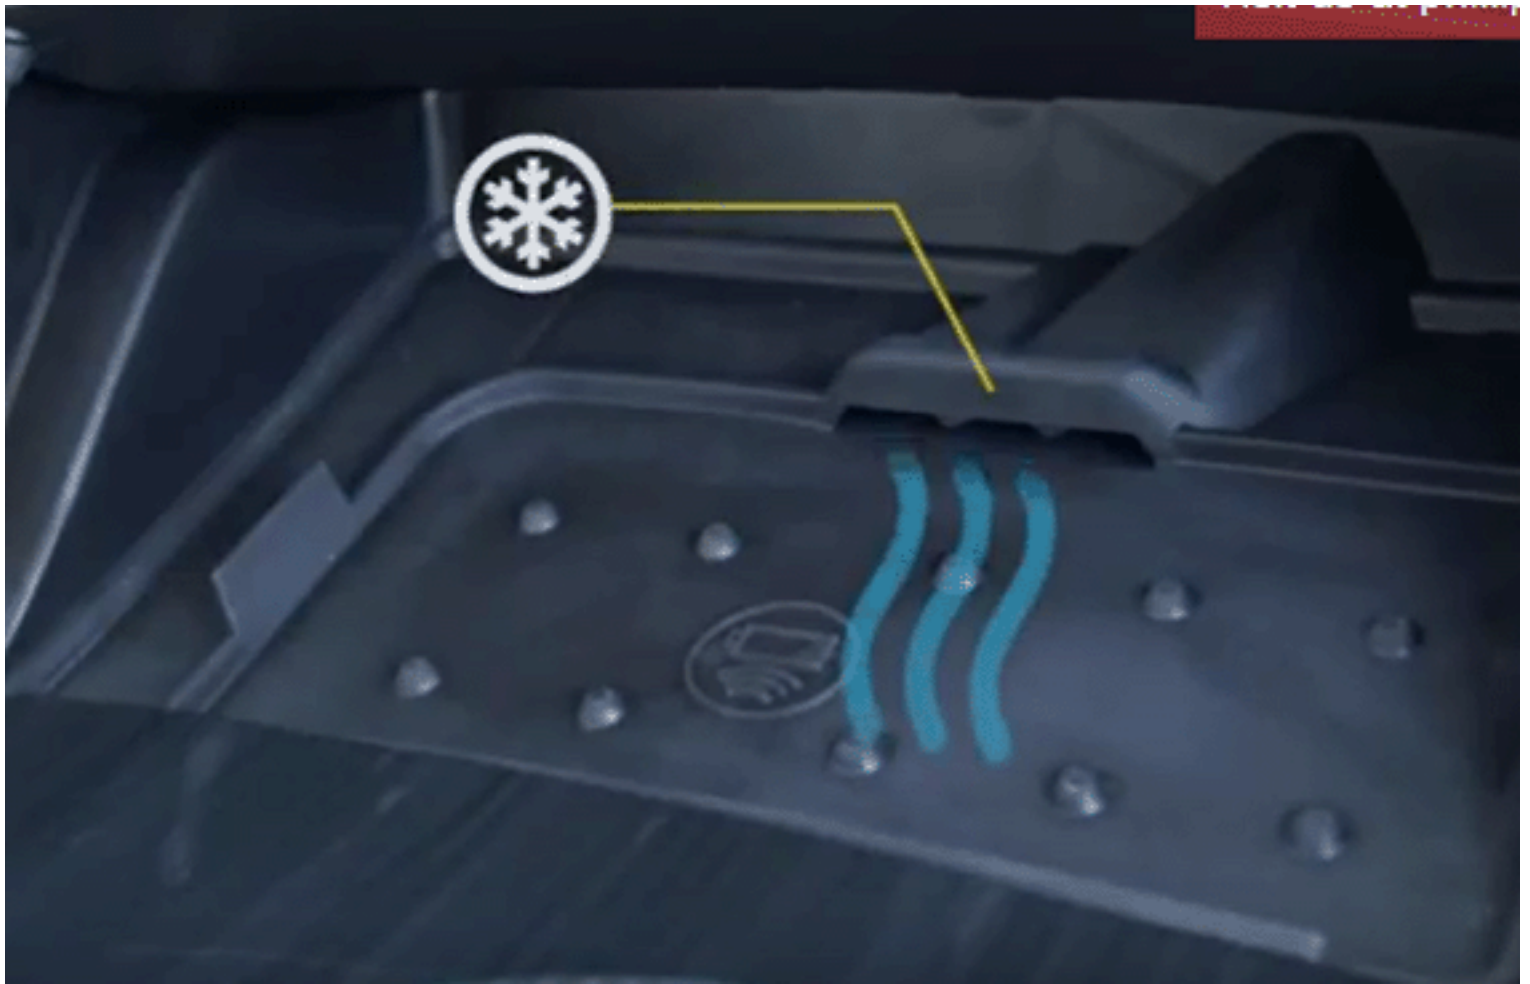
Involved Region or Country	North America
Additional RPO/s:	K4C
Condition	Some customers may complain of Cold Air Blowing from the Center Console or Cold Air Blowing from the Wireless Charging Mat area. Some customers may also notice that the air flow increases when AC fan speed is increased.
Cause	The cooling of the cell phone from the wireless charger is connected to the HVAC duct work.

This is by design for the cooling of the phone during charging and should be considered a normal operating characteristic of the vehicle.
