Service Bulletin

PRELIMINARY INFORMATION

Subject: Mil On With DTC P0171 And / Or P1101

Models: 2013-2016 Buick Encore
2013-2016 Chevrolet Trax (Canada)
2015-2016 Chevrolet Trax (US)
With 1.4L LUV

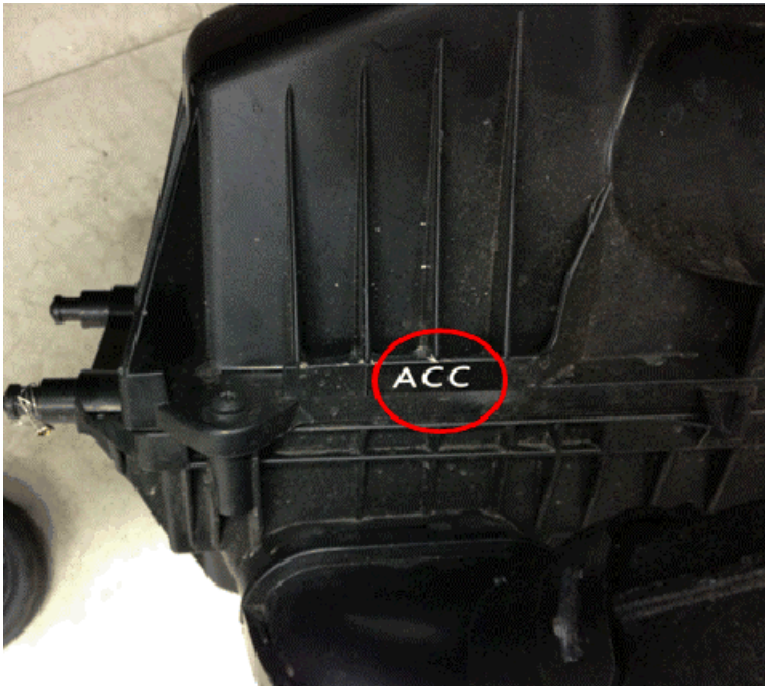
If SI diagnostics do not isolate the cause of the concern, inspect the ID code on the Air Cleaner Housing. (See photo below).

If the Hydro Carbon Absorber is missing, or the ID code is other than ACD, replace the Air Cleaner Housing with the latest listing in the Electronic Parts Catalog

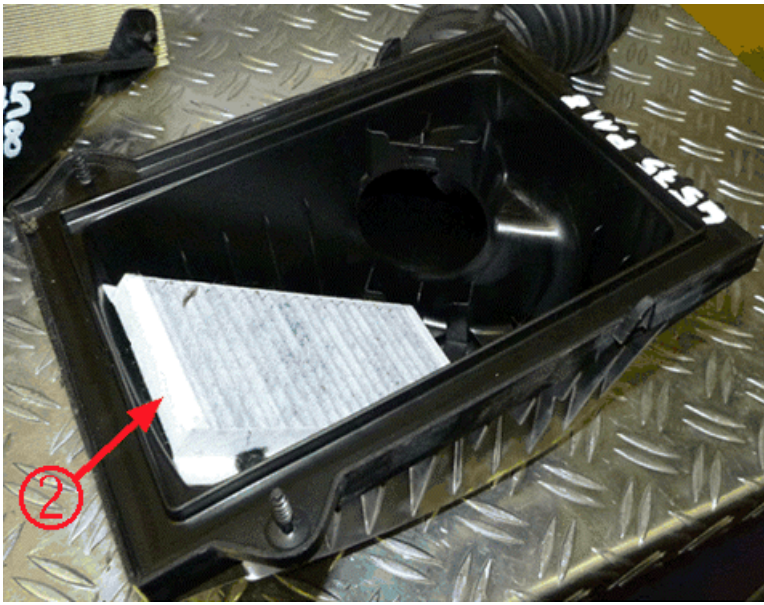
The correct application for the 2013-2016 Buick Encore and 2013-2016 Chevrolet Trax will have an ID code of ACD and will be fitted with a Hydro Carbon Absorber as shown below.

If the Hydro Carbon Absorber is present and the ID code is ACD, refer back to current SI diagnostics.
