Service Bulletin

PRELIMINARY INFORMATION

Subject: Front Seat Lateral Movement and/or Unable To Install Front Seat Lateral Retainer When Performing PI1376 Or PI1183

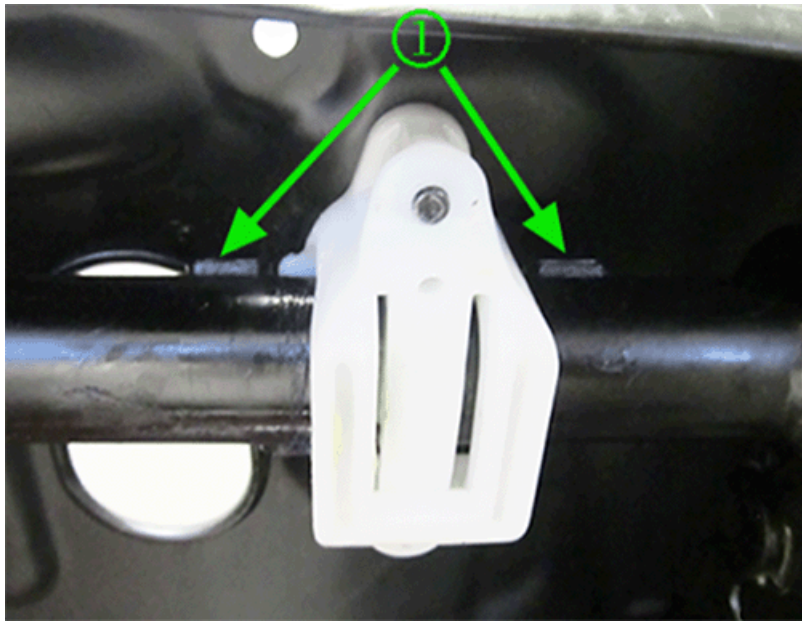
Involved Region or Country	North America and N.A. Export Regions
Additional RPO/s:	N/A
Condition	Some customers may comment of excessive lateral driver or passenger seat movement and/or a clunk/click/pop type feeling or noise. This condition occurs when the seat is occupied and the vehicle is being driven on roads with curves, or during low speed turning maneuvers.
Cause	<p>This concern could be caused by movement between the seat pan front pivot points and the seat frame pivot bar.</p> <p>For 2014 and 2015 Model years, a front seat lateral retainer was developed to correct lateral seat movement, as outlined in PI1376 and PI1183. If the seat frame base was previously replaced for any reason, the new seat frame would have the 2016/2017 updates, which incorporates the welded brackets as described below (1).</p> <p>For 2016 and 2017 model years, an updated seat frame design that incorporates welded brackets (1) to the seat frame pivot bar on each side of the white guide block. This helps to reduce the excessive lateral seat movement.</p> <p>Regardless of the model year, in some cases, even with the updated seat frame design, there still could be excessive clearance between the welded brackets (1) and the white guide block. This will cause excessive lateral seat movement.</p>

If excessive lateral seat movement is found between the welded brackets (1) and the white guide block, the front seat lateral retainer (GM PN 13405675) can be installed to correct this condition.
