Service Bulletin

PRELIMINARY INFORMATION

Subject: Intermittent Loss of Power Steering Assist

Brand:	Model:	Model Year:		VIN:		Engine:	Transmission:
		from	to	from	to		
Chevrolet	Camaro	2016	2016	ALL		ALL	ALL

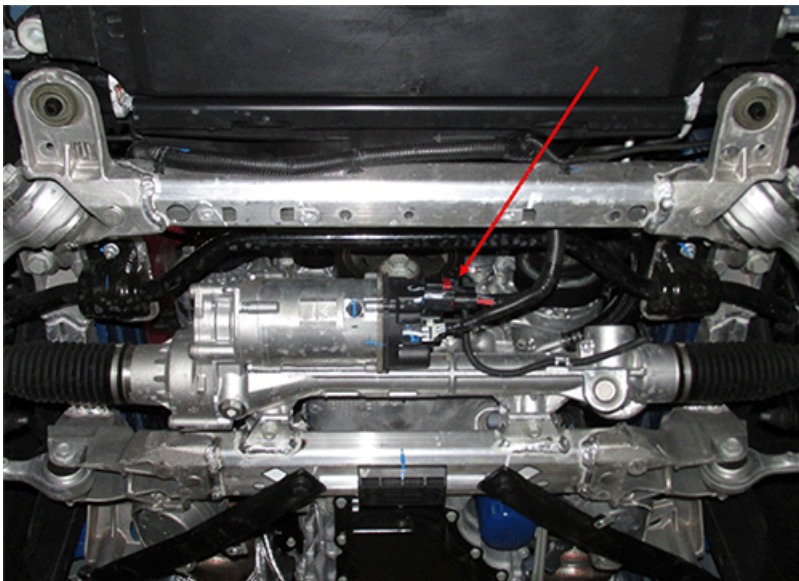
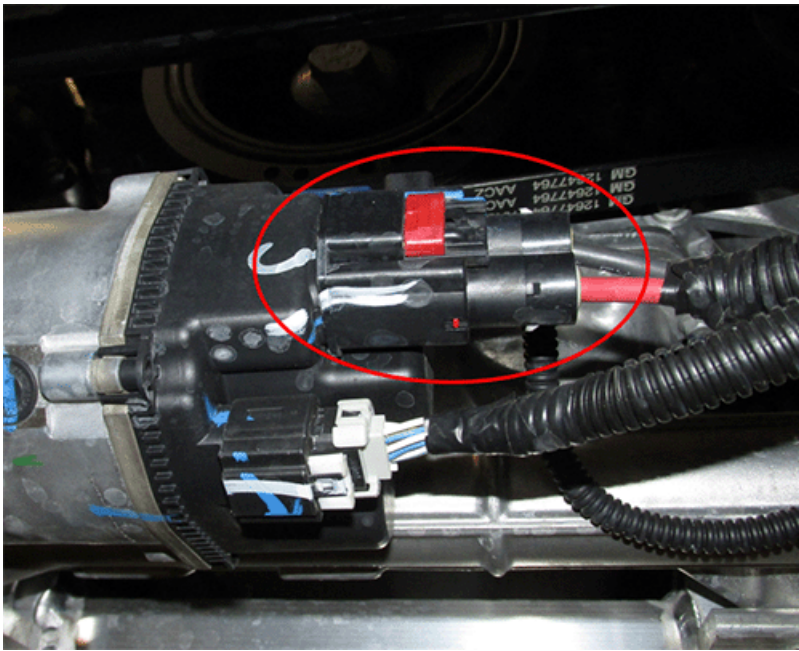
Involved Region or Country	ALL
Condition	Some customers may comment on an intermittent loss of power steering assist.
Cause	This may be caused by a poor connection at the X1 connector of the power steering gear. This is the large, 2-way connector that is located on the front of the gear. The connector can be seen in the two photos below.

Dealership technicians are to inspect the X1 connector of the Electronic Power Steering Gear to make sure it is fully seated and that the CPA is fully engaged.

If the connector is found to be partially unhooked, inspect the terminals/connector for damage and replace them as required.

If no terminal/connector damage is present, reconnect the connector, seat the CPA, and reevaluate the customer's concern to verify it has been resolved.
