Service Bulletin

Subject: Rattle From the Turbocharger on Cold Start

Brand:	Model:	Model Year:		VIN:		Engine:	Transmission:
		from	to	from	to		
Cadillac	CTS-V Sport	2014-2016		All	All	LF3 Turbo	All
Cadillac	XTS	2014-2016		All	All	LF3 Turbo	All

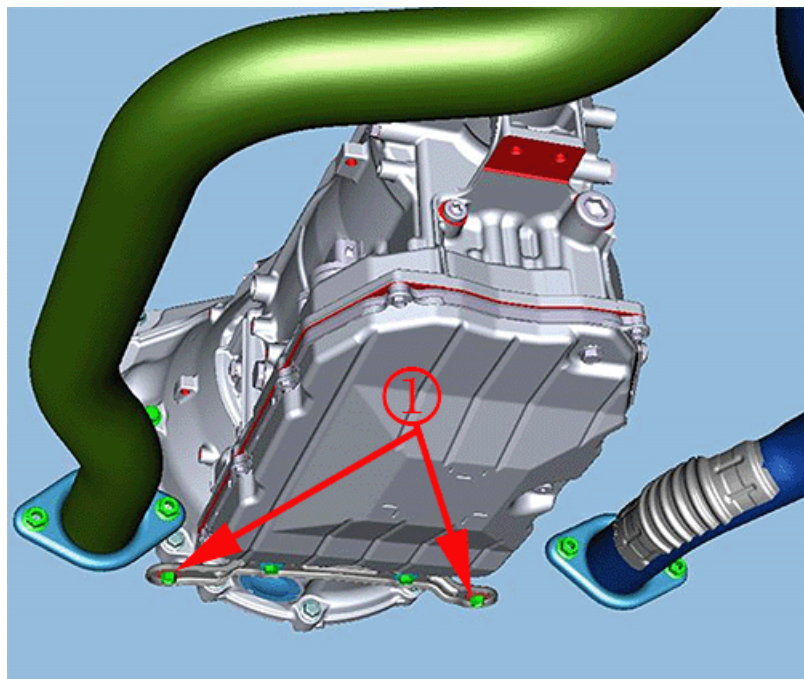
Inspect the M8 nuts noted in the picture that secure the catalytic converters to the exhaust bracket.

Over time during normal operating conditions these nuts can lose torque and cause a rattle that sounds like it is coming from the turbocharger.

If technician finds the M8 nuts are loose it will be necessary to replace them with new torque prevailing nuts, P/N 11546441 LF3 (2 nuts).
