Service Update

16189 Electronic Steering Column Lock Module Installed In Error

Reference Number: N162055980

Release Date: January 2017

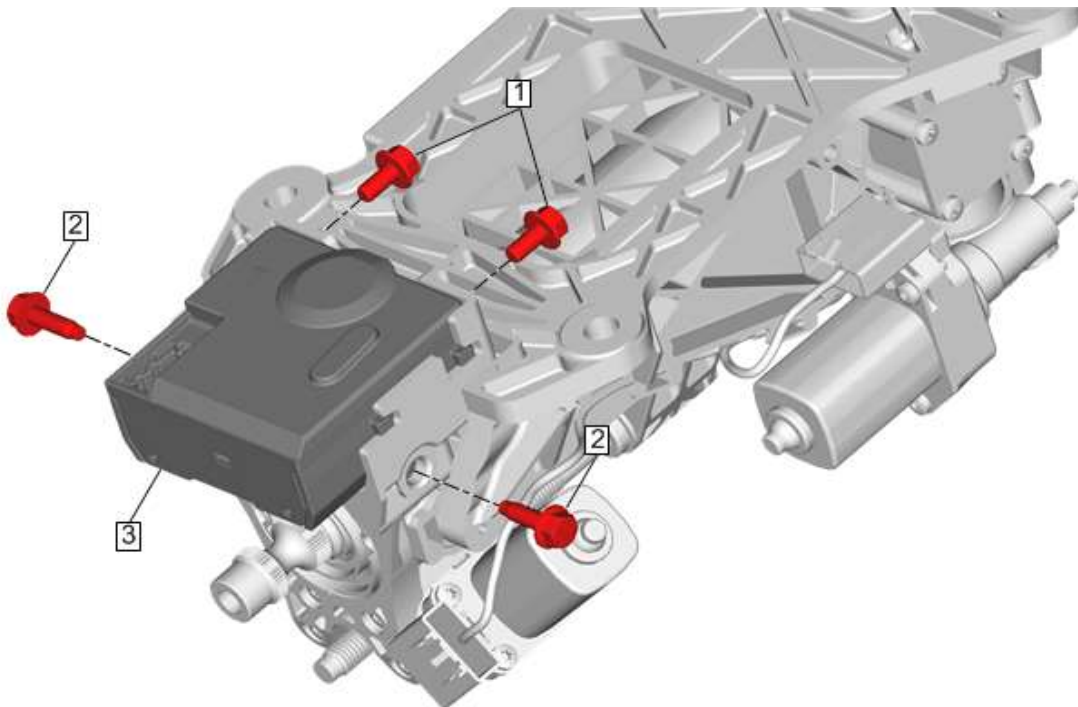
4254524

3. Inspect for the presence of the steering column lock control module (3).
 - If the steering column lock control module is NOT present, no further action is required. Proceed to the next step.
Note: Do NOT install a replacement module. Remove the steering column lock control module if it is present and DISCARD it.
 - If the steering column lock control module is present, remove the steering column lock control module and DISCARD. Refer to *Steering Column Lock Control Module Replacement* in SI.
4. Install the instrument panel lower trim panel insulator - left side. Refer to *Instrument Panel Lower Trim Panel Insulator Replacement - Left Side* in SI.
5. Center the steering angle sensor. Refer to *Steering Wheel Angle Sensor Centering* in SI.
6. Close the driver door.
