# Service Update

## 16189 Electronic Steering Column Lock Module Installed In Error

**Reference Number:** N162055980

Models: 2016 Cadillac CT6

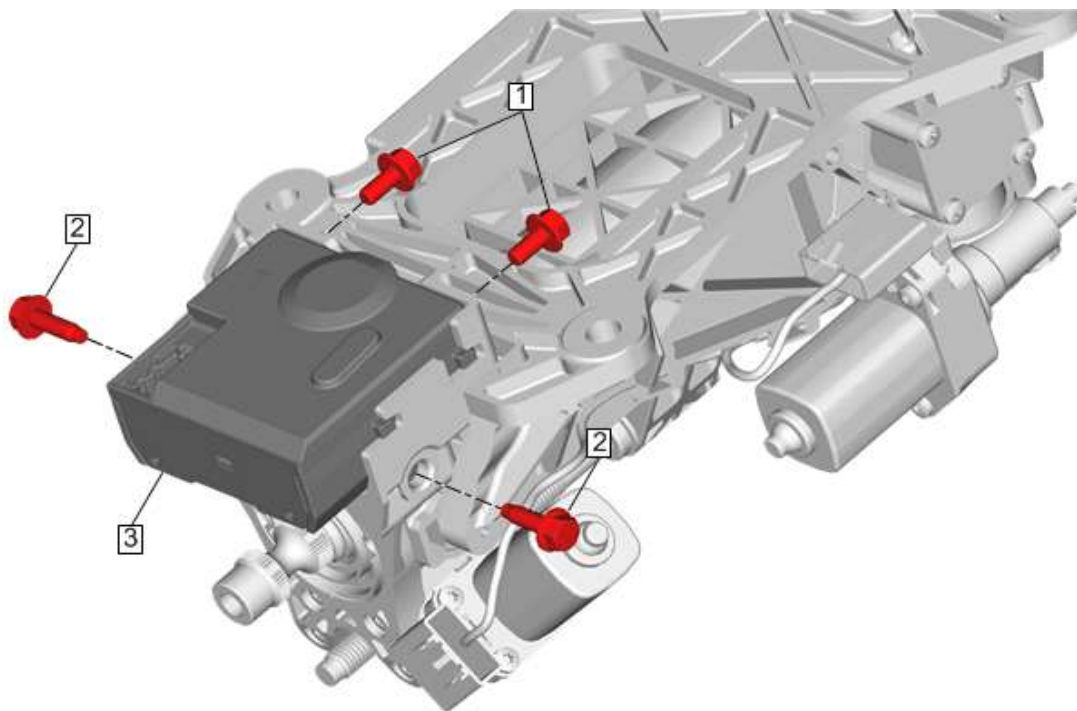
4254524

<b>Condition</b>	Certain 2016 model year Cadillac CT6 base model vehicles may have an electronic steering column lock (ESCL) module installed that does not require the component. If the ESCL is not removed, the lock bolt can potentially move out of its position and lock the column.
<b>Correction</b>	Inspect and, if present, remove the ESCL module.

3. Inspect for the presence of the steering column lock control module (3).
  - If the steering column lock control module is NOT present, no further action is required. Proceed to step 5.

**Note:** Do NOT install a replacement module. Remove the steering column lock control module if it is present and DISCARD it.

- If the steering column lock control module is present, remove the steering column lock control module and DISCARD. Refer to *Steering Column Lock Control Module Replacement* in SI.
4. Center the steering angle sensor. Refer to *Steering Wheel Angle Sensor Centering* in SI.
5. Install the instrument panel lower trim panel insulator - left side. Refer to *Instrument Panel Lower Trim Panel Insulator Replacement - Left Side* in SI.
6. Close the driver door.
