Service Update

17069 Auxiliary Coolant Pump to Transmission Fastener Attachment

Reference Number: N162077350

Make	Model	Model Year		RPO	Description
		From	To		
Chevrolet	Malibu	2017	2017

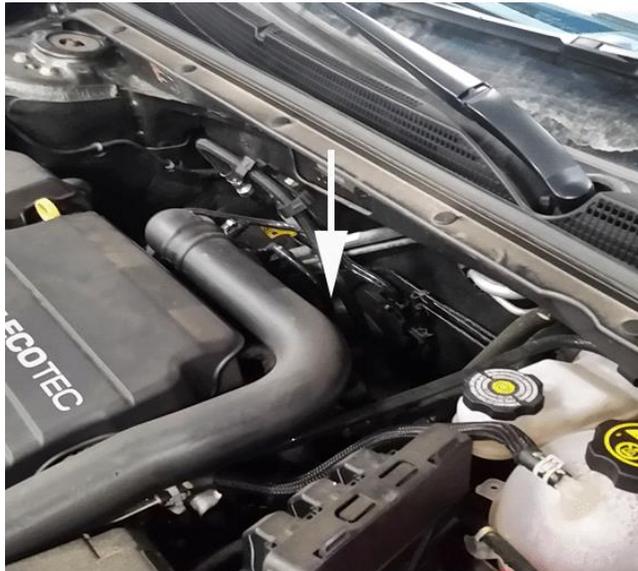
4705856

2. Locate the heater coolant pump.

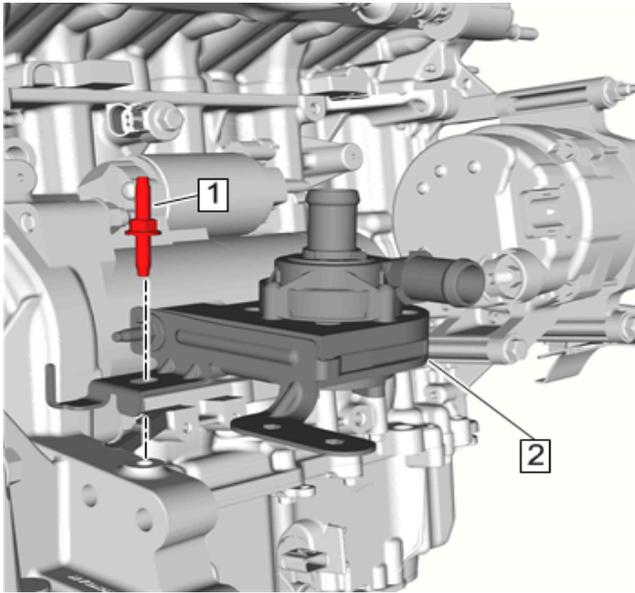
4214494

Condition	The counter bore in the torque converter housing used for auxiliary coolant pump attachment was drilled deeper than specification. The increased counter bore depth limits the usable thread distance for the original fastener to contact. There is only one fastener used to hold the pump.
Correction	Replace the double ended auxiliary coolant pump mounting stud with revised attachment bolt.

3. Remove the heater coolant pump bracket bolt (1).

Note: The new heater coolant pump bracket bolt has a hex head and is NOT a double ended stud.

4. Install a new heater coolant pump bracket bolt and torque to 9 Nm (80 lb in).
5. Remove fender covers and close hood.
