# Preliminary Information

## PIT5380B Front Row Seat Back Appears To Lean Outward (Seat Cover Improperly Installed)

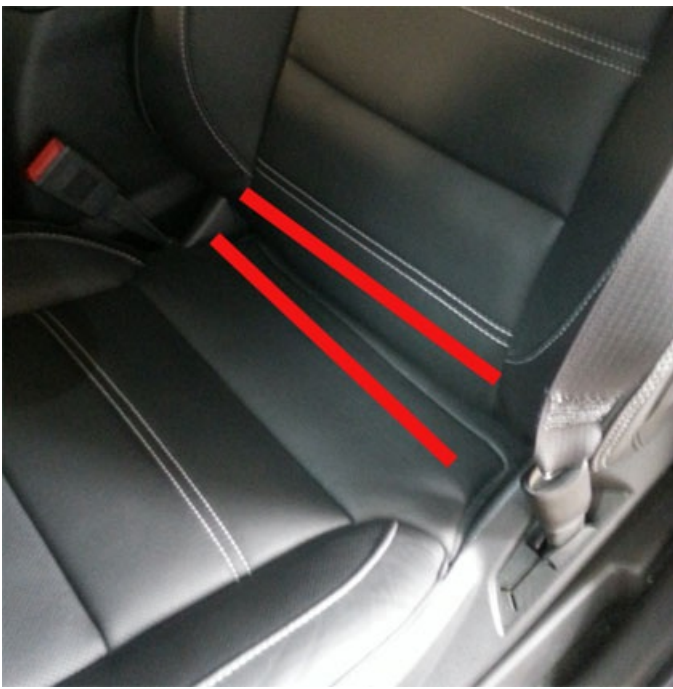
Some owners may perceive that the front driver's or passenger's seat back may lean or be turned outward, as shown below.

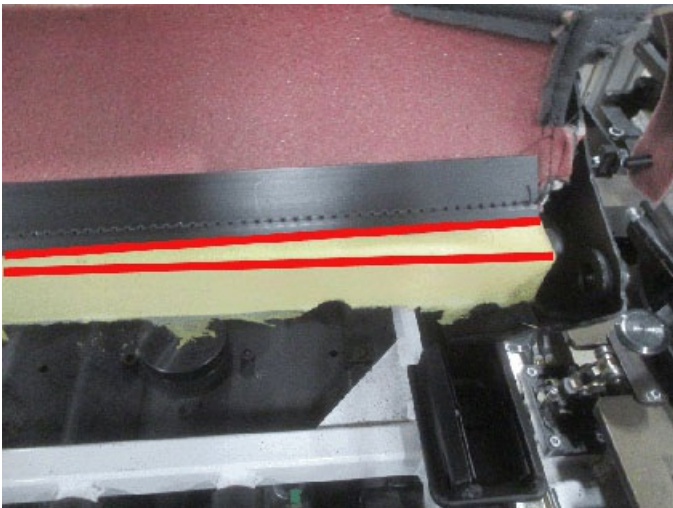
This concern could be caused by the seat bottom trim cover not installed correctly onto the cushion/foam, as shown below. If the seat cover is not completely and squarely installed onto the cushion/foam, it will give the appearance that the seat back is leaning or turned outward.
