Preliminary Information

PIP5468 Check Engine Light On with DTCs P0101, P0299, P11CC, P11DC, P2002 and / or P20EE set.

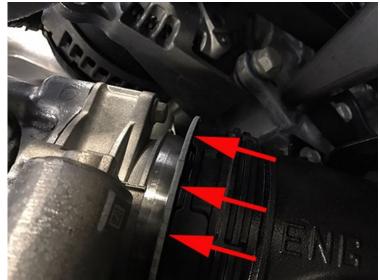
Picture of a non-secured connection between the charged air cooler pipe and the throttle body.

If any combination of DTCs P0101, P0299, P11CC, P11DC, P2002 or P20EE are set; check for loose charged air cooler ductwork at the turbocharger outlet pipe, the charged air cooler inlet pipe, the charged air cooler outlet pipe and the connection at the throttle body. Please note that a static visual inspection may not reveal that the connection is not adequate and that it is most likely to occur during engine roll or brake torque.
