# Preliminary Information

## PIP5457C Surge hesitation Chuggle Misfire Feeling With A Light Tip In

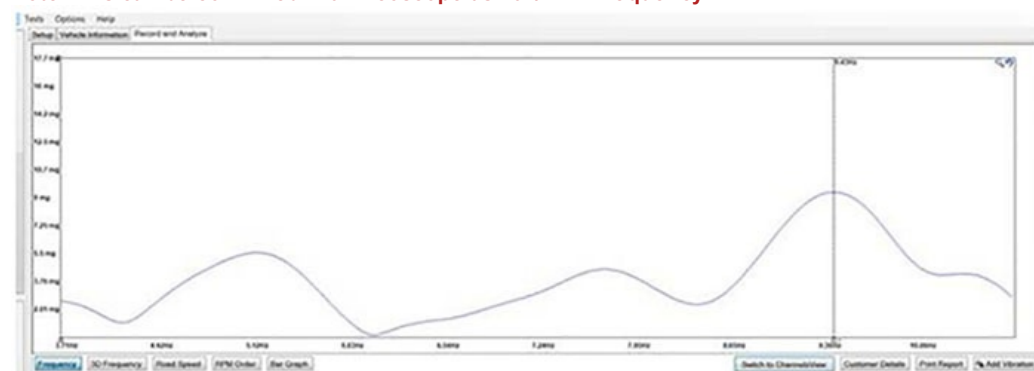
Note: This can be confirmed with Picoscope as 10+/-2 Hz frequency.
