Bulletin No.: PIP5029H
Published date: 02/13/2017

PIP5029H Rough Idle Crank No Start Extended Crank Or Misfire Due to Excessive Carbon On Top of the Valves or Sticking Valves

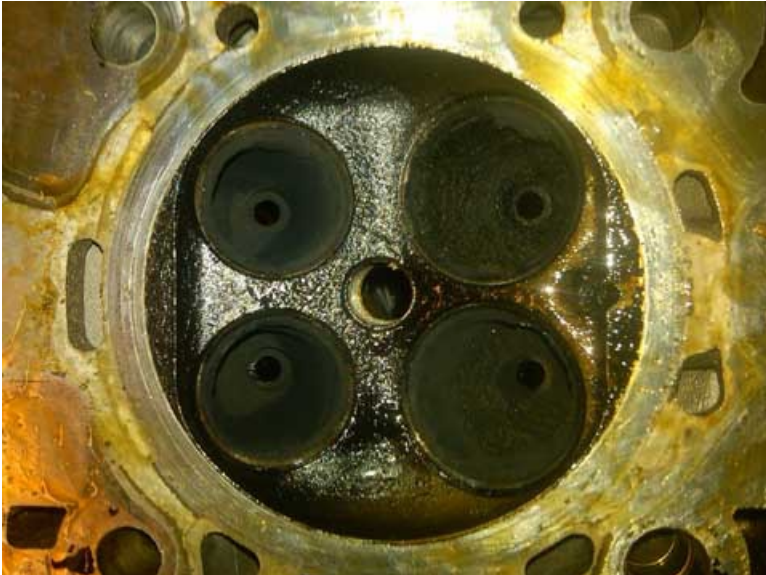
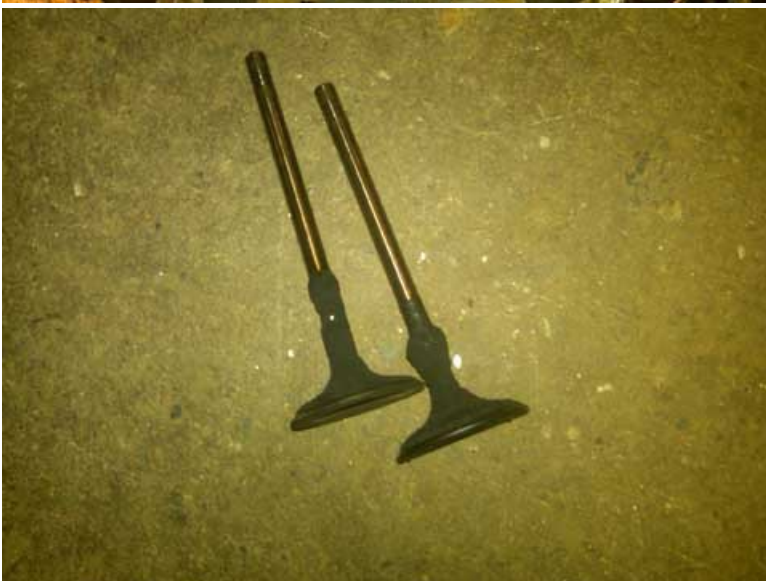
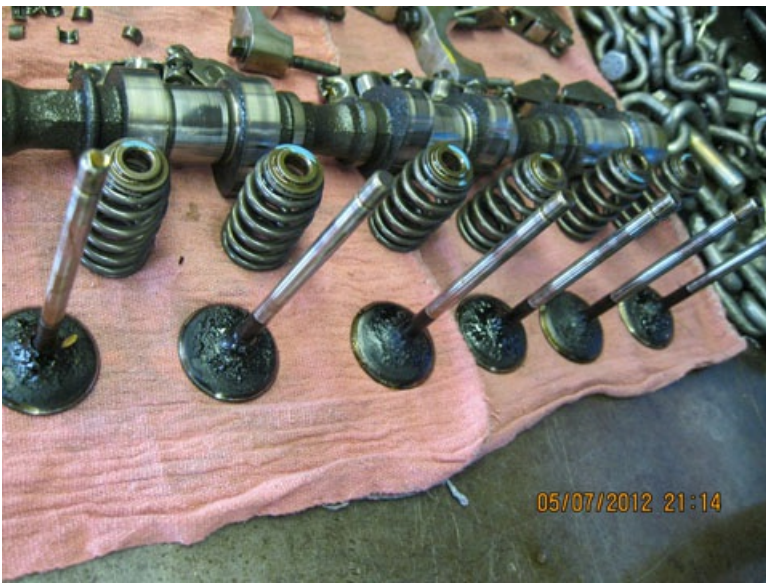
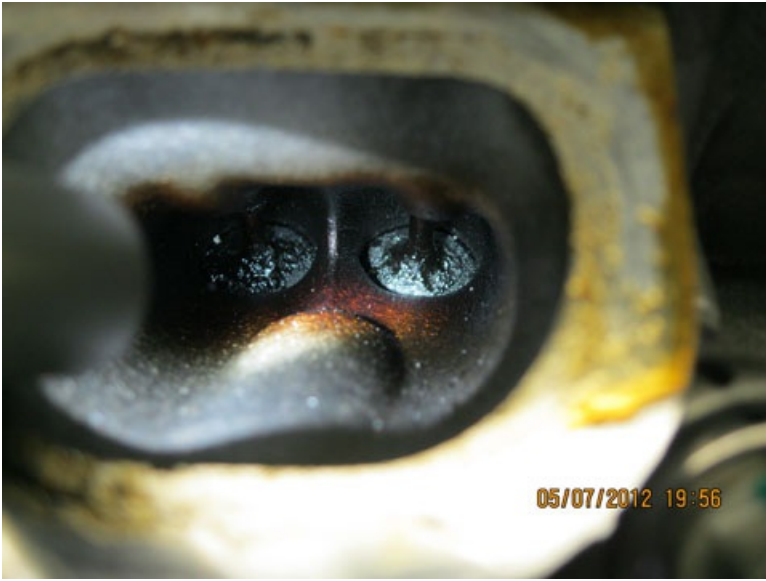
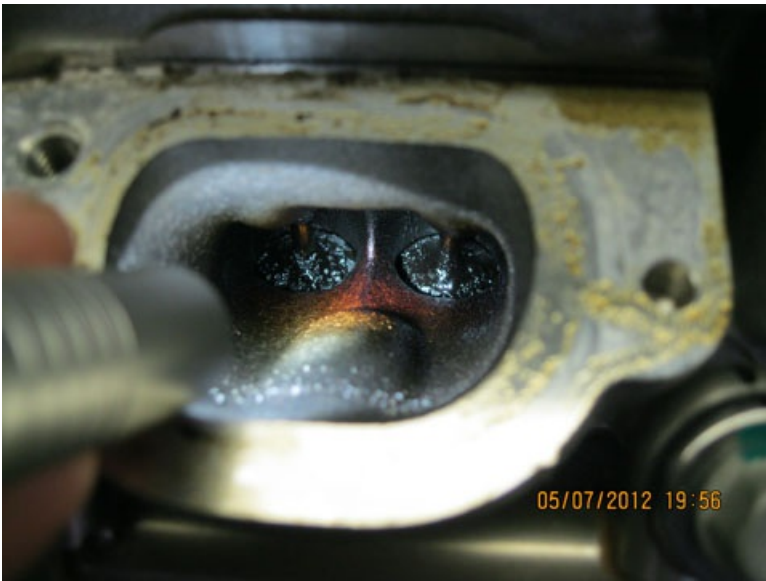
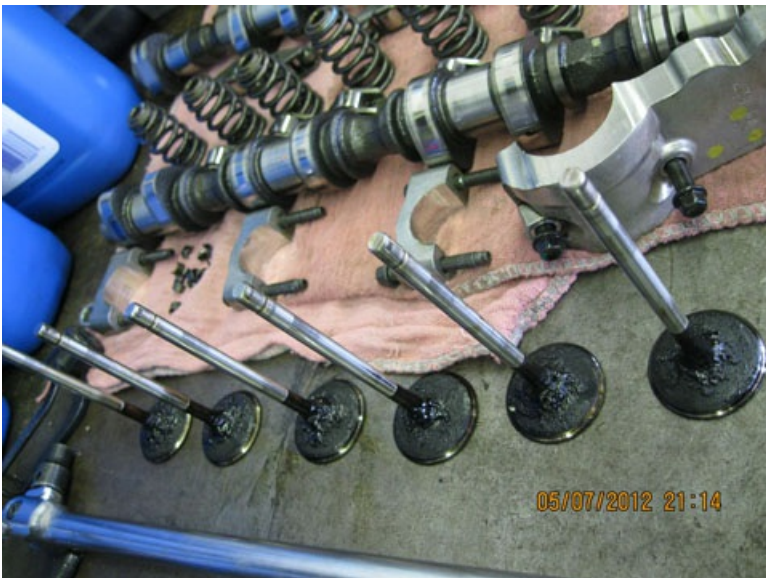
This may be the result of major carbon build up on the intake and/or exhaust valves due to fuel contamination or incomplete burning of the fuel as shown below so the misfires should not have appeared until accumulating at least 5,000 miles or more.

When the engine is cold, the compression on multiple cylinders may be at 0 PSI.

The engine also may pop through the intake or exhaust while cranking and the spark plugs may be fuel fouled when inspected.

Some engines may also experience valve damage or cam followers that are out of position as a result of this.

If there is no sign of valve damage or cam followers that are out of place, perform the following procedure to free up sticking valves and to remove carbon from the valves and pistons.

If valve damage is present or if there are cam followers that are out of place, perform engine mechanical repairs as necessary to correct the concern and then perform the procedure below to prevent the concern from returning.

Perform an upper engine and valve cleaning procedure as outlined below.

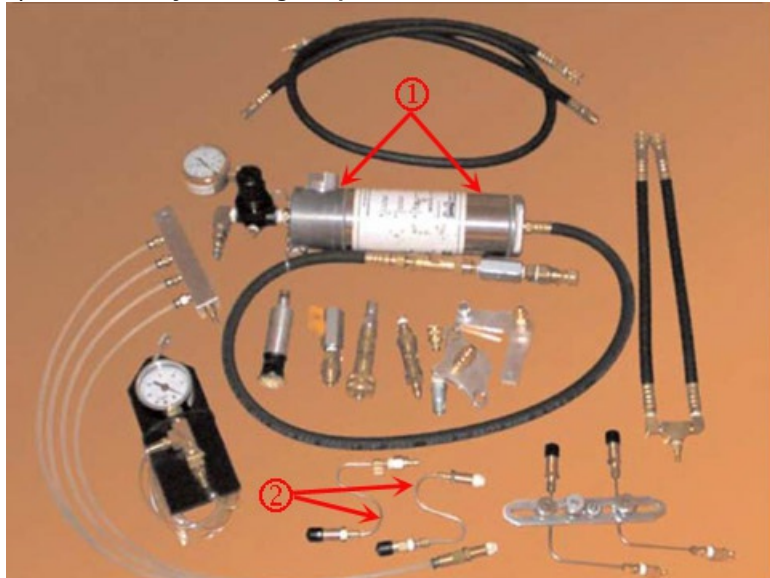
Kent Moore Tool Kit # J-45076

1) Pressurized Canister from J-45076 is Shown - J-35800-A is Similar (Equivalent Pressurized Canister Acceptable)

2) Throttle Body Cleaning Adapters J-45076-46 and J-45076-55 Shown (Equivalent Adapters Acceptable)

***For best results, it is suggested to induce the cleaner through the throttle body with Kent Moore Tool # J-45076 / J-35800-A or equivalent (shown below).
