# **Preliminary Information**

PIP5331D Ticking, Tap, or Rattle Noise From Engine

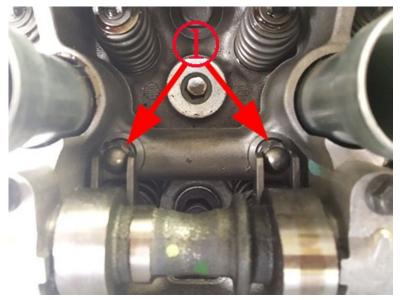
- 1. Perform injector diagnosis to ensure there are no leaking injectors causing a noise due to excessive fuel in 1 cylinder.
  - a) Perform GDS2 or AFIT test on injectors to isolate a leaking injector.
  - b) Replace any out of specification injectors
  - c) Reevaluate the noise.
- 2. Remove the intake manifold and visually inspect for excessive carbon on the intake valve stems and top of the valve causing noise
  - a) If carbon is present then follow the latest version of PIP5029 to clean the valves or replace heads as needed.
  - b) Reevaluate the noise concern.
- 3. Remove the cam cover of the affected bank (both if needed) to inspect for soft or spongy SHLAS (stationary hydraulic lash adjusters) (Lifters).
  - a) Push down on the rocker end at the SHLA to test for soft or spongy. (right side exhaust are most common but could be any) SEE PICTURE

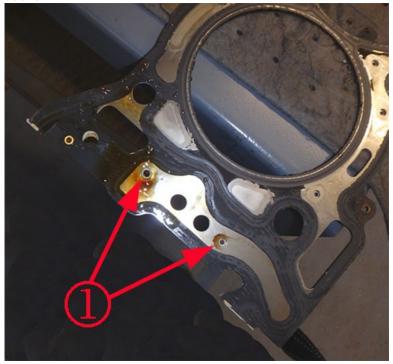
b) If soft or spongy SHLAS are found, carefully remove the affected head and inspect the oil passage below the head gasket for debris.

- c) If debris is found, inspect the camshaft caps for wear or discoloration due to lack of oil.
- d) If wear or discoloration is found then replace the cylinder head assembly with camshafts.
- e) If there is no wear or discoloration, clean the oil passages and replace the head gasket.
- f) Change the oil and filter.
- g) Reevaluate the noise concern.
- 4. Raise the vehicle while running or with an assistant inside.
  - a) With chassis ears or a stethoscope, listen to the right and left side of the engine.
- b) Once the noise is isolated or if unable to isolate, remove the piston and rod assemblies from the affected bank(s) to inspect for either; a loose rod bushing in the rod, or a loose wrist pin in the bushing. We have seen both.
  - c) There should be no metal through the oil for this condition.
  - d) If this is found a piston and rod assembly will repair this noise.
