Bulletin No.: PIP5197D
Published date: 02/17/2017

PIP5197D Possible Oil Consumption - Oil Leaks - Blue Smoke From The Exhaust - MIL - Or Fuel Trim Codes

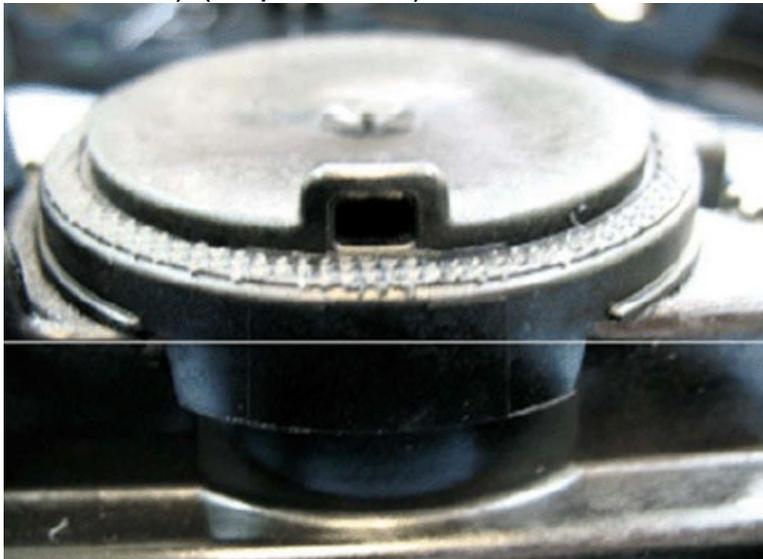
Check the PCV orifice for leaking oil or drawing vacuum at idle thru its external port. (The PCV orifice is an integral part of the camshaft cover). (See picture below).

If the PCV orifice external port is leaking oil or vacuum, replace the camshaft cover assembly.

Clean oil from all induction system components and retest for oil consumption, leaks or DTCs resetting.

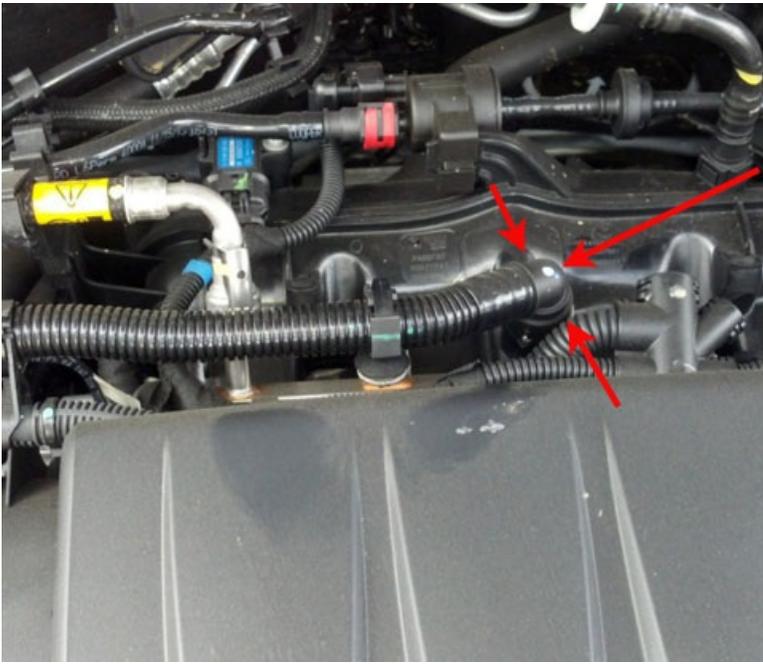
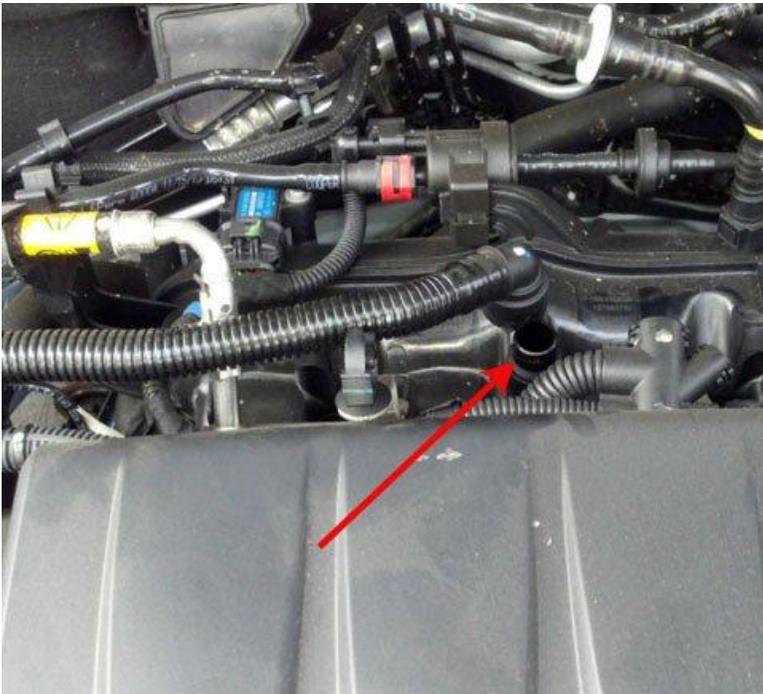
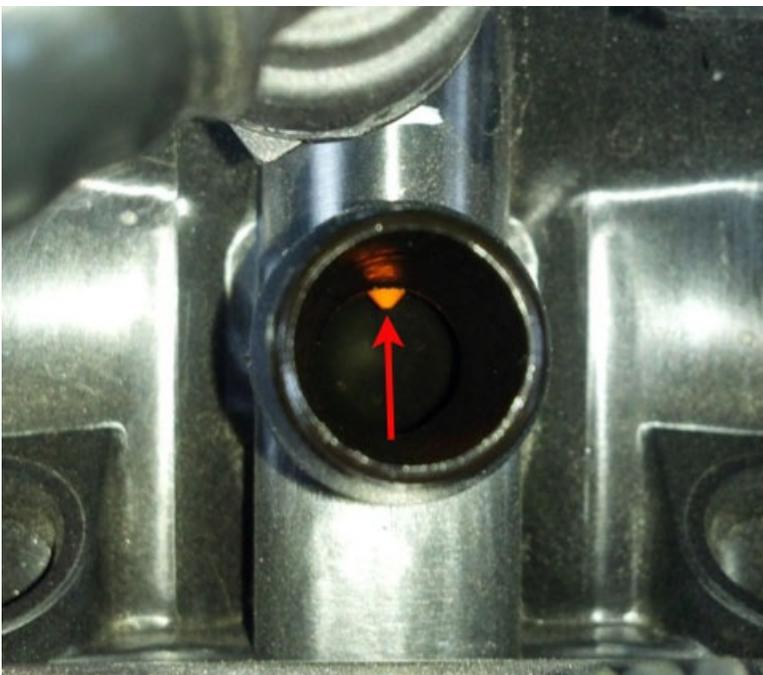
Check for a missing intake manifold Non Return Valve that may have damaged the PCV orifice diaphragm. (See pictures below for inspection procedure).

If the non return valve is not visible as shown in picture, then use a long cotton swab to wipe any excess oil from the valve to validate.

If the non return valve is still not visible, then intake manifold removal for inspection is required to validate.

If the valve is present reinstall the intake manifold. Do not replace.

If the intake manifold Non Return Valve is missing, then replace the intake manifold assembly,

Clean oil from all induction system components and retest for oil consumption, leaks or DTCs resetting.

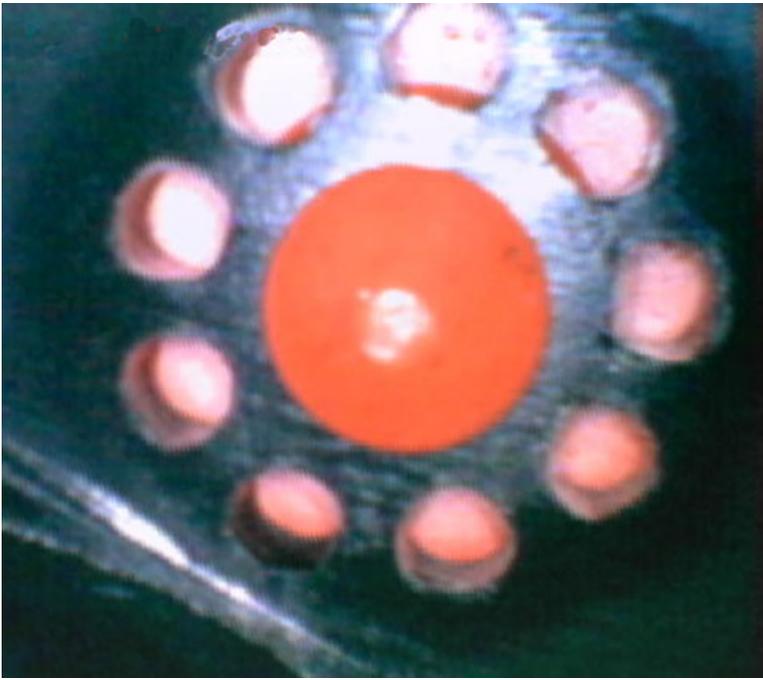
Properly seated Non Return Valve as viewed with the intake manifold removed.

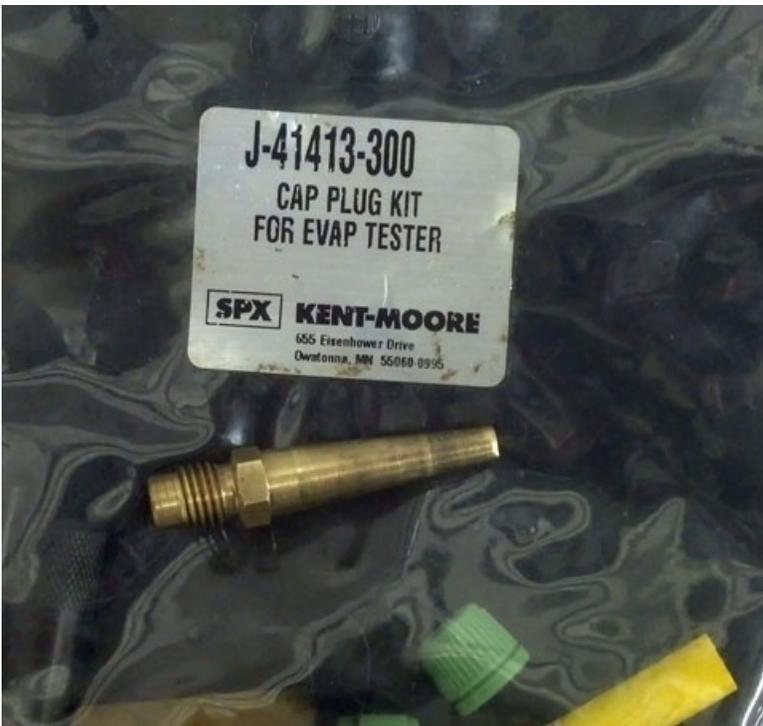
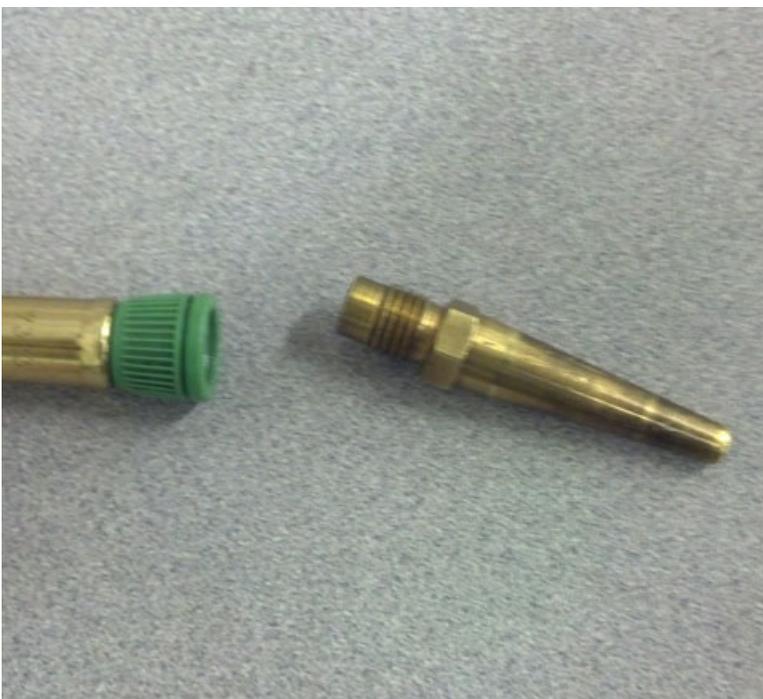
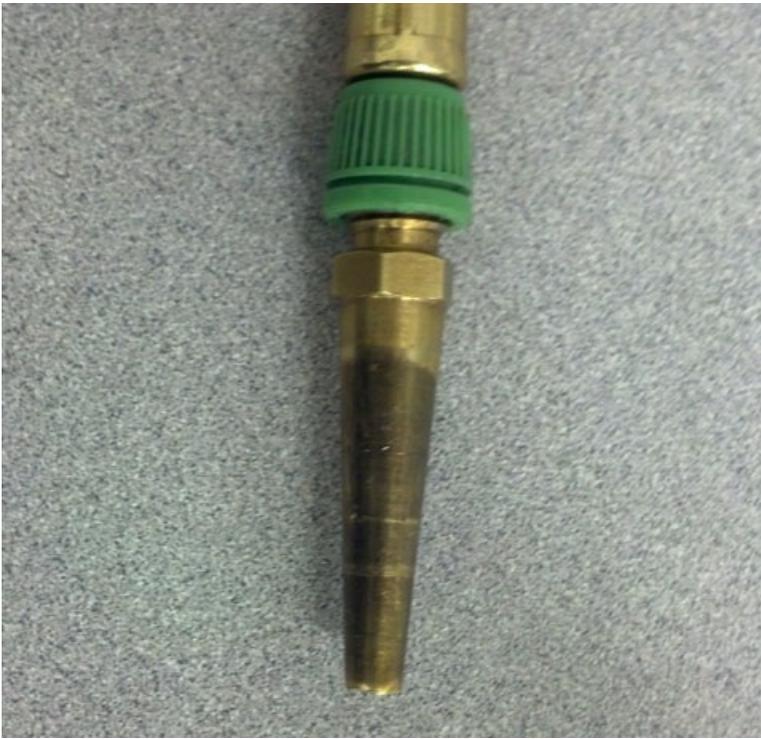
Record the crankcase pressure. (Normal crankcase pressure readings are between -11 & -18 inches of water in park at hot idle) / (ESST gage works best, see pictures below for connection of ESST at the engine oil dipstick hole in the camshaft cover.

Record the crankcase pressure at hot idle in park as well as under snap throttle.

Note: The connection must be made with the engine off. The engine is then started and the pressure readings are recorded.

If the crankcase pressure is between -10 and 0 inches of water then a cylinder leakage / crankcase pressure concern exists.

This is likely caused by a weak or broken piston ring land.

Replace all four piston assemblies and retest for proper crankcase pressures.

Clean oil from all induction system components and retest for oil consumption, leaks or DTCs resetting.
