# Preliminary Information

PIP5476 No crank, loss of communication with ECM and TCM, ignition key stuck in ignition cylinder, dead battery

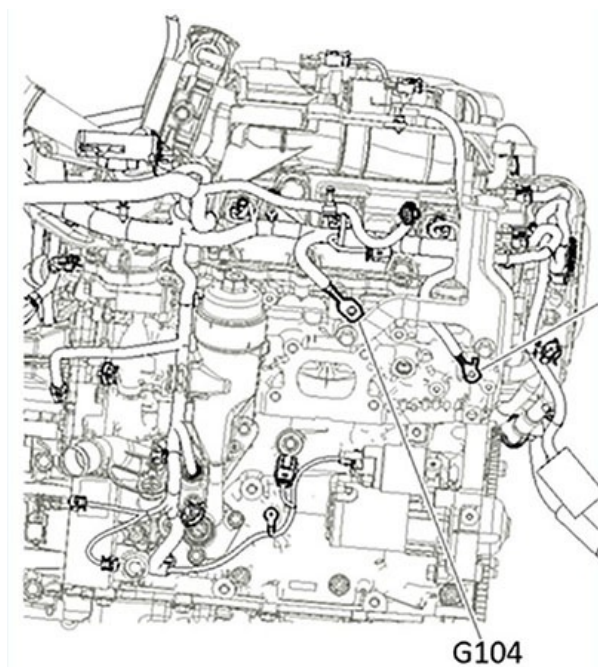
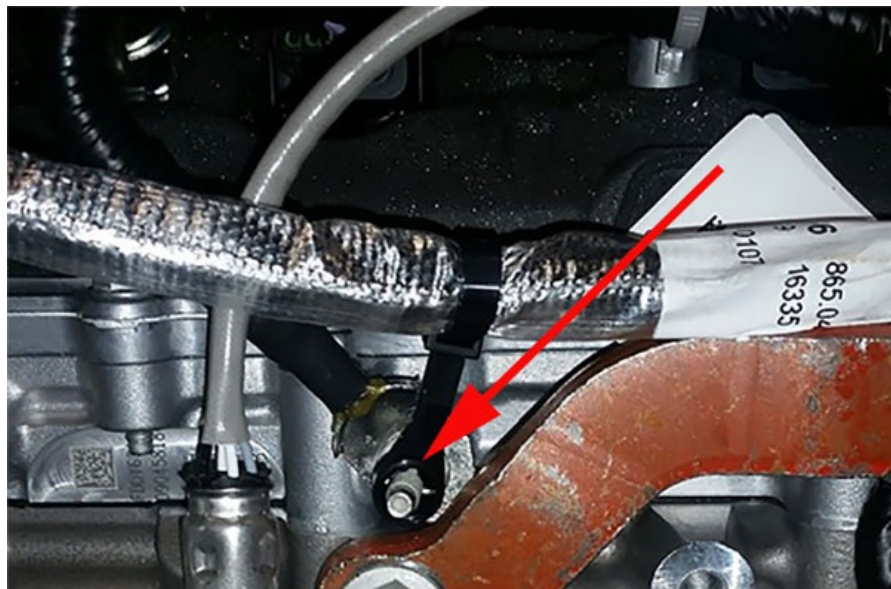
Brand:	Model:	Model Years:	VIN:		Engine:	Transmissions:
			from	to		
Chevrolet	Colorado	2017	ALL	ALL	3.6 LGZ	ALL
GMC	Canyon	2017	ALL	ALL	3.6 LGZ	ALL
Involved Region or Country	North America					
Additional Options (RPO)	N/A					
Condition	Some customers may comment on one of the following conditions: Intermittent, No crank, loss of communication with ECM and TCM, ignition key stuck in ignition cylinder, dead battery DTC's P018C P0449 P0452 P0463 U0101 U0100 U0401 U0121 U0131 U18A2 P0522 P16E5 P0118 may also be set.					
Cause	This condition may be caused by a loose ECM TCM ground on driver's side cylinder head (see illustration).

Correction:

Inspect G104 and tighten or repair as necessary.
