Preliminary Information

PIP5246A (EREV) Reduced Propulsion with P0C17 P1B03 Or P0C01 (Drive Motor 1 Only)

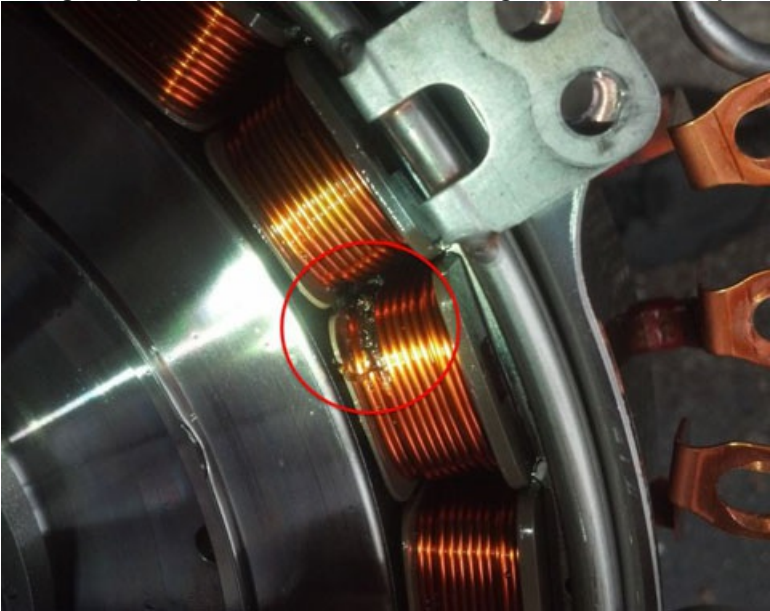
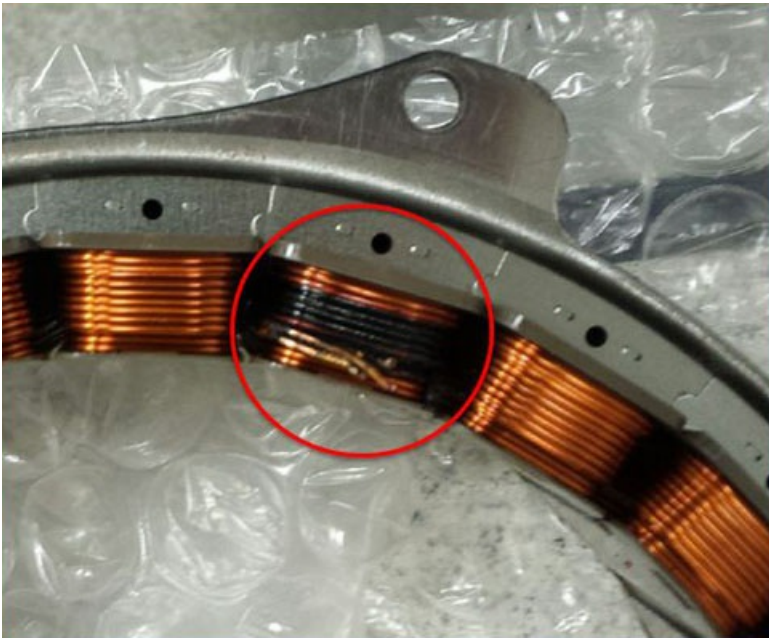
Some SI diagnostic procedures may not comprehend the possibility of the Motor 1 Stator as the cause of these DTCs. If one or more of these diagnostics are set, especially on a vehicle with a lifetime fuel economy below 50 mpg and above average annual mileage, inspect the Motor 1 Stator for damage as shown in the pictures below.

If no damage is found, replace all of the following parts: Motor 1 Position Sensor, Transmission Internal Harness, and Motor 1 Stator (damage may be on windings below the top layer). Replacing the Drive Motor Generator Control Module should only be ordered if the condition persists after replacing these parts.
