# Preliminary Information

PIP5474 Diagnostic tip for 4 Wheel Drive Inoperative with no DTCs.

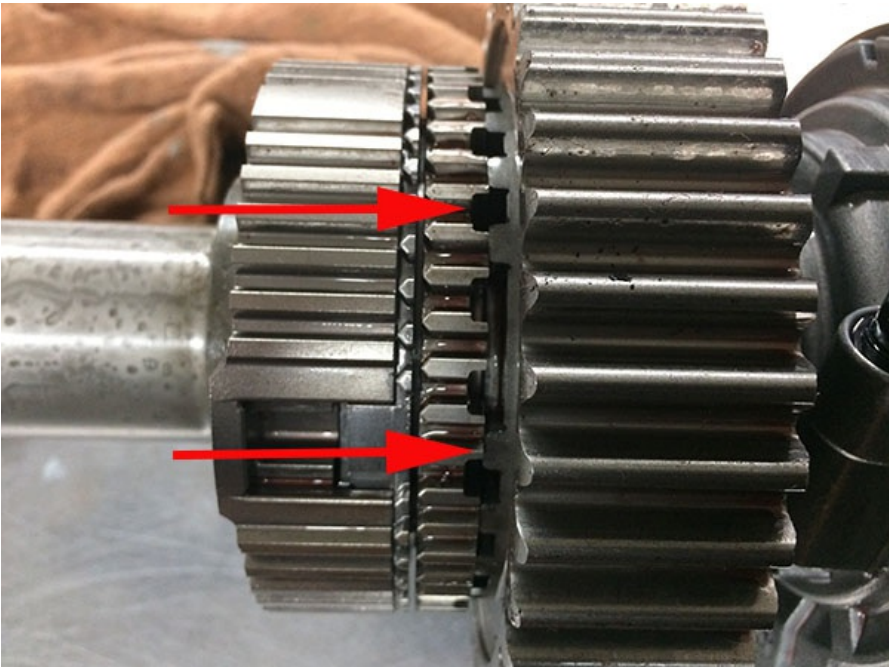
The above photo shows a gear that the body ring has separated from. This is a press fit and the ring should not separate from the gear. If the ring has separated from the gear, gear replacement is required. That gear is item 1 in the picture below.

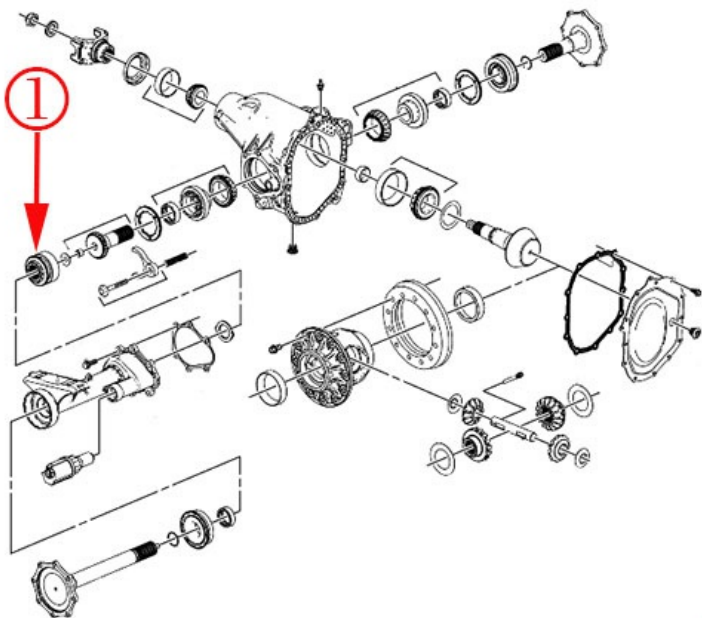
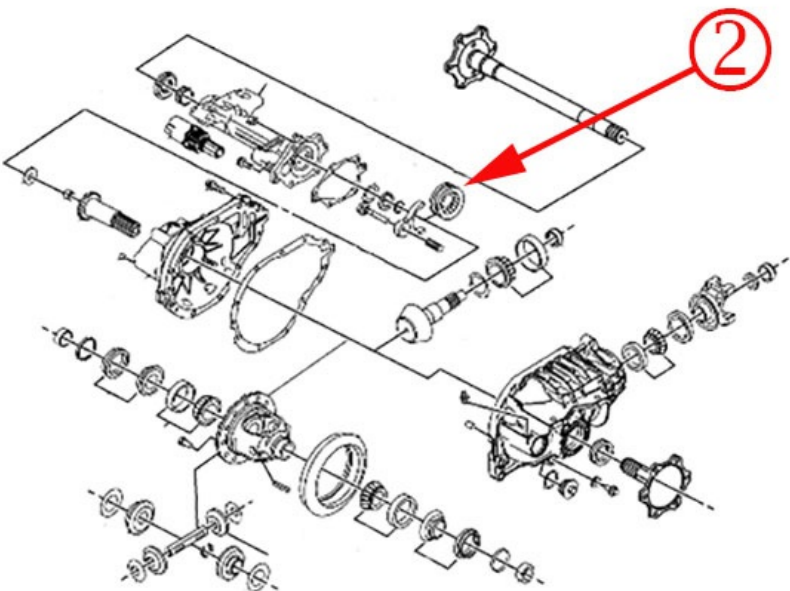
For vehicles that have been isolated to the front axle see pictures below as to what could be 1 cause of no power transfer through the differential to the front wheels.
