Preliminary Information

PIC5626B BAS+ (Hybrid) eAssist Service Charging System Message, MIL On With or Without DTCs P0A8F and P062F

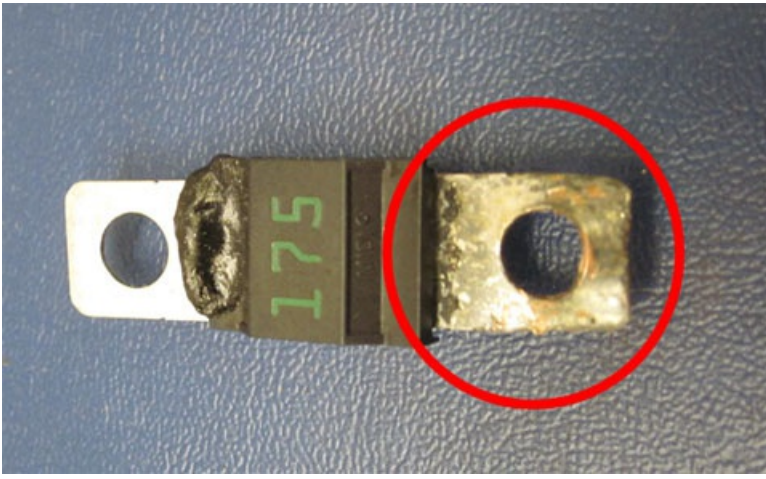
If the fuses are within specifications, inspect around the edge of the black plastic portion of these fuses for any sign of voltage stress as shown in the photo below. Make sure that the metal blades of the fuse are not bent or showing signs of thermal damage. Service P/N is 19119015.

If the fuses show voltage stress is present, this is most likely the result of a poor connection. The Fuses are now available individually. If the entire fuse block needs to be replaced for any reason the fuse block includes both fuses.

If the fuses pass inspection and they are not visually damaged in any way, install the fuses, carefully torque them to 4.7 Nm (42 lb-in), and re-evaluate the charging system operation. If the 175A fuse is open or has a poor connection, a P0A8F may be stored in history but the DTC may not consistently reset.
