Preliminary Information

PIT5404C Squeak Chirp Whistle Rattle Type Noise from Rear of Vehicle (Passive Exhaust Valve) or Buffeting Vibration Drone Exhaust Tone Change Body Pressure Booming (AFM Exhaust)

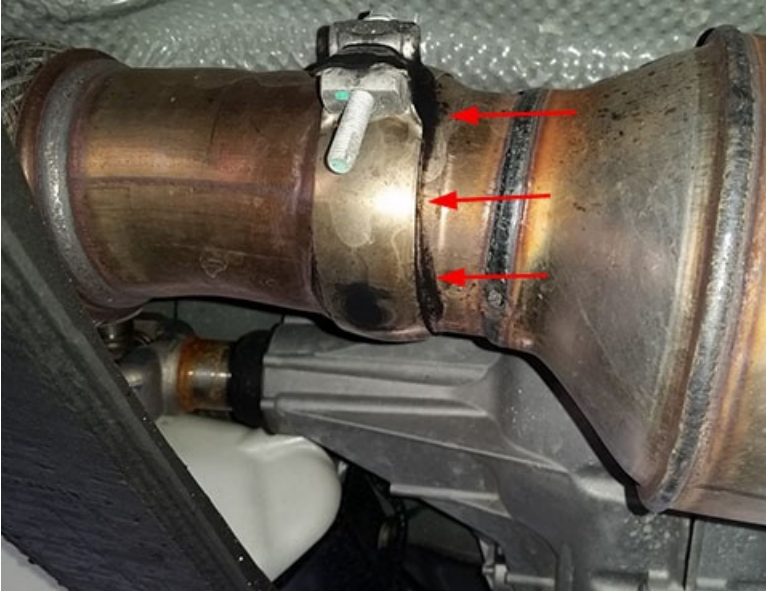
1. Ensure there are no leaks at the exhaust band (Norma) clamp joint. It has been found in some cases that a leak at the clamp joint could allow some level of exhaust tone change or exhaust vibration/drone type noise and/or buffeting vibration or body pressure booming to occur. Refer to latest version of PIP5442.
