PIT5549 Diagnostic Tip - SIR Lamp On

Product Investigation Review Required

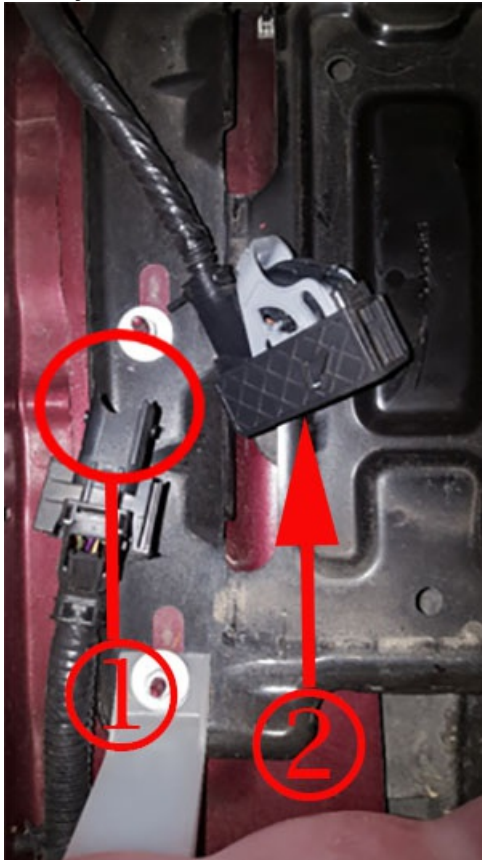
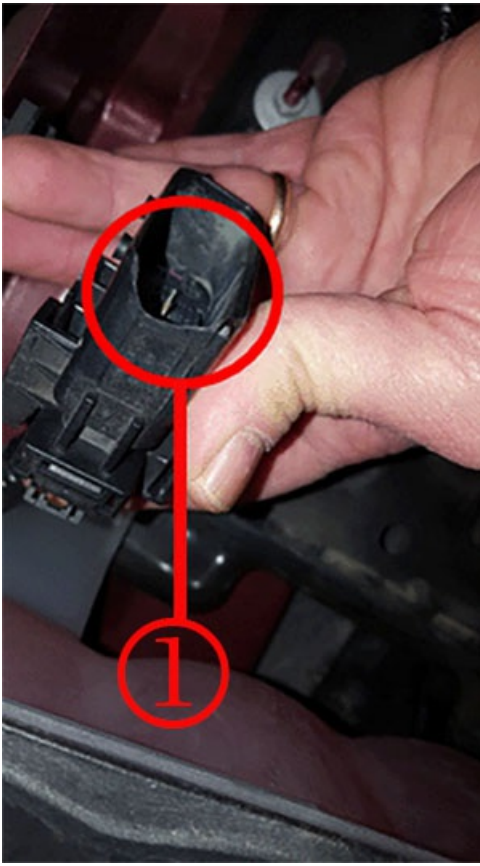
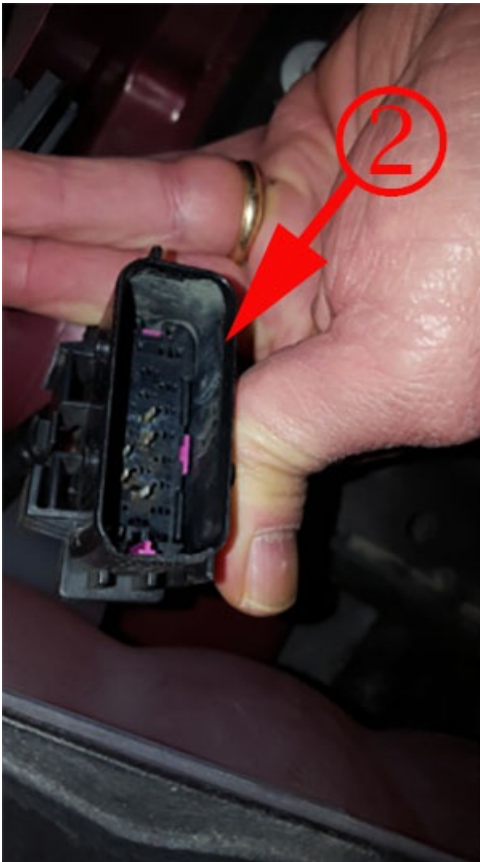
Inspect Connector X150 for being damaged as shown below. If connector is damaged, water can follow the harness into the vehicle and enter the SDM connector body and cause corrosion.

- 1: Forward Lamp Harness side of X150 which is damaged and has terminal corrosion due to water intrusion.
- 2: Body Harness side of X150 which has terminal corrosion due to water intrusion.

Repair affected connector or harness as needed.
