# Preliminary Information

## PIP5490 Malfunction Indicator Lamp Illuminated With DTC P0300

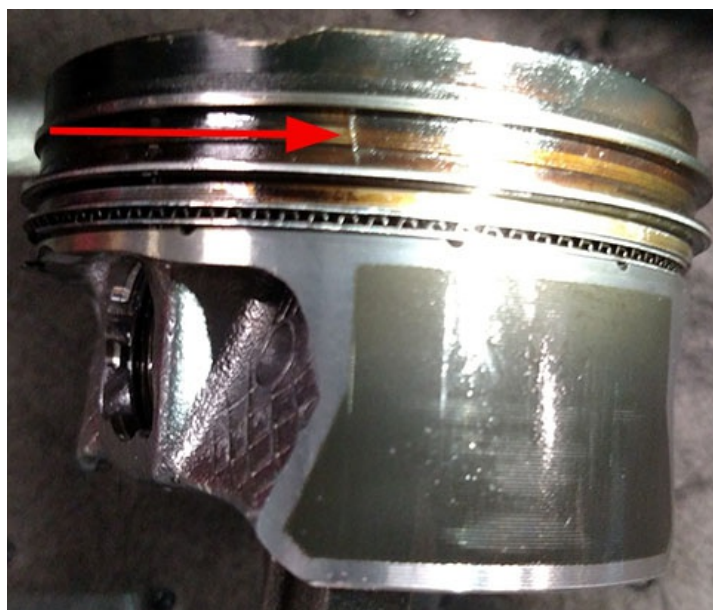
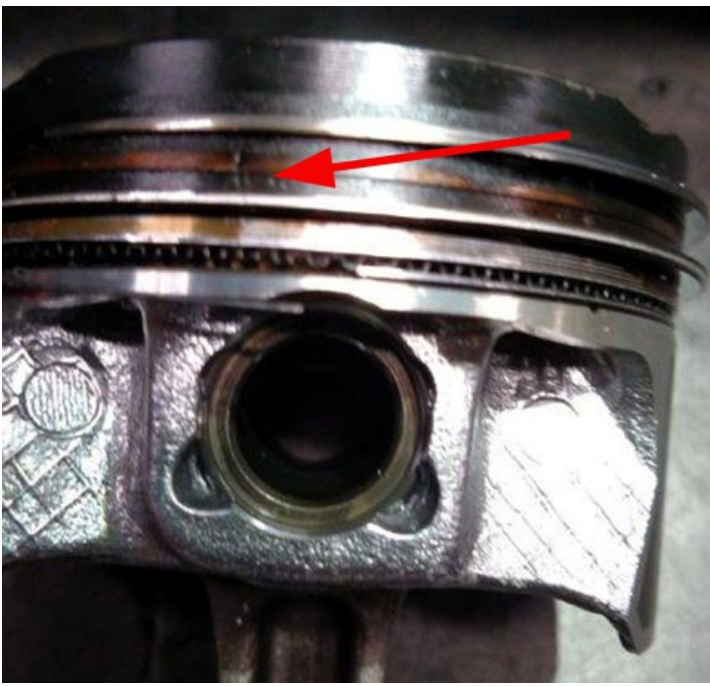
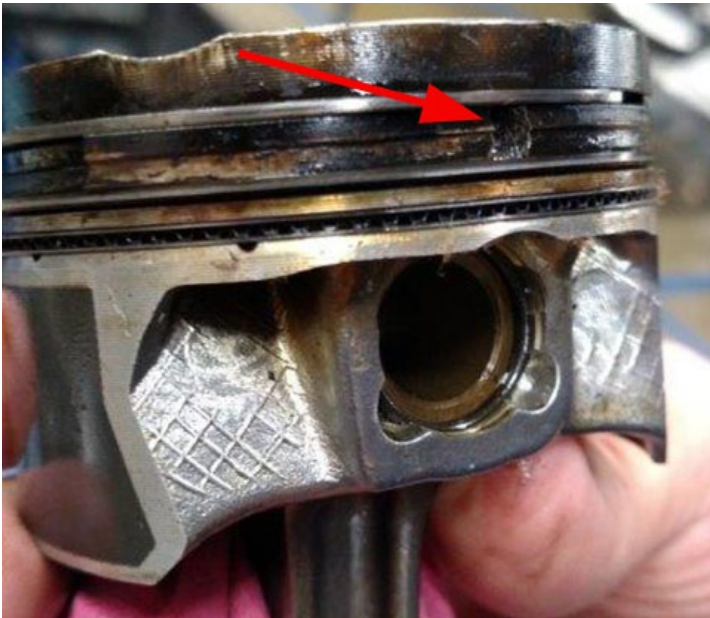
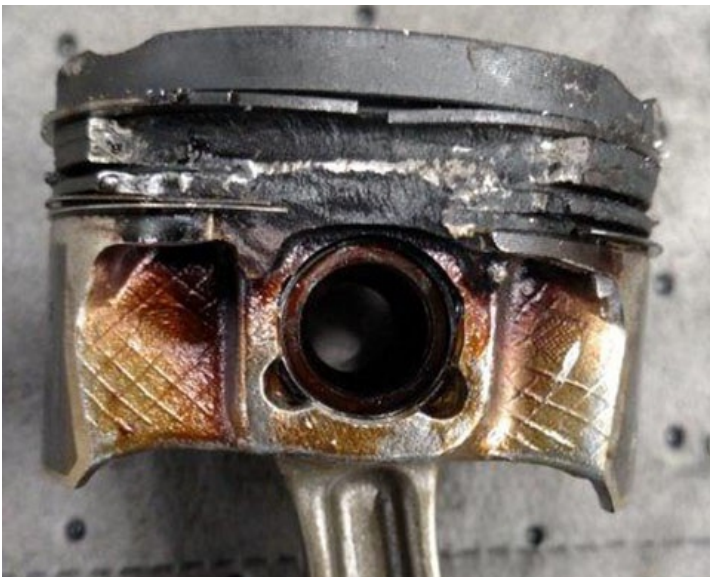
| Brand: | Model: | Model Years: | VIN: | | Engine: | Transmissions: |
|---|---|---|---|---|---|---|
| Cause | This condition may be caused by a damaged piston requiring replacement. | | | | | |

Shown below are examples of pistons with varying levels of damage.

If the cylinder wall surface has not been compromised, replace only the damaged piston and fill the crankcase with only current specification Dexos 1 oil.

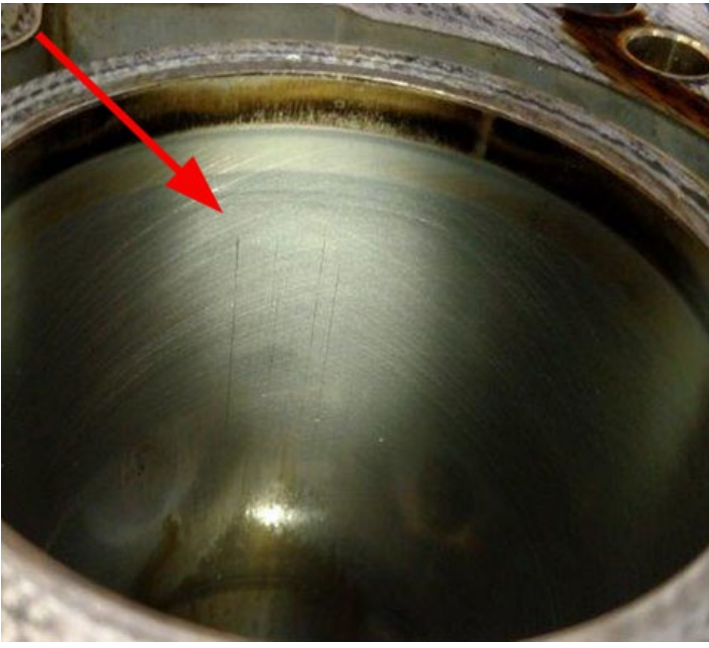
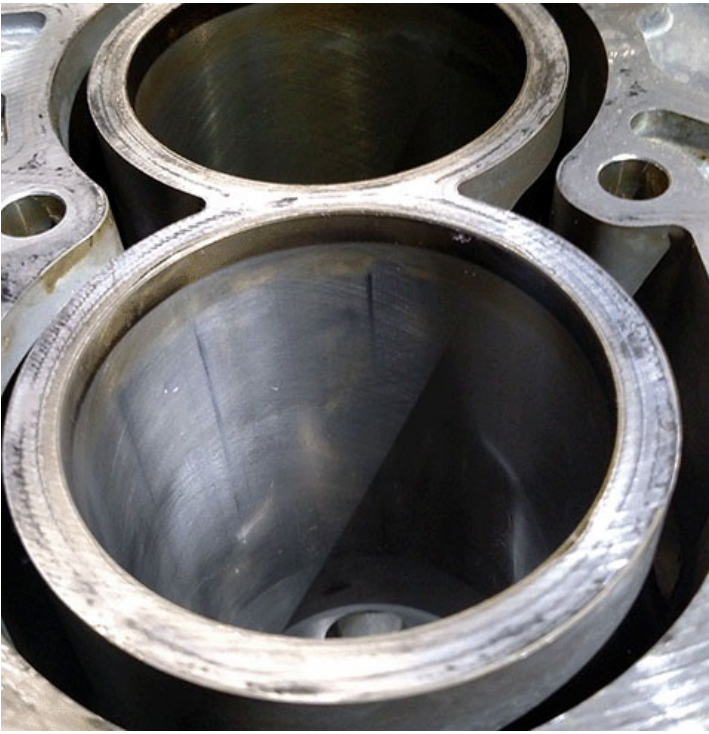
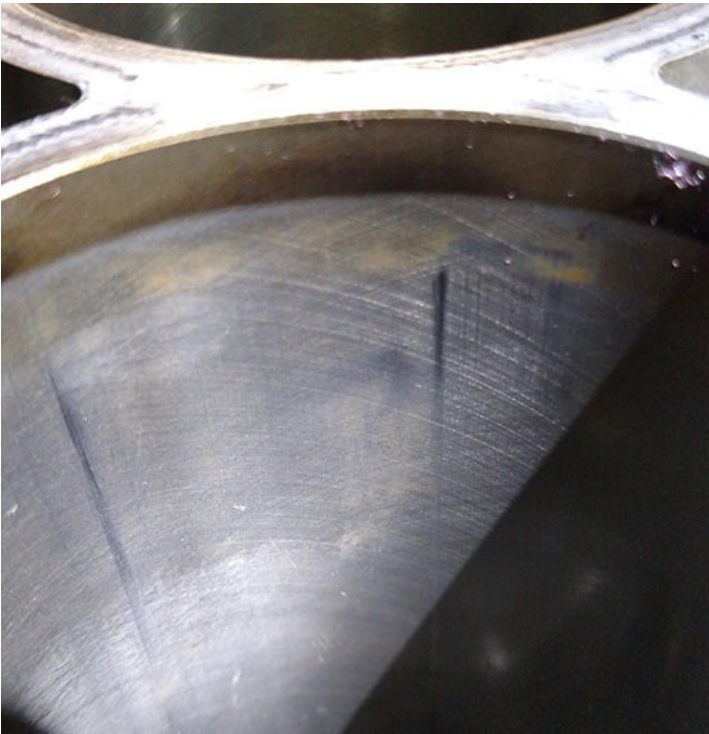
Shown below are several examples of light vertical marks visible on the cylinder wall. In these examples, none of the marks in the cylinder walls could be felt with the finger tip or nail and engine replacement is not recommended.

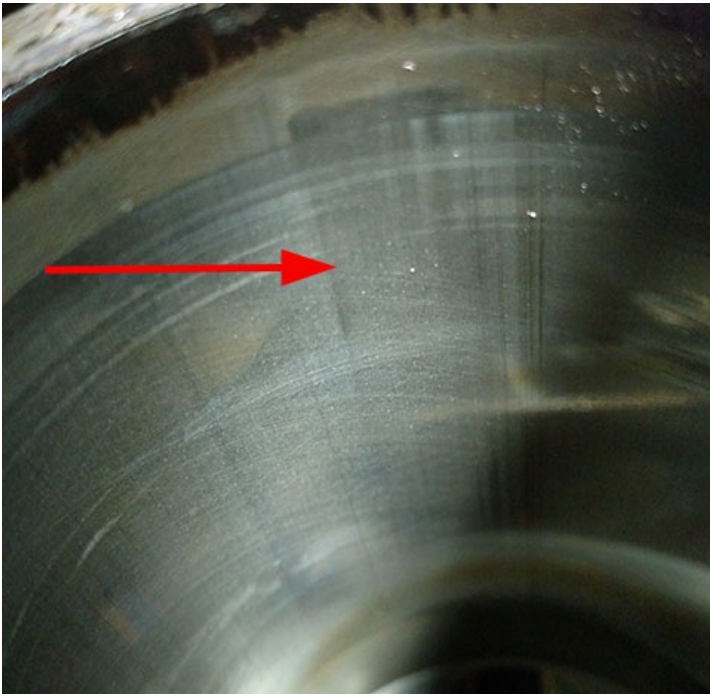
Shown below is an example of a damaged cylinder wall.  
In this example the scuffing is wide and has removed the crosshatch from the cylinder wall in the area above the arrow.  
This would result in oil consumption and requires engine replacement.
