Bulletin No.: PIP5197E
Published date: 04/4/2017

PIP5197E Possible Oil Consumption - Oil Leaks - Blue Smoke From The Exhaust - MIL - Or Fuel Trim Codes

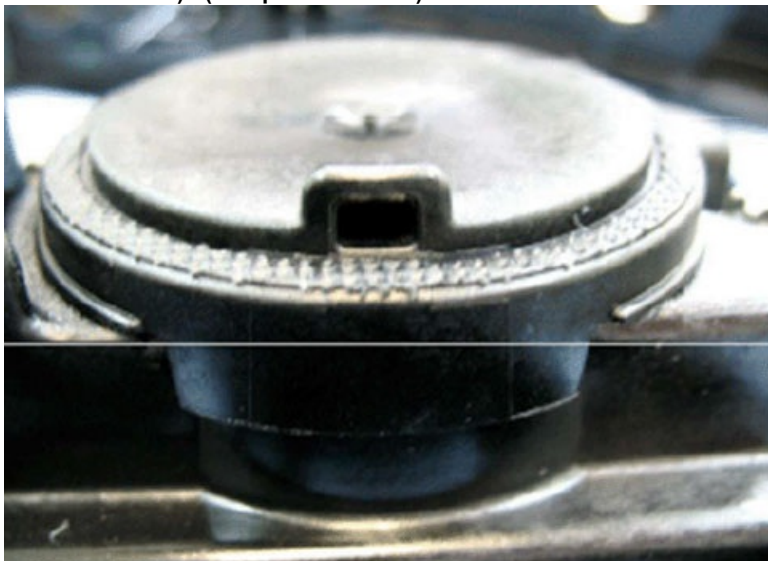
Check the PCV orifice for leaking oil or drawing vacuum at idle thru its external port. (The PCV orifice is an integral part of the camshaft cover). (See picture below).

If the PCV orifice external port is leaking oil or vacuum, replace the camshaft cover assembly.

Clean oil from all induction system components and retest for oil consumption, leaks or DTCs resetting.

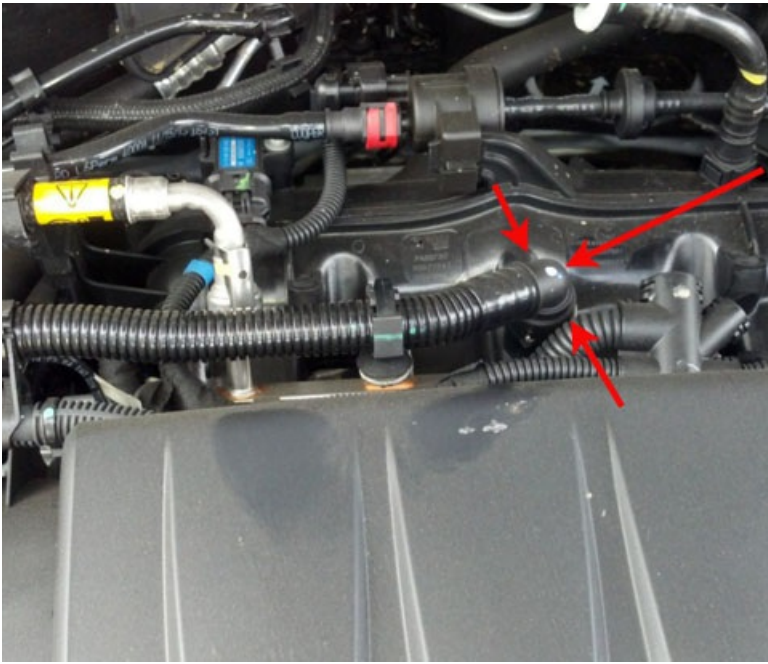
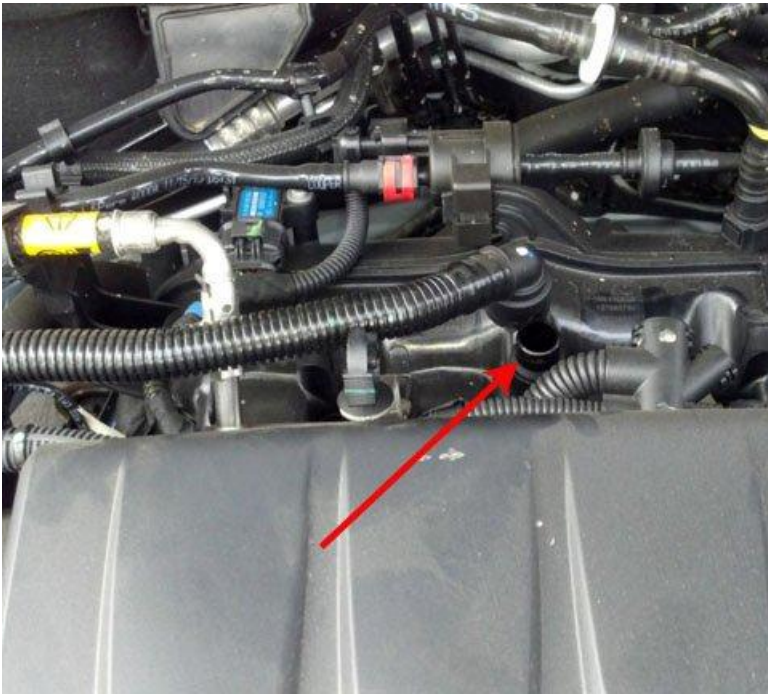
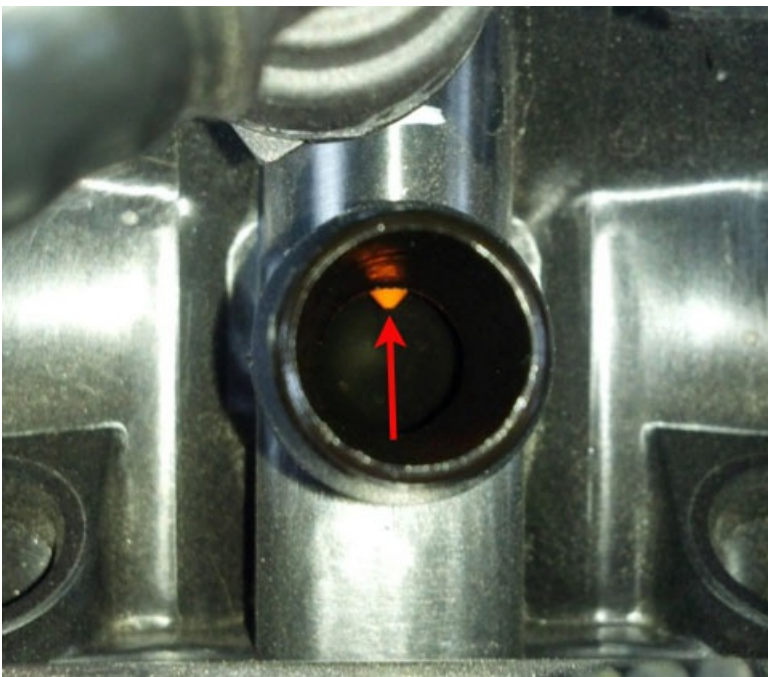
Check for a missing intake manifold Non Return Valve that may have damaged the PCV orifice diaphragm. (See pictures below for inspection procedure).

If the non return valve is not visible as shown in picture, then use a long cotton swab to wipe any excess oil from the valve to validate.

If the non return valve is still not visible, then intake manifold removal for inspection is required to validate.

If the valve is present reinstall the intake manifold. Do not replace.

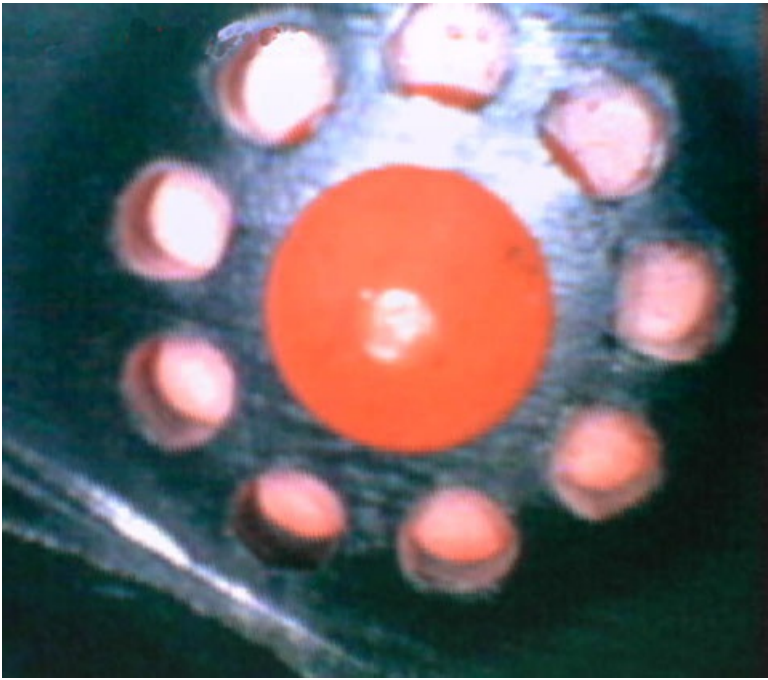
Properly seated Non Return Valve as viewed with the intake manifold removed.

If the intake manifold Non Return Valve is missing, then replace the intake manifold assembly,

Clean oil from all induction system components and retest for oil consumption, leaks or DTCs resetting.

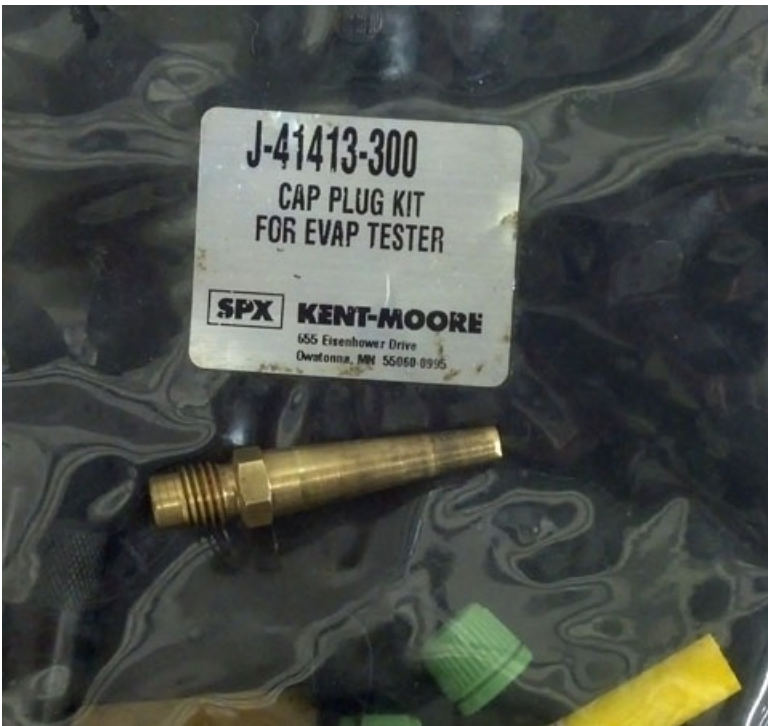
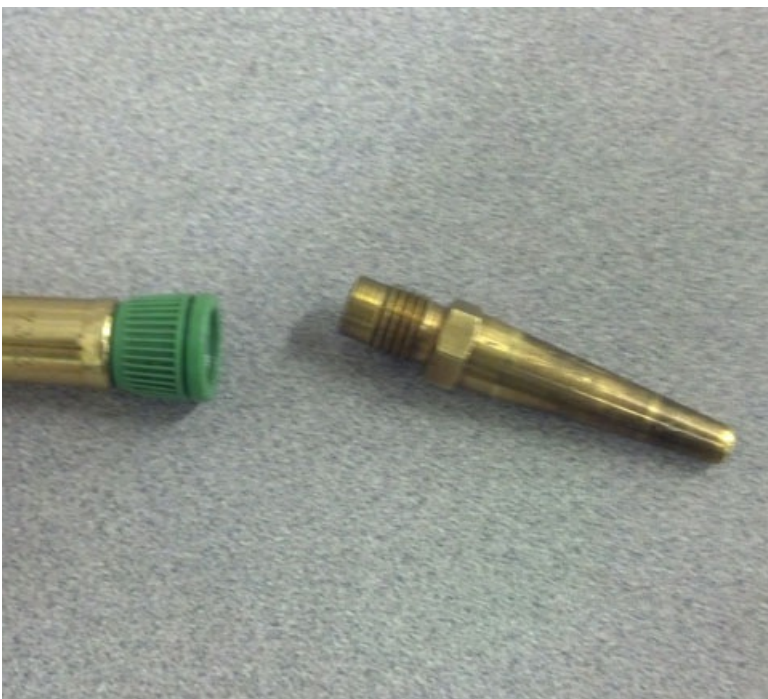
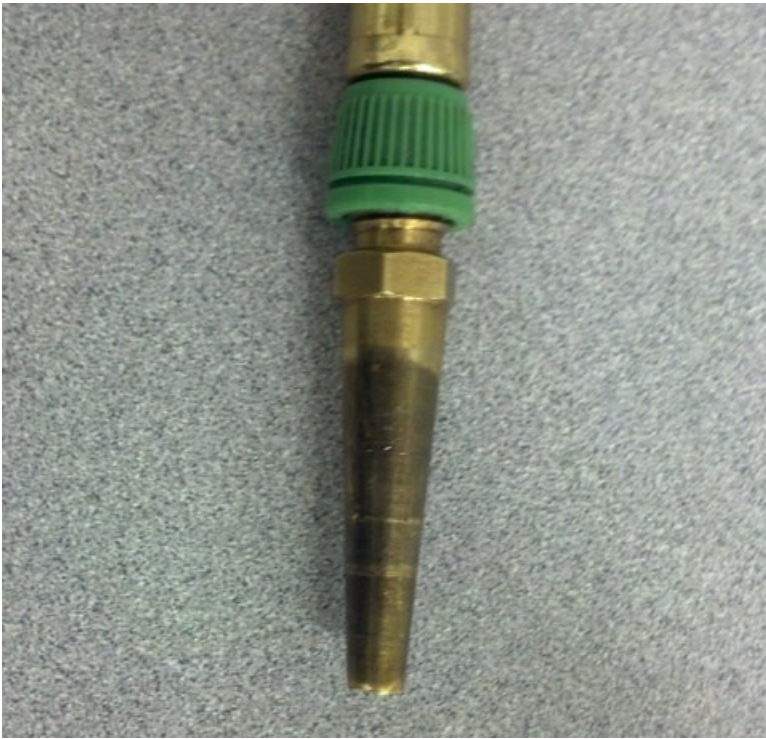
Record the crankcase pressure. (Normal crankcase pressure readings are between -11 & -18 inches of water in park at hot idle) / (ESST gage works best, see pictures below for connection of ESST at the engine oil dipstick hole in the camshaft cover.

Record the crankcase pressure at hot idle in park as well as under snap throttle.

Note: The connection must be made with the engine off. The engine is then started and the pressure readings are recorded.

If the crankcase pressure is between -10 and 0 inches of water then a cylinder leakage / crankcase pressure concern exists.

This is likely caused by a weak or broken piston ring land.

Replace all four piston assemblies and retest for proper crankcase pressures.

Clean oil from all induction system components and retest for oil consumption, leaks or DTCs resetting.
