Preliminary Information

PIT5457B Service ABS / TCS / Power Steering and/or Suspension Message DTC U0077 U0121 U0126 U0131 U0139 U0151 U0401 U0415 U0428 (Circuit 5986 High Resistance)

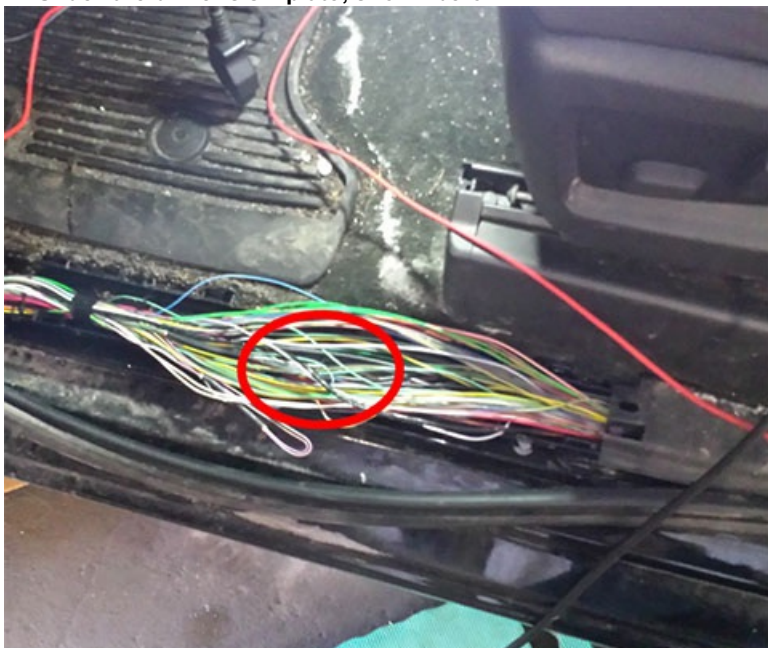
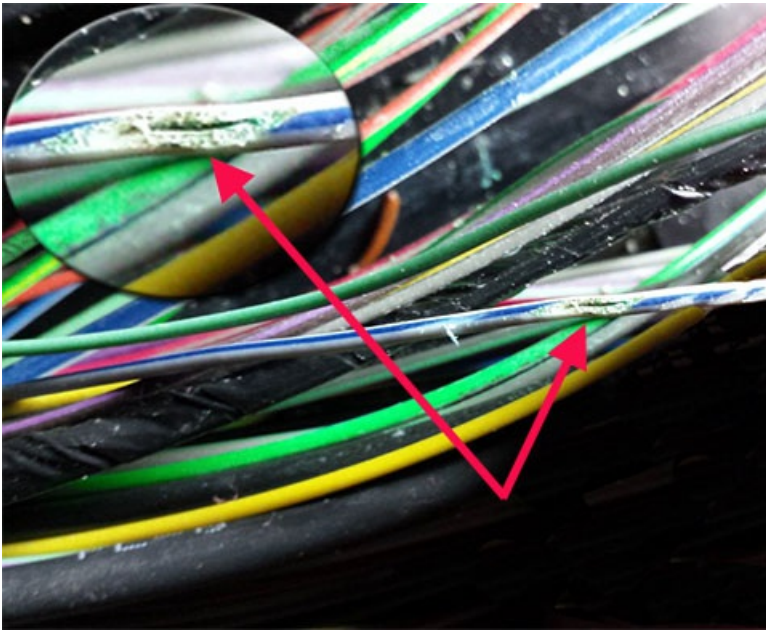
These concerns could be caused by high resistance/open in the Communication Enable circuit 5986. The BCM activates this circuit when the ignition key is in ACC, ON, and START positions (There will be voltage present in the OFF position only for a short time until the BCM goes to sleep). The communication enable circuit wakes up the module for serial data bus communication. Circuit 5986 will have approximately 12 volts and should light a test light, but is not designed to handle heavier electrical loads like a headlight bulb. Below are three known areas where circuit 5986 has been found to be open/shorted/high resistance:

1. On short wheel base utilities (Escalade, Tahoe and Yukon), the chassis harness cut/pinched/shorted between the body and spare tire crossmember, see latest version of PIT5556 for more details.
2. Under the driver's sill plate, shown below.

Monitor the voltage on the communication enable circuit 5986 at any of the modules affected, example EBCM, PSCM, SWPS, SDM, HMI, PTO, and/or SCM. If low voltage or no voltage is present when the concern occurs, inspect for open/high resistance/shorts on circuit 5986. Repair any opens/high resistance/shorts in the circuit.

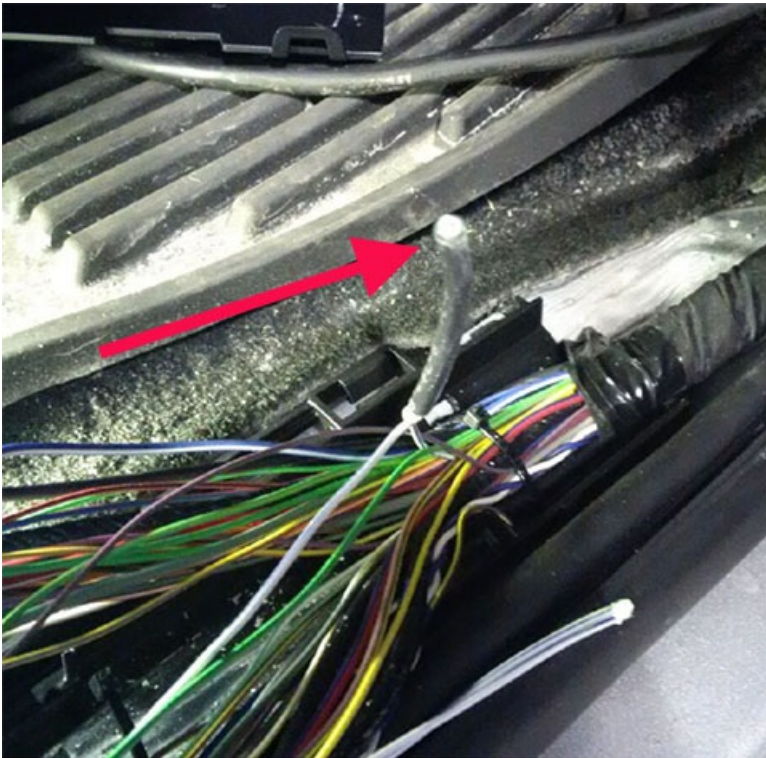
3. Splice J365 located under the passenger front sill plate, shown below.
