# Service Bulletin

**Subject:** Infotainment System Upgrade for Android Auto Feature

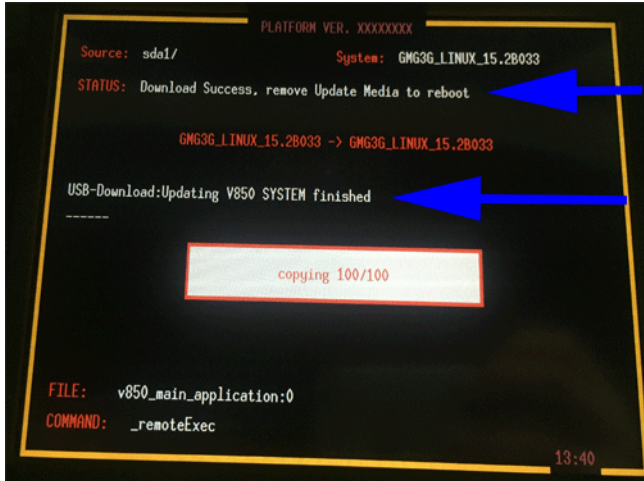
**Important:** Once the updating file hits 90% the screen may go blank. DO NOT REMOVE the USB at this time. The illustration above shows when the programming is complete. (See blue arrows above.)

7. Connect the USB drive to the USB port in the vehicle.
8. The infotainment system will recognize that update files are available. Follow the infotainment display on-screen instructions and select Update when prompted. Programming will take several minutes.

9. Upon completion of programming, remove the USB drive. Follow the infotainment display on-screen instructions.
10. Access the Service Programming System (SPS) and follow the on-screen instructions.
11. On the SPS Supported Controllers screen, select K74 Human Machine Interface Control Module – Programming and follow the on-screen instructions.
12. At the end of programming, choose the “Clear DTCs” function on the SPS screen.
13. Ignition OFF, Retained Accessory Power (RAP) OFF, remove the key fob from range of the vehicle, and let the vehicle sit for five minutes. Retest system operation to verify the repair.

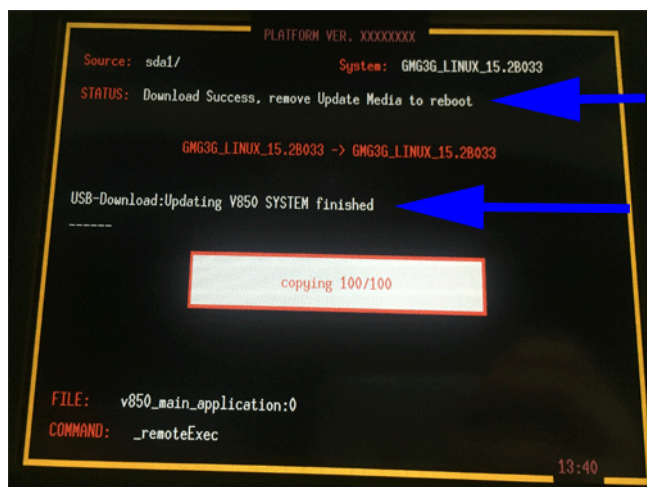
**Important:** Once the updating file hits 90% the screen may go blank, DO NOT REMOVE the USB at this time. The illustration above shows when the programming is complete. (See blue arrows above.)

7. Connect the USB drive to the USB port in the vehicle.
8. The infotainment system will recognize that update files are available. Follow the infotainment display on-screen instructions and select Update when prompted. Programming will take several minutes.

9. Upon completion of programming, remove the USB drive. Follow the infotainment display on-screen instructions.
10. Access the Service Programming System (SPS) and follow the on-screen instructions.
11. On the SPS Supported Controllers screen, select K74 Human Machine Interface Control Module – Programming and follow the on-screen instructions.
