# Service Bulletin

**Subject:** Instrument Panel (IP) Top Trim Pad to Navigation Screen Upper Trim Cover Misalignment

| Brand: | Model: | Model Year: | | Date Breakpoint: | | Engine: | Transmission: |
|---|---|---|---|---|---|---|---|
| Chevrolet | Impala (VIN 1) | 2016 | 2016 | SOP | Prior to May 20, 2016 | All | All |

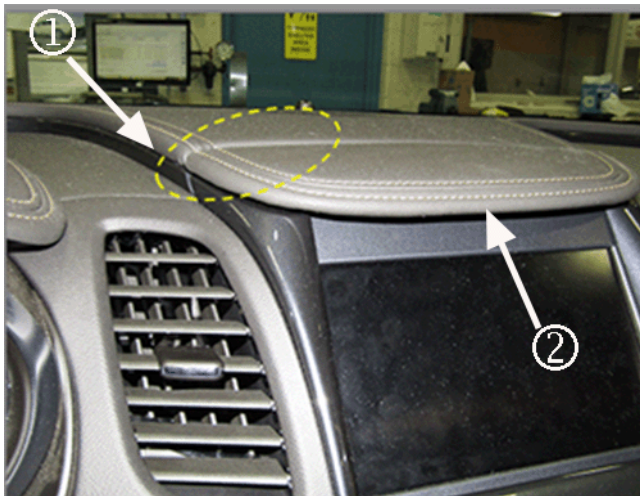
| <b>Condition</b> | <p>Some customers may comment on a misalignment of the IP top trim pad (1) to the navigation screen upper trim cover (2). This causes the right side of the upper trim cover to appear higher than the left side, which is the most common customer concern.</p> |

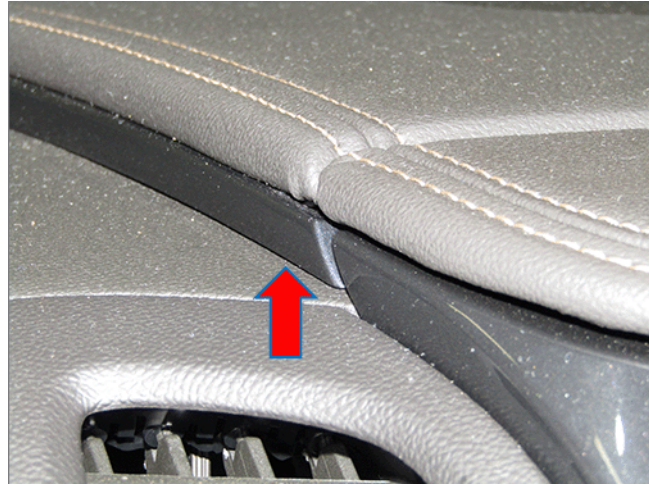
The cause of the condition may be a heat stake/sonic weld left unprocessed at the supplier. This standing heat stake results in the IP pushing upward on the IP carrier, causing a gap at the left side of the trim cover.

Add a self threading nut to the unprocessed heat stake on the IP top trim pad and drill a clearance hole into the IP carrier, following the Part Information and Service Procedure below.

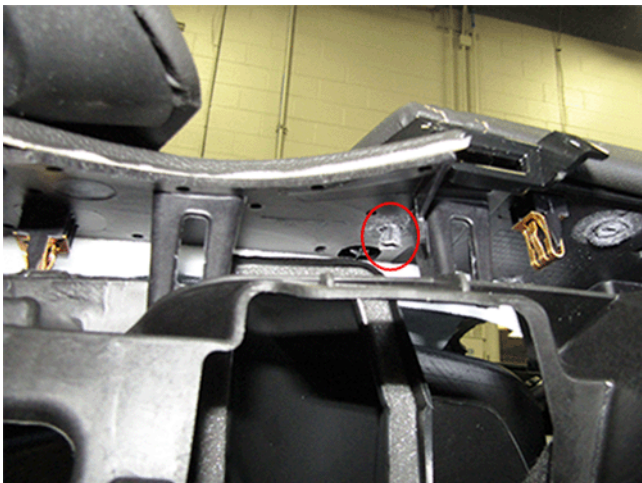
2. Locate the unprocessed heat stake (shown circled in the graphic above) on the driver side of the trim pad.

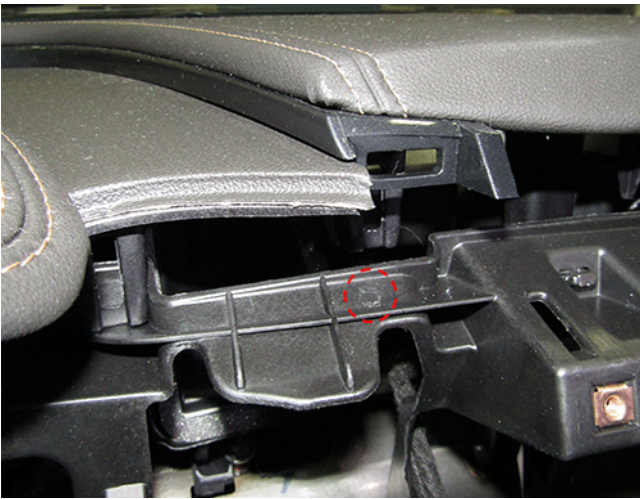
4. In-line with the heat stake location, inspect the black plastic IP carrier for a witness mark (shown circled in the graphic above) on the drivers side, where the heat stake has been contacting the carrier.
