Service Bulletin

Subject: Tips for Customers Having Difficulty Launching Android Auto or Apple Carplay

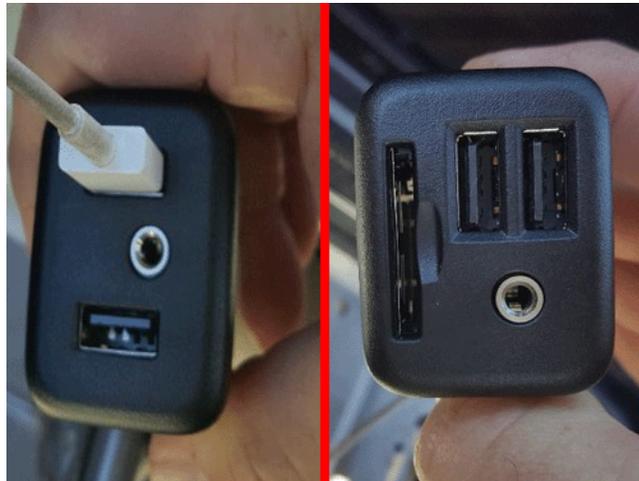
Note: Original Left Receptacle 2017 Silverado with Radio RPO IOB (Correct), Replacement Right Receptacle 2017 Silverado with Radio RPO IOB (Incorrect).

- Ask the dealership to verify that the correct USB receptacle/hub was installed if this started happening right after they replaced the USB receptacle/hub for another complaint like the example above that shows a 2017 Silverado with radio RPO IOB that recently had the incorrect USB receptacle/hub (receptacle shown on the right) installed during service for a non related concern.

Note: To ensure the correct receptacle is installed, cross-reference the part number on the receptacle with the Electronic Parts Catalog all while using the VIN filter feature within the EPC.
