Service Bulletin

Subject: Active Shutters Inoperative, Malfunction Indicator Lamp (MIL) Illuminated - DTCs P059F, U1501, U1510, U1511 Set

Brand:	Model:	Model Year:		VIN:		Engine:	Transmission:
		from	to	from	to		
Cadillac	ATS	2016	2017				
	стѕ

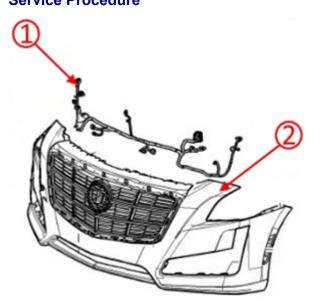
Involved Region or Country	North America and N.A. Export Regions
Additional Options (RPOs)	XFE
Condition	Some customers may comment that the MIL is illuminated. The Technician may find one or more of the following DTCs set: • P059F • U1501 • U1510 • U1511
Cause	 This condition may be caused by the following conditions: Snow and/or ice buildup in the front lower grille area of the vehicle, which could prevent the active aero shutters from opening or closing. Loose connection of the front fascia harness (HARNESS, FRT OBJECT ALARM SEN WR). Possible high resistance with the front fascia harness.
Correction	Note: Do Not replace the front object alarm wrg harness until an inspection, diagnosis and testing of the shutters has been completed. If the above inspection did not find any signs of previous snow or ice in the active shutter system, validation of the front fascia wiring harnesses condition will be required.

- 1. Verify nothing is obstructing the shutters.
- 2. Verify proper shutter operation.
 - If the above inspection and testing did not find any damage and there are signs of previous snow or ice in the active shutter system, Do Not proceed with this procedure.
 - If the shutter operation has failed testing, proceed with the procedure.
- 3. Follow SI diagnostics for set DTC.
- 4. Remove the front bumper fascia (2). Refer to SI for removal.
- 5. Verify condition and connection of the front fascia harness (1).
- 6. If required, replace the front fascia harness.
- 7. Install front bumper fascia.
- 8. Verify proper shutter operation.
 - If the active shutters wiring harness has been found not to be the cause of the DTCs set, refer to SI for further diagnostics.
