# Service Bulletin

**Subject:** Radio Will Not Turn On or Function

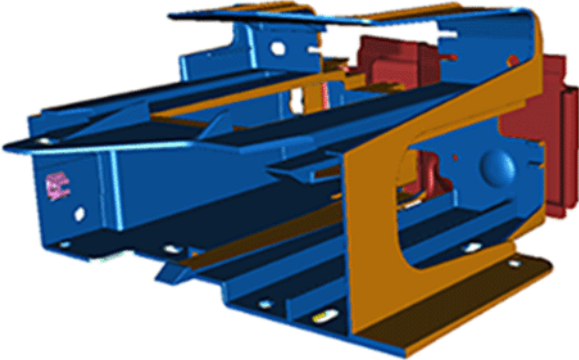
<b>Involved Region or Country</b>	North America, Korea, Middle East, Israel
<b>Additional Options (RPOs)</b>	Radios - Regal (IO5, IO6), Impala (IO3, IO5, IO6)
<b>Condition</b>	Some customers may comment that the radio will not turn on or function.
<b>Cause</b>	The cause of the condition may be water intrusion into the radio receiver. The original radio bracket did not protect the receiver against HVAC condensation.
<b>Correction</b>

<p>Replace the radio receiver as normal AND update the radio bracket assembly to the new part number listed in the Parts Information table.</p>
