# Service Bulletin

**Subject:** Service Theft Deterrent System Message on DIC, No Start, DTC B2955

Brand:	Model:	Model Year:		VIN:		Engine:	Transmission:
		from	to	from	to		
Chevrolet	Trax	2017	2017			All	All

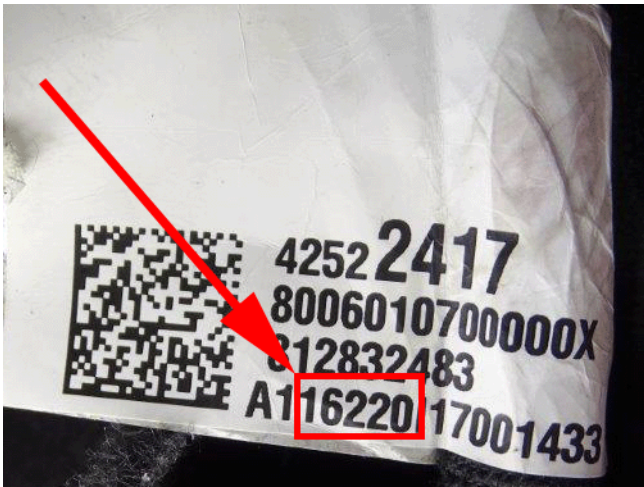
2. Visually inspect the julian date on the IP harness.

**Note:** The julian date goes as follows: XXAABBB (AA = Year (Example shown shows 2016) BBB = Day (Example shown shows August 9th 2016))

- If the julian date is prior to November 11, 2016, continue onto Step 3.
  - If the julian date is after November 11, 2016, continue diagnosis referring to SI.
3. Remove the lower steering column trim cover. Refer to *Steering Column Lower Trim Cover Replacement* in SI.

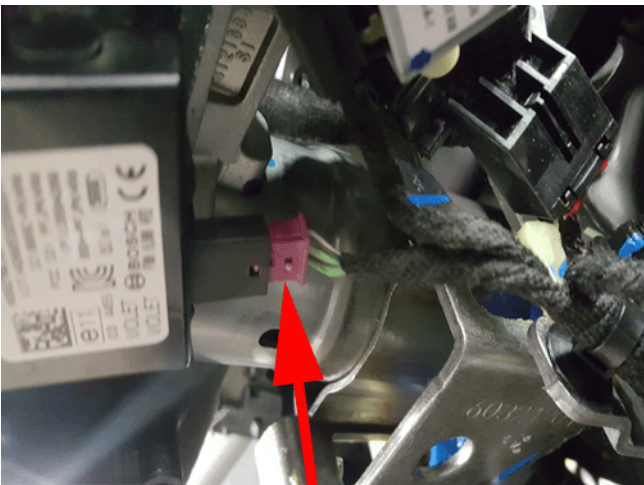
4. Visually inspect the Immobilizer Control Module Connector to see if it has become disconnected.
5. If the connector has become disconnected, replace the connector. Refer to the repair instructions in *Wiring Systems and Power Management* section of SI.

**Important:** Do NOT use a service pigtail kit. Use the service connector part number called out in the Parts Information section of this bulletin.
