Service Bulletin

Subject: Information on Body Seam Locations as Possible Intrusion Areas for Water Leaks, Musty Odor, Wet Carpet and/or Water Leaking on Driver Side Floor

Brand:	Model:	Model Year:		VIN:		Engine:	Transmission:
		from	to	from	to		
Chevrolet	Trax	2017	2017			All	All

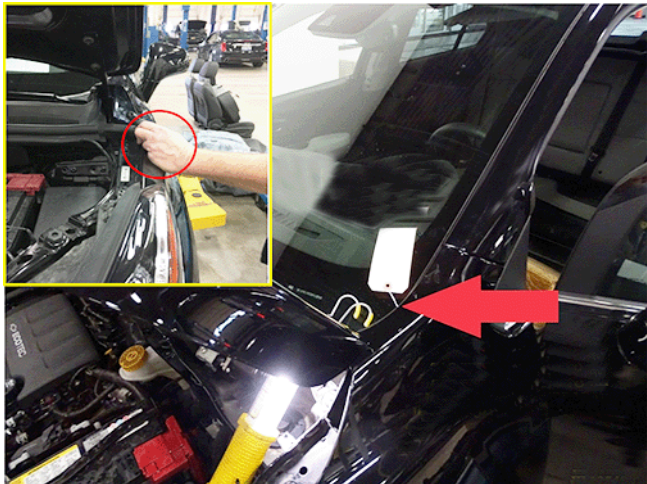
<p>The cause of the condition may be voids in one or several body seam areas. The tag/wire noted by the arrow in the graphic above is pointing to one of the more common locations at the driver A-pillar.</p>
Correction	Using Kent Automotive High-Tech™ Clear Seam Sealer, or equivalent, reseal the body seam areas referenced in the Service Procedure below.

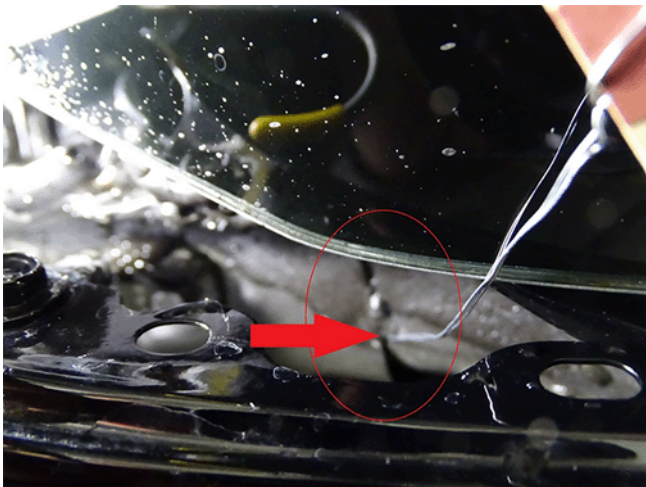
- Inspect the driver side upper hinge pillar seam (below the windshield edge, behind the hood hinge), again shown by the tag/wire in the graphic above.

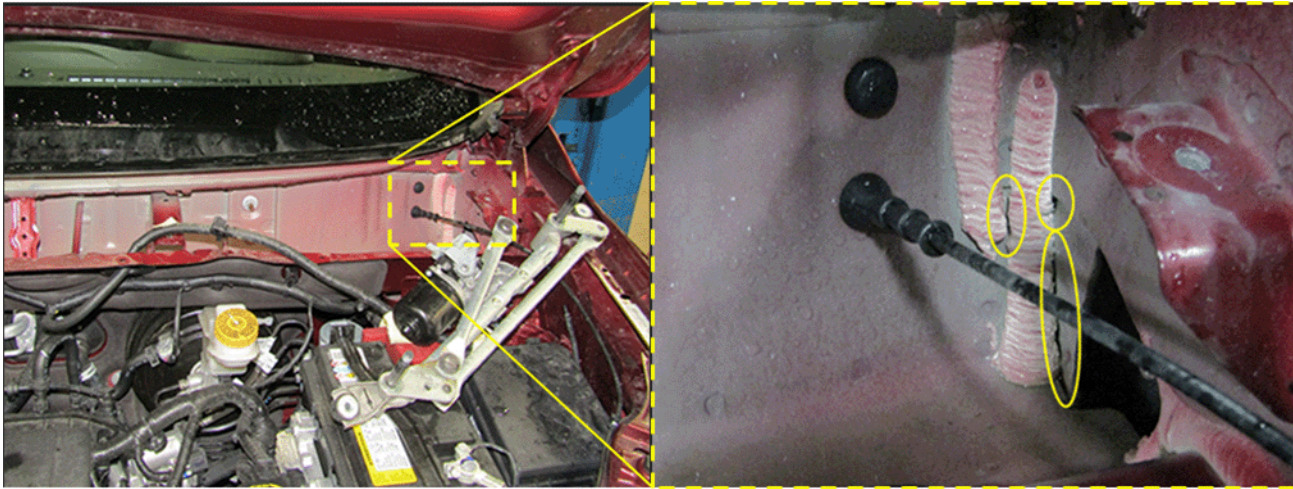
- Inspect the vertical body seam in the cowl area, shown in the graphic above.
