Service Bulletin

Subject: **Rattle or Flutter Noise from Side Door**

Brand:	Model:	Model Year:		VIN:		Engine:	Transmission:
		from	to	from	to		
Chevrolet	Trax (1st Position of VIN – 3)	2017	2017			All	All

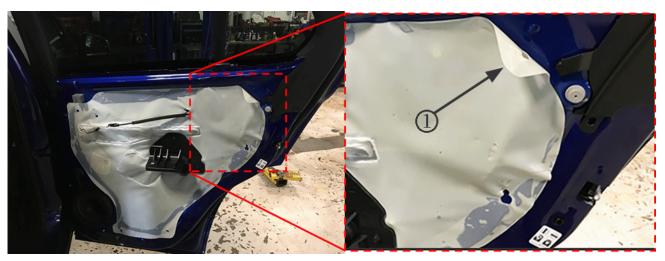
Involved Region or Country	North America
Condition	Some customers may comment on hearing a rattle or flutter noise coming from a side door.
Cause	The cause of the condition may be wind passing through the door catching a loose segment of the door water deflector, causing it to rattle/flutter.
Correction	Remove the door trim panel and reinstall the water deflector, as necessary, on the affected door.

- 2. Inspect the door water deflector for any areas (1) where the deflector may have pulled loose from the door sheet metal. Re-secure the deflector.
- 3. Reinstall the door trim panel. Refer to the appropriate Front or Rear Side Door Trim Replacement (Chevrolet) in SI.
