Service Bulletin

Subject: Modified Headlamp Aim Procedure for Horizontal Aim Adjuster Difficult or Inoperative

Brand:	Model:	Model Year:		VIN:		Engine:	Transmission:
		from	to	from	to		
Cadillac	ATS	2013	2017			All	All

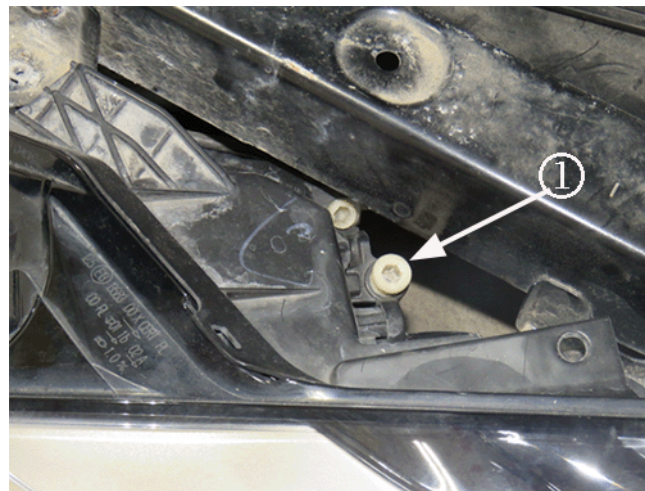
Some technicians or customers may comment that it is difficult to adjust a headlamp(s) horizontal aim. The horizontal adjuster location (1) is shown in the graphic above.

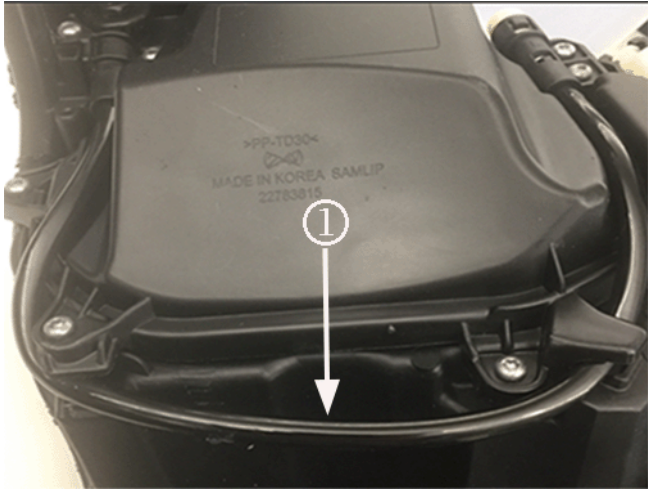
<p>The cause of the condition may be that the aim adjuster cable (1) may have become corroded due to water intrusion.</p>
<p>Correction</p>	<p>Horizontal aim can be accomplished following the modified Service Procedure below.</p>
