Service Bulletin

Subject: Information on Diagnosis/Repair of Wind Noise from Outside Rear View Mirror (OSRVM) or Door Areas

Brand:	Model:	Model Year:		VIN:		Engine:	Transmission:
		from	to	from	to		
Buick	Regal	2013	2017			All	All

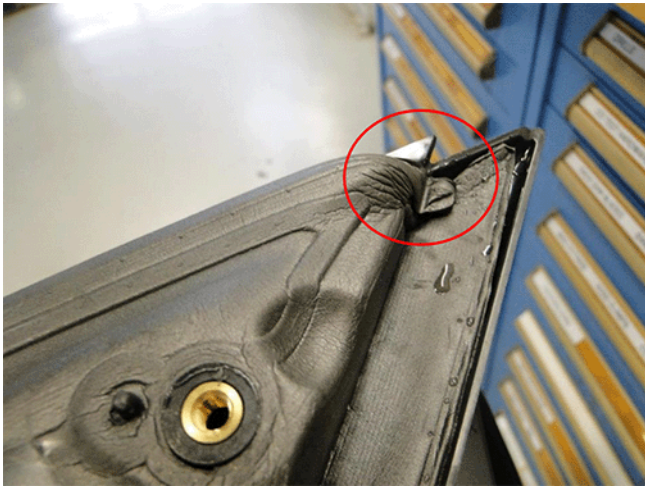
Wind noise verified from OSRVM area.

Note: The mirror should be installed by the top leading corner first. When installed from bottom corner first, the gasket may catch on the door glass run channel and roll over causing the imperfection shown in the graphic above.

The wind leak path is most commonly found to be a rolled mirror insulator gasket at the top of the mirror.

Attempt to rework the insulator gasket into proper position; in cases where the gasket has taken a permanent set, it will be necessary to replace the mirror.

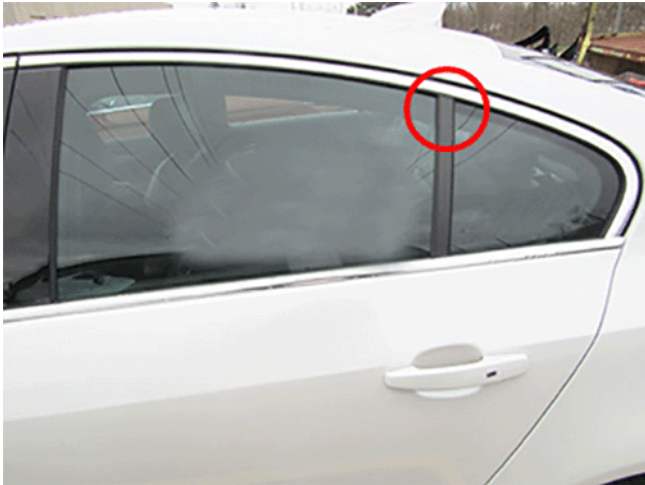
Wind noise verified from outside upper rear door

Wind leak cause is most likely gaps at the upper window division post applique and weatherstrip rubber seal.

Attempt to rework the weatherstrip rubber and applique to properly fit the division post and ensure the backside retaining clip is fully engaged. In some cases, it may be necessary to remove the rear side door stationary window, reposition the applique/seal, and then reinstall the window.

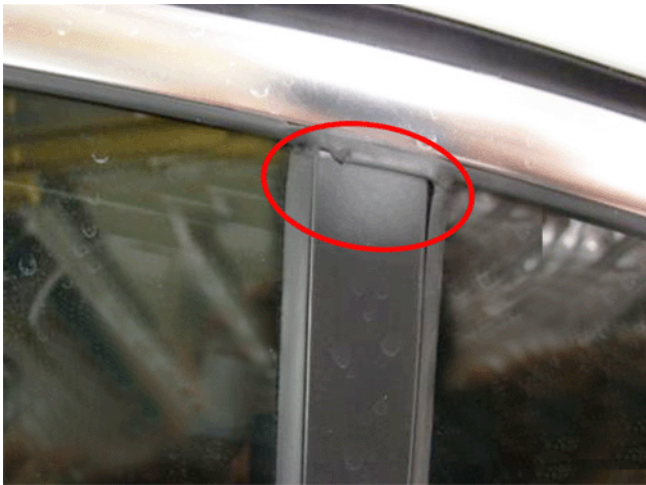
- Inspect the upper division post applique and weatherstrip rubber seal for possible mis-alignment.

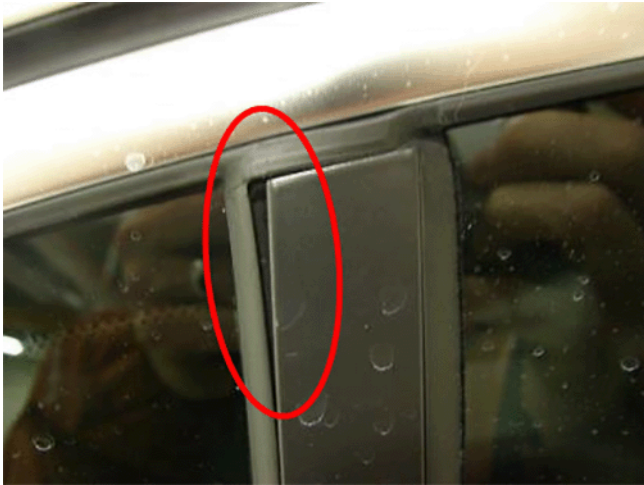
- Inspect for a gap caused by the back side retaining clip of the weatherstrip not fully engaged into the door frame.

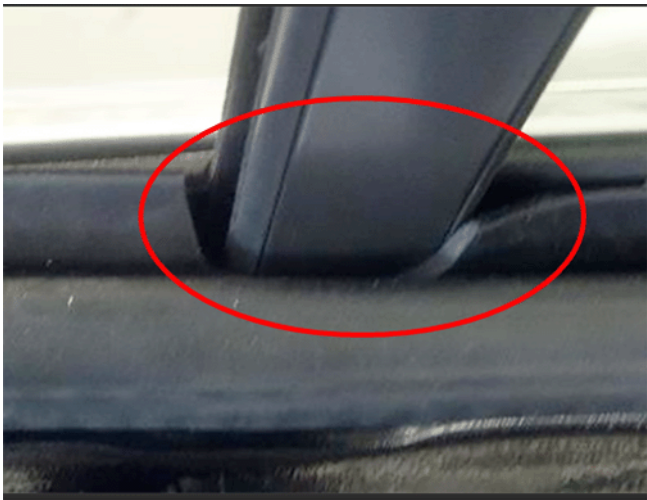
Wind noise verified from inner rear door.

Wind leak cause is most commonly found to be an improperly installed rear side door window inner sealing strip at the lower inner division post.

Remove the rear door trim panel, properly position the inner sealing strip and reinstall the trim panel.
