# Service Bulletin

**Subject:** Diagnostic Tips for DTC P0741: Torque Converter Clutch Stuck Off

**Models:** 2015-2016 Chevrolet Colorado

2015-2016 GMC Canyon

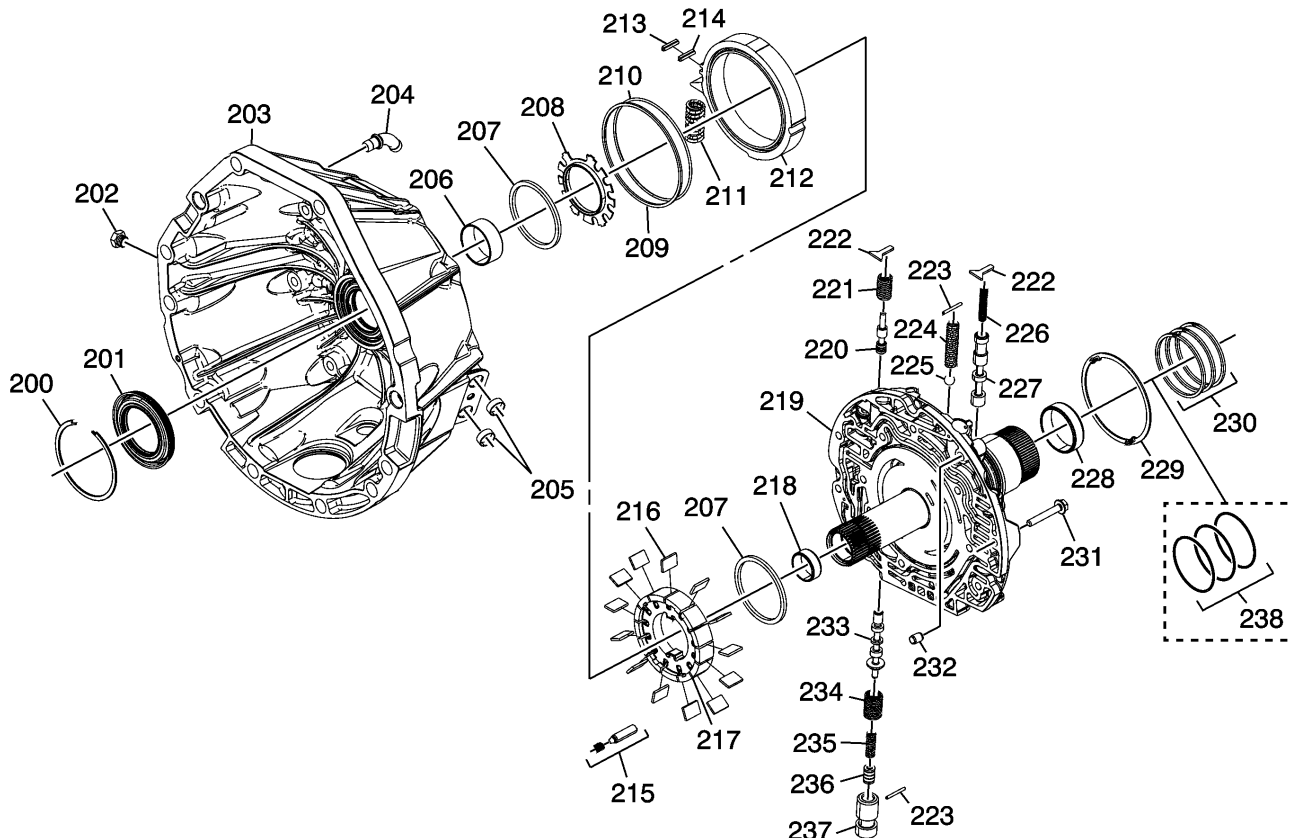
This condition may be caused by a damaged turbine shaft front bushing (218). The turbine shaft may also be damaged in the journal area that is in contact with this bushing.

Disassemble the pump to inspect the turbine shaft front bushing (218). If the bushing is damaged, replace the pump cover and the 4-5-6 (w/Turbine Shaft) Housing Assembly (441).
