Preliminary Information

PIT5564A SIR MIL With DTC's B0012 B0013 B0014 B0015 B0019 B0020 B0021 and/or B0022
(Aftermarket USB/Phone Charger)

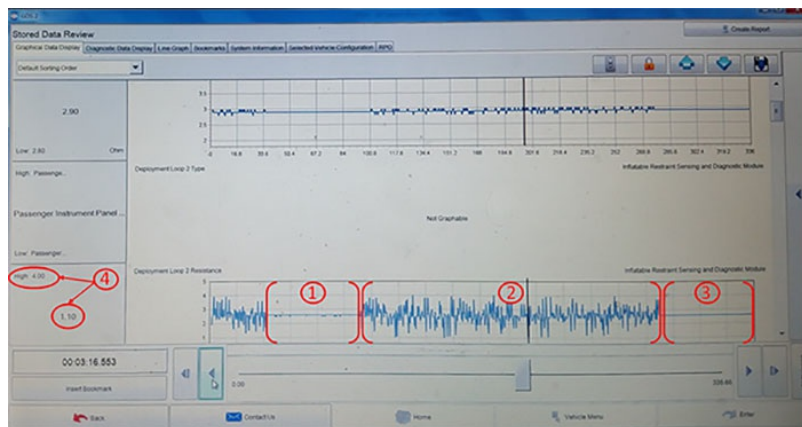
Involved Region or Country	North America
Condition	Some owners may comment of an intermittent SIR MIL. When checking for DTC's, any of the following may be set: B0012, B0013, B0014, B0015, B0019, B0020, B0021, and/or B0022. In most cases, it will have symptom codes for both high and low loop resistance (0D - Loop Resistance Above Threshold and 0E - Loop Resistance Below Threshold).
Cause	<p>This concern could be caused by interference from an aftermarket USB and/or phone charger plugged into the 12 volt power outlet. Below is a screen print of the scan tool displaying the resistance of an air bag deployment loop.</p> <ul style="list-style-type: none"> - 1 is with only a USB charger plugged into the center console 12 volt power outlet and slight resistance changes can be seen. - 2 is when a phone was plugged into the USB charger and the deployment loop resistance is fluctuating up and down greatly. This fluctuation up and down is why many cases will have both symptoms codes for the loop resistance being above and below threshold (0D and 0E). - 3 is with everything unplugged from the 12 volt power outlet and the resistance is very steady, as it should be.

If, after following normal diagnostics and the root cause is not found, inspect the vehicle and/or question the customer if they are using any type of USB/phone charger/etc.

As in the example above, the scan tool was used to monitor the suspect air bag loop resistance while using/operating the aftermarket item plugged into the 12 volt power outlet.

If the concern is intermittent and/or can not be duplicated, ask the owner to refrain from using anything that is being plugged into the 12 volt power outlets and see if the issue goes away.

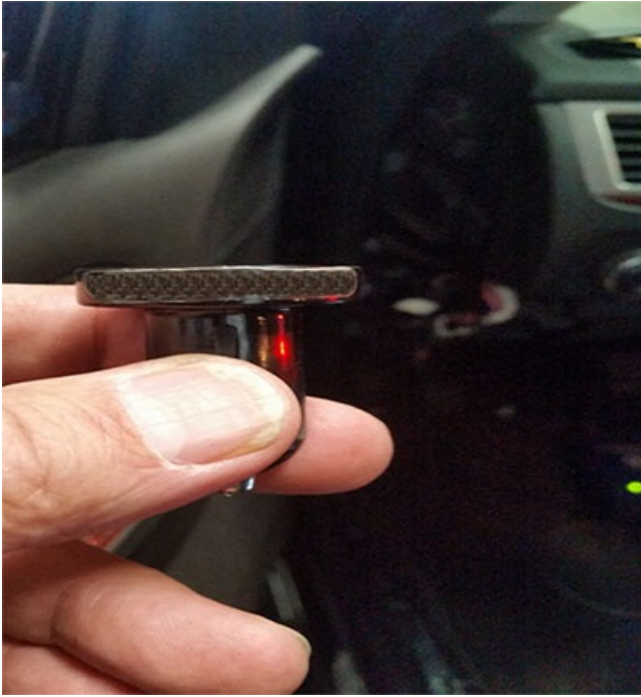
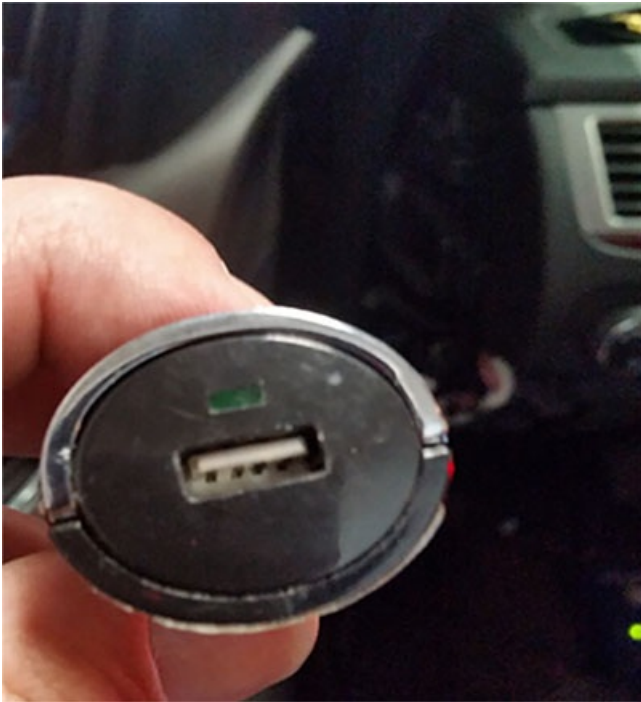
Shown below is one example of a USB charger that has caused this type of concern.
