Bulletin No.: PIT5535B
 Published date: 07/7/2017

PIT5535B Service Front Camera / Service Lane Departure Warning / Service Lane Keep Assist Message with DTC B1008 SYM4B / IntelliBeam Headlight / Windshield Wind Rush Noise

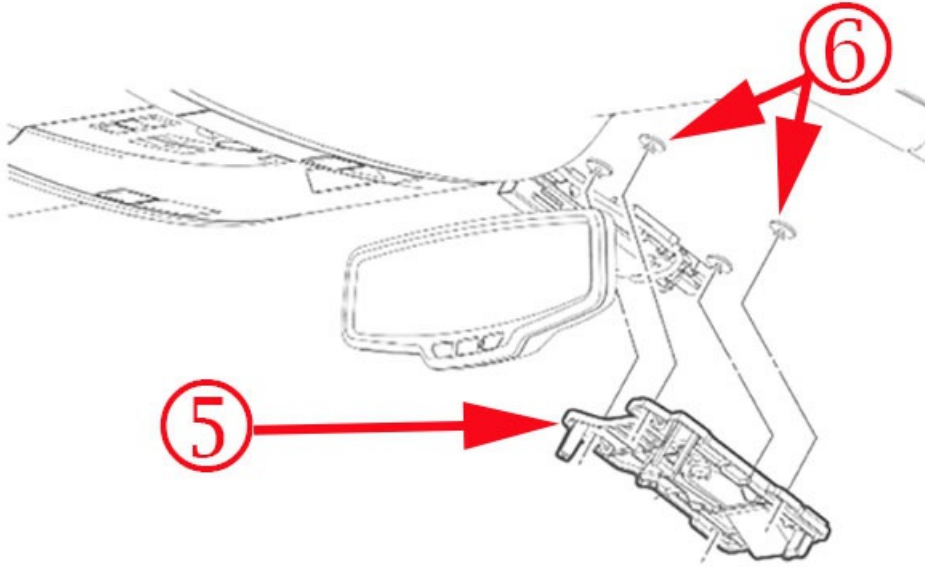
- Verify the front view camera module bracket (5) is fully seated down and secured on the windshield pins (6), shown below.

Do NOT replace the Front View Camera Module if it is only setting DTC B1008 SYM4B.
Perform the following checks and repair as necessary:

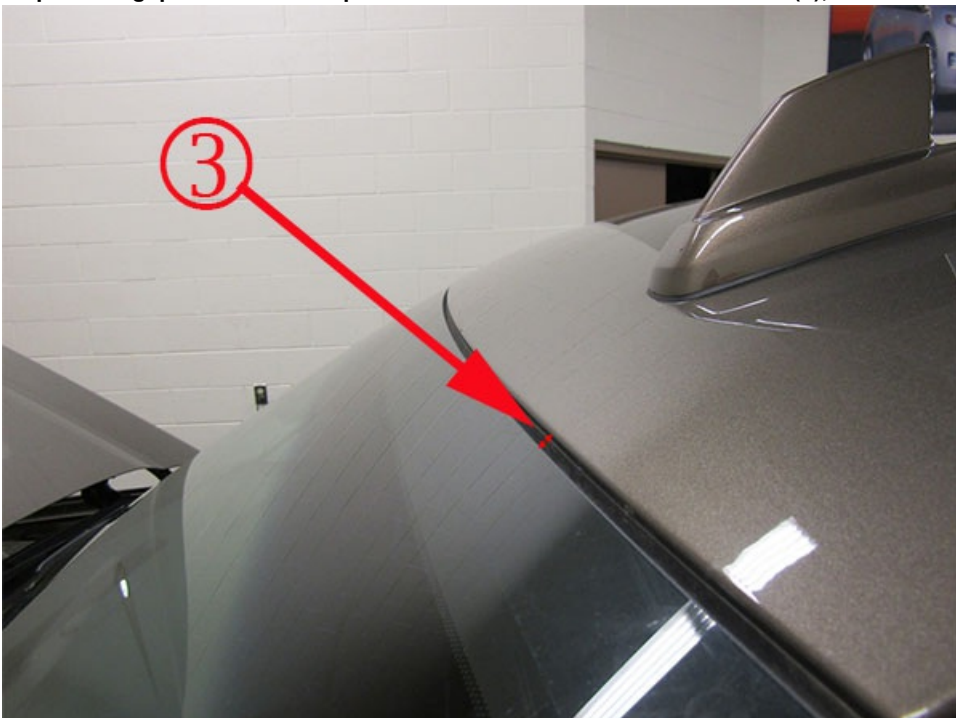
Inspect the gap between the top of the windshield and roof sheet metal (3), shown below. This gap should be 3.6 mm (+/- 1 mm).

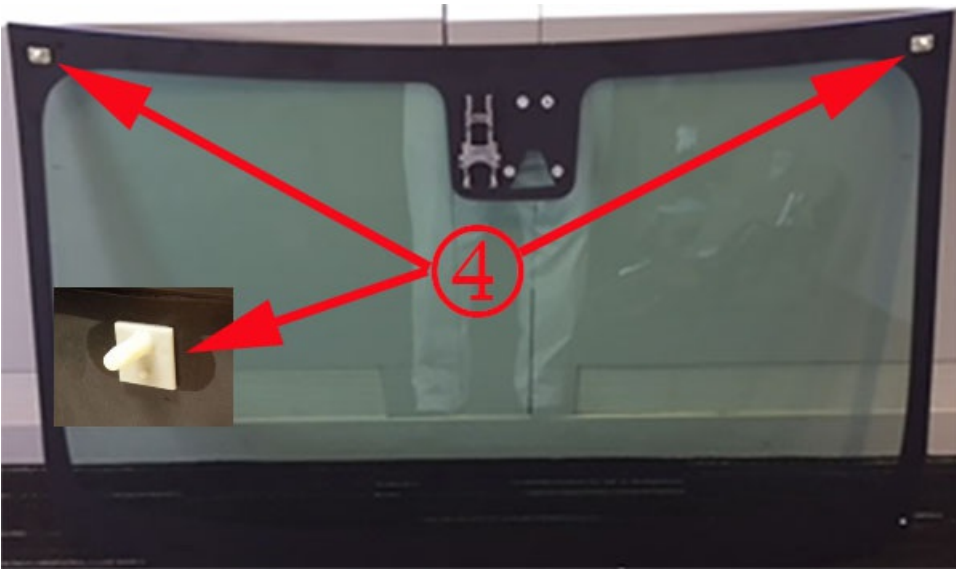
Factory GM windshields use alignment/locating pins (4) in the upper corners of the windshield, which makes it much easier to properly align the windshield to the body opening, shown below. Most aftermarket windshields do not use these alignment/locating pins, which can make it more difficult to ensure a proper installation.

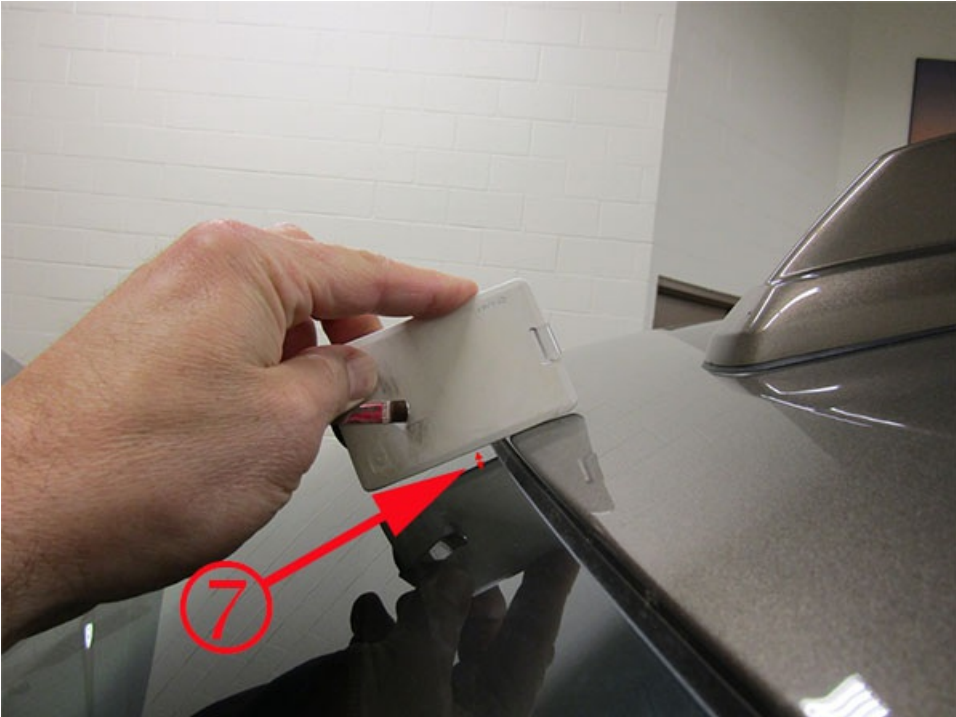
Also, inspect to make sure the windshield is sub-flush to the roof sheet metal (7), as shown below. If the windshield is proud of the roof sheet it could indicate:

- The old urethane adhesive bead was not cut low enough and left excessively thick.
- Windshield alignment/locating pin(s) are not fully in the alignment hole(s).
- During windshield installation it was not firmly pressed around the entire outside edge in order to wet-out the urethane adhesive bead.
- The urethane adhesive bead dried before the windshield was installed.

NOTE: A windshield proud of the roof sheet metal could cause excessive wind noise.

Either of these windshield mounting issues could cause the camera to be misaligned and unable to complete the learn.

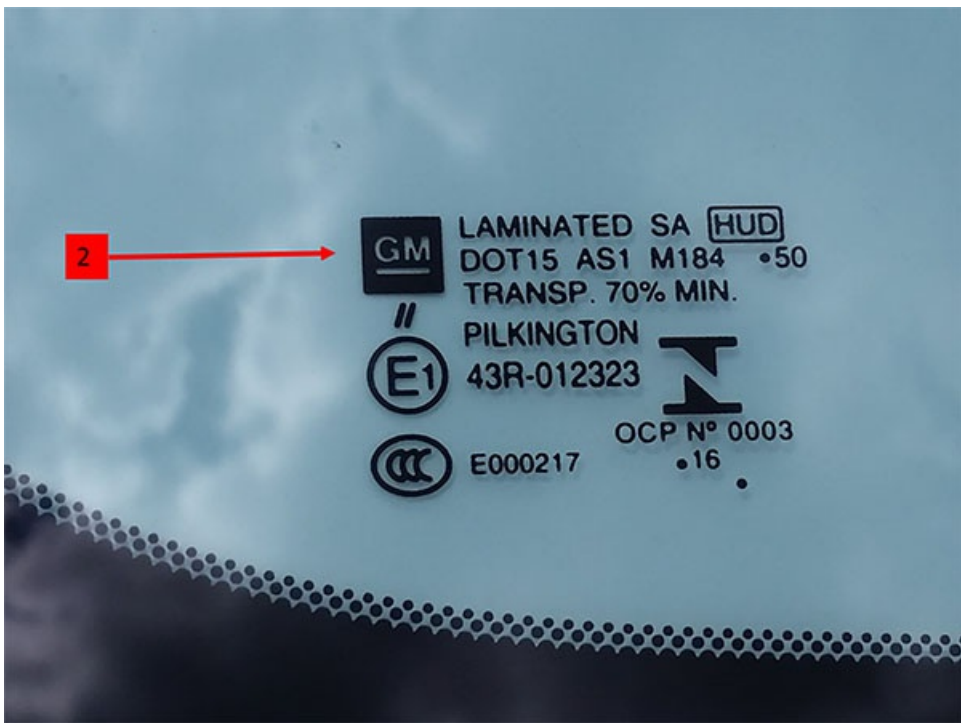
- If, after performing the checks listed above and the root cause of the camera not completing the calibration/learn is still not found, inspect for an aftermarket windshield being installed in the vehicle. To determine whether or not the windshield is an aftermarket or factory windshield, inspect for the "GM" Logo in the lower right corner of windshield, as shown below (2). If the "GM" Logo is not present, then the windshield is aftermarket.

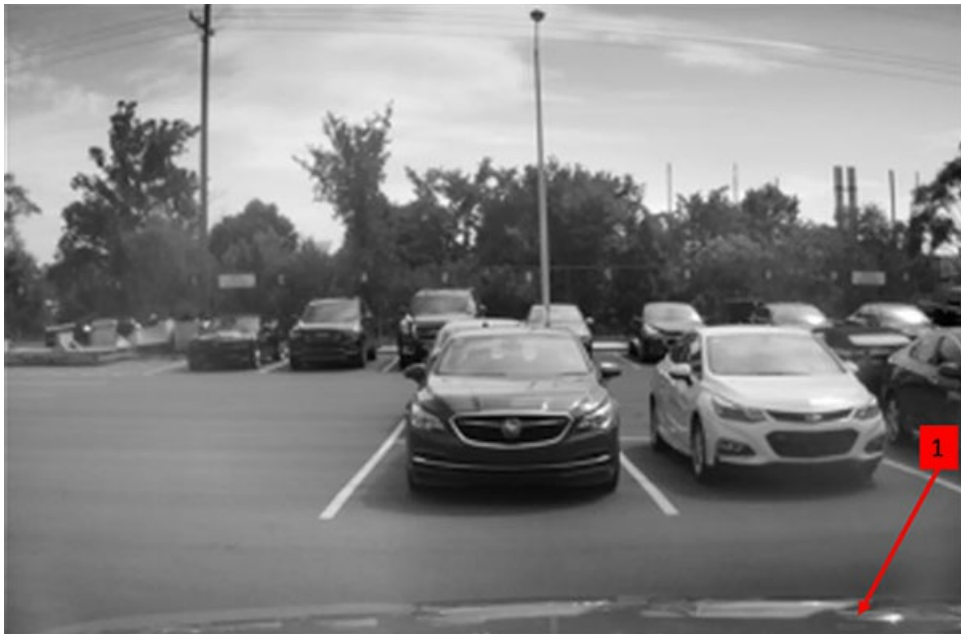
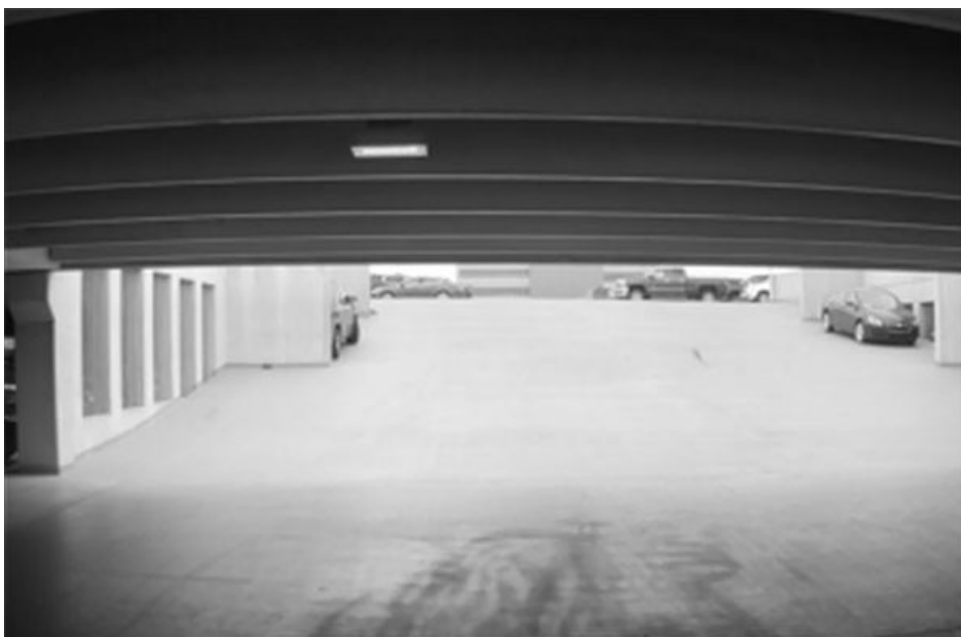
It has been found that some aftermarket windshields do not properly mount/position the front view camera. Shown below are some images, taken with engineering tools (see note below), of what the front view camera is actually seeing. The first image is taken from a truck with an aftermarket windshield. As shown below, the camera is seeing part of the hood (1). Because of this, the camera is not seeing movement in the area of the hood and can not complete the learn. The second image below is from a truck with a factory windshield and there is no hood seen by the front view camera.

Note: The images shown below can only be seen using engineering tools and there is NO way for the dealership's service tools (GDS2) to see the front view camera images.

NOTE: If the windshield has to be removed/replaced for any of the above reasons, it is suggested that a factory GM windshield be installed.
