Preliminary Information

PIP5248C Stalling Shudder And/or Hard shifting Into 1st Gear Or Reverse Vibration On launch (With Excessive Crankshaft End Play)

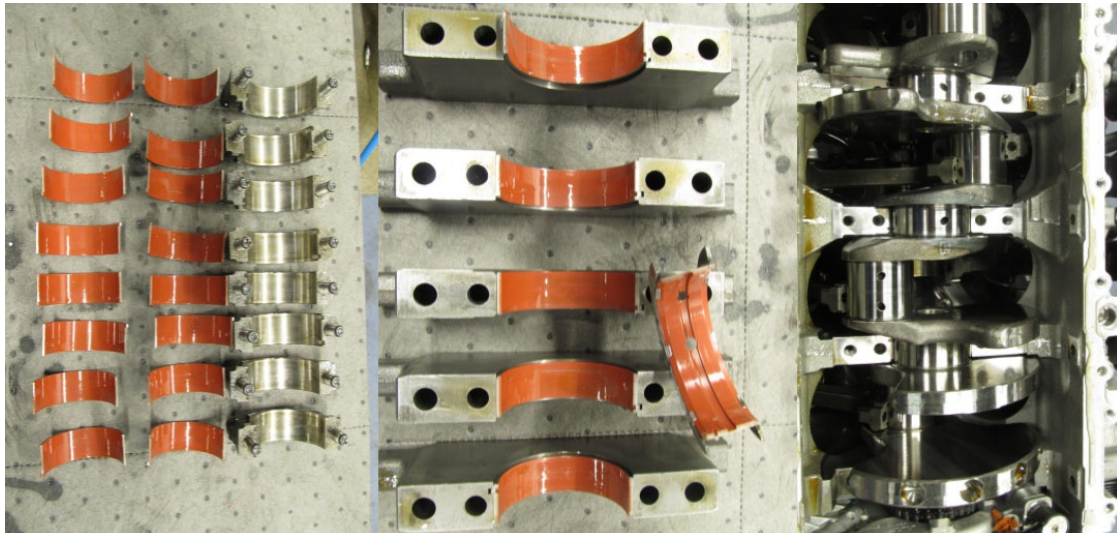
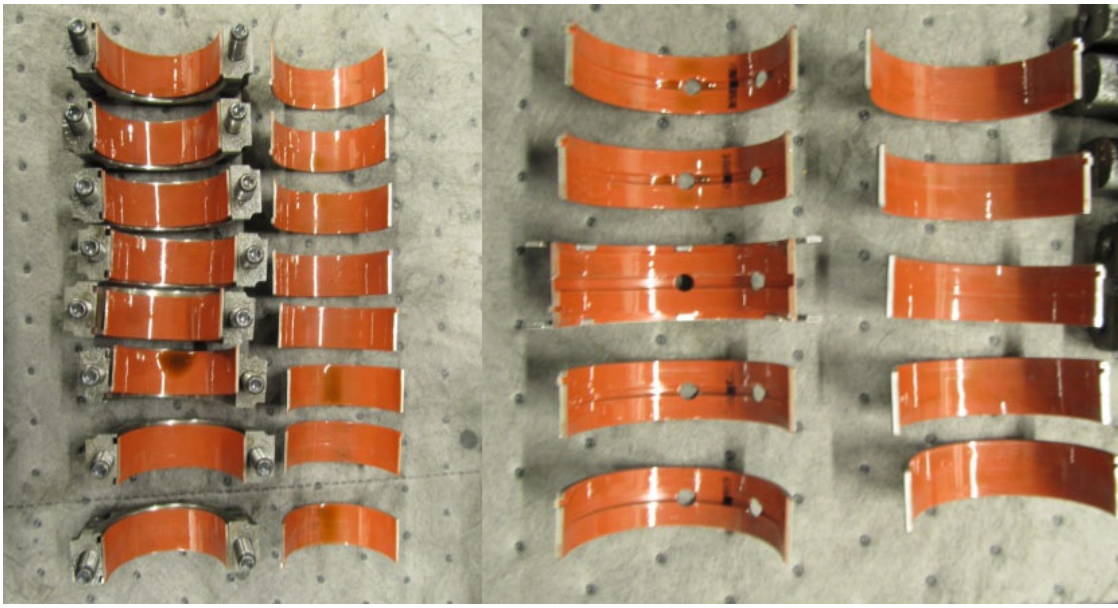
Note: If bearings and crankshaft look like components in attached picture, damage has not occurred.

Inspect thrust bearing for wear on one side and crankshaft on that “mating” surface.

If wear is evident (3 vertical channels worn off) replace connecting rod bearings, main bearings, thrust bearing and crankshaft.
