PIT5510C Fuel Gauge Displays Empty / Low Fuel Light On / DTC P2636

Brand:	Model:	Model Years:	VIN:		Engine:	Transmissions:
			from	to		
Chevrolet	Silverado 3500 Chassis Cab	2016	All	All	6.6L LML	All
GMC	Sierra 3500 Chassis Cab	2016	All	All	6.6L LML	All

With Dual Fuel Tanks RPO N2N

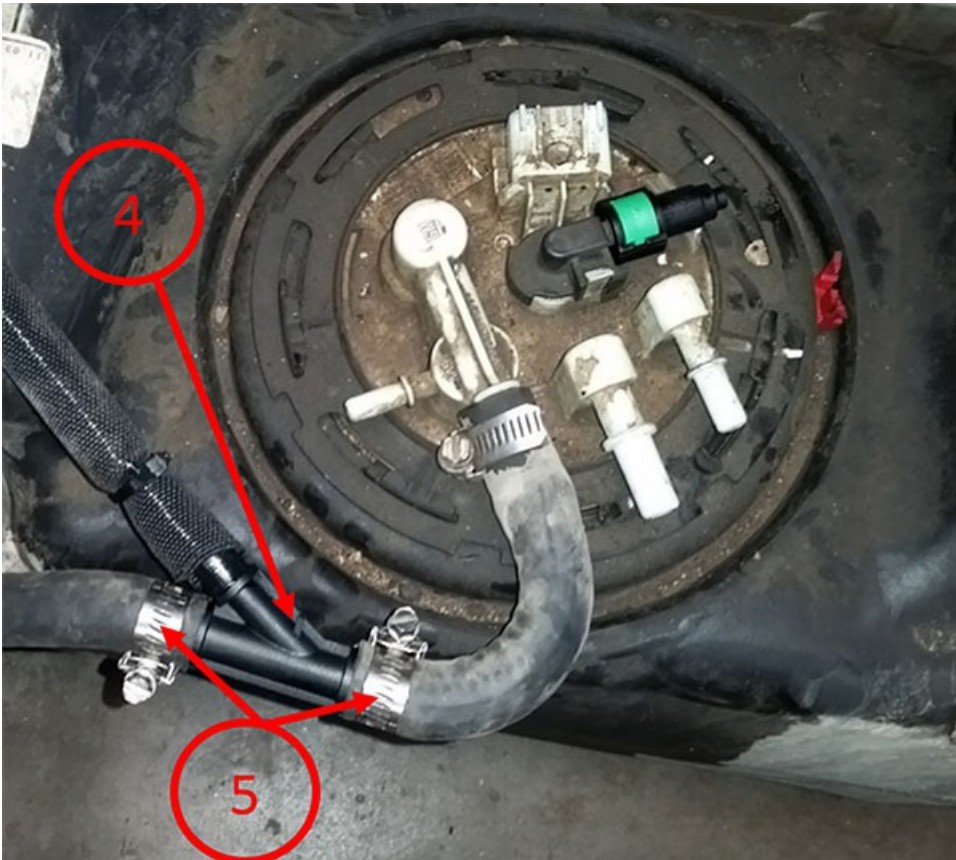
NOTE: Before installing the new fuel transfer line kit, see the diagnostic tip below for inspecting the line for any kinks. A kinked line could occur during installation/shipping/etc. and will restrict fuel flow, causing a repeat P2636.

5. Connect the supplied hose, from the fuel transfer line kit part number 84214102, with the side of the "Y" facing toward the tank as seen below (4). Secure using the supplied hose clamps (5) and torque to (2.5N-m; 22 lb-in.).

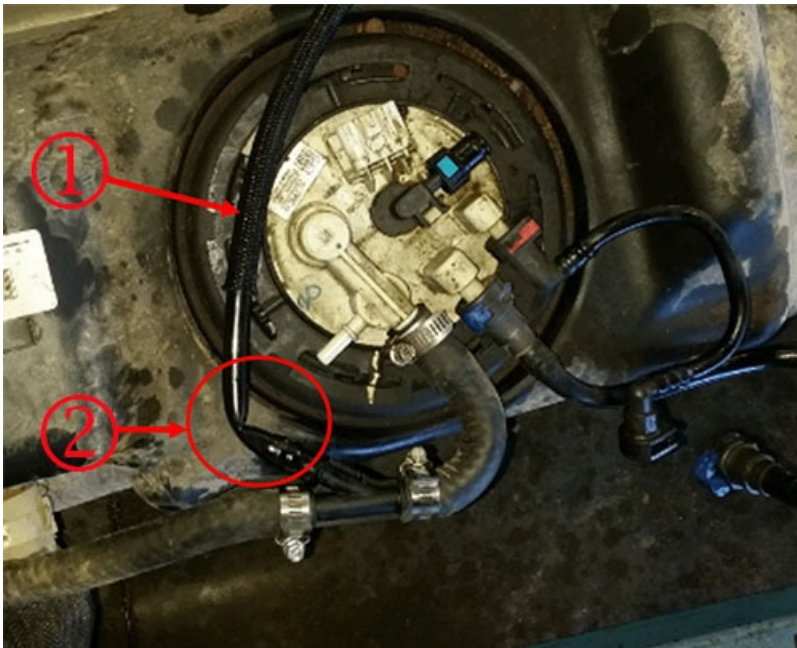
Diagnostic Tip-

During installation of the new fuel transfer line kit, or if a vehicle returns with a P2636 after the new fuel line kit and ECM calibration has been completed, inspect the new fuel transfer line for being kinked (2), as shown below. Because the line is covered with a conduit (1) it will be necessary to remove any zip ties and slide the conduit back to inspect the fuel transfer line for any kinks. If the line is kinked, it will restrict the fuel flow and cause a P2636 to set. Replace the fuel transfer line kit if the line is kinked.
