PIT5574A Fuel Gauge Will Not Go To Full

| Brand: | Model: | Model Years: | VIN: | | Engine: | Transmissions: |
|---|---|---|---|---|---|---|
| Chevrolet | Equinox | 2018 | All | All | All | All |

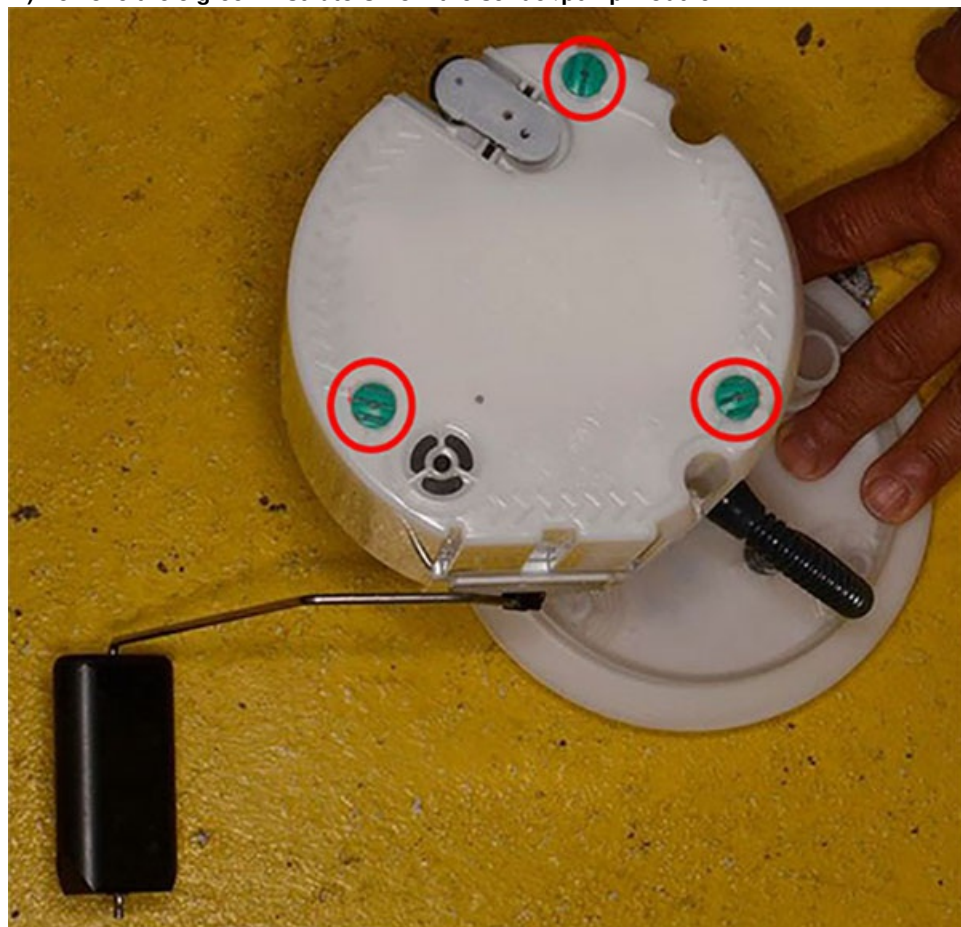
| Condition: | After fueling vehicle fuel gauge does not go to full. |
| Cause: | Fuel module not properly seated in the bottom of the tank. |

- 1.) Remove the fuel tank and the fuel sender / pump assembly. Follow the instructions in eSI.
- 2.) Remove the 3 green insulators from the sender/pump module.

- 3.) Place the sender/pump module on a flat surface.
- 4.) Measure the distance from the flat surface to the bottom on the level float in the empty position expected 6mm distance.
- 5.) Raise the level sensor arm to the full position and measure the distance from the flat surface to the bottom of the level float expected 181mm.
- 6.) If the distances are not as expected , reposition the float arm to acquire proper measurements and recheck at top and bottom.
- 7.) Reinstall sender / pump assembly and the tank. Follow the instruction in eSI.
- 8.) Refill tank and verify operation.
