## **TECHNICAL SERVICE BULLETIN**

**SB-17-021 COE ABS HARNESS CHAFE**

**BULLETIN NO: SB-17-021**

## **SUBJECT VEHICLES:** 13MY-14MY Cab Over Engine (COE) Trucks

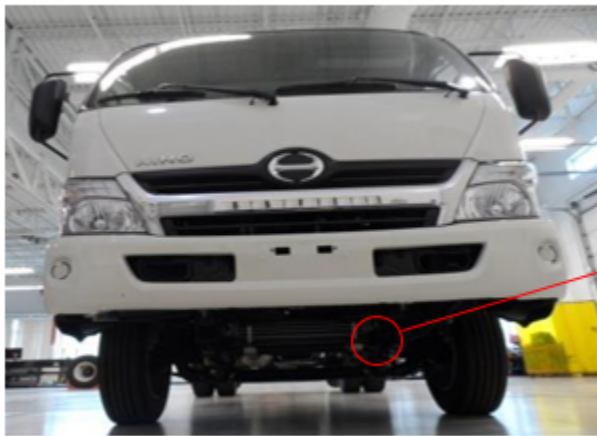
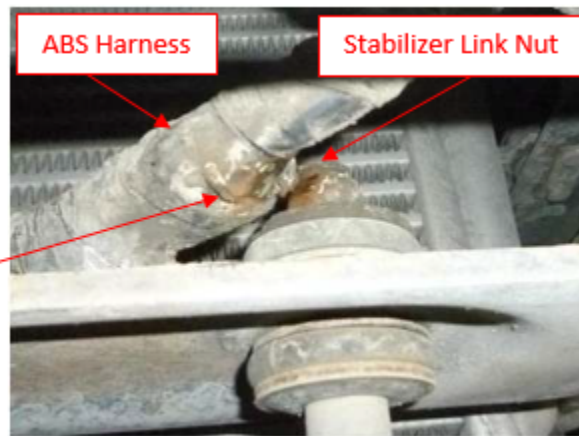
Due to manufacturing variances, subject vehicles may exhibit chafing of the ABS wiring harness between the ABS harness and the stabilizer link nut on the driver's side of the vehicle. If the vehicle exhibits this condition, it is recommended to repair the wire harness and tie the harness back using zip ties to prevent interference between the harness and the stabilizer link nut.

1. Inspect the ABS harness above the drivers side front stabilizer link nut. If the harness is chafing on the stabilizer link nut, the harness will require repair. Proceed to the repair procedure, below.
