Where's the Sealing Bolt in That Reman 9-Speed A/T?

2016–17 Pilot Touring and Elite

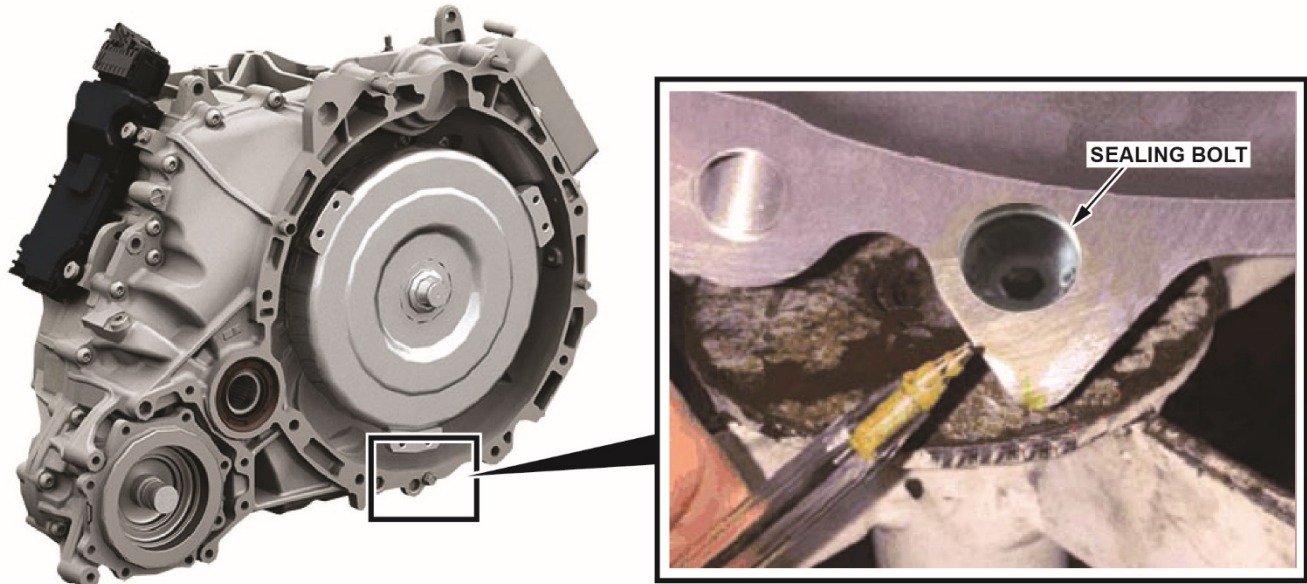
Because of a transmission case casting flaw, the inside of the torque converter bracket hole in some 9-speed A/Ts is porous enough that ATF could leak from the hole. This flaw was found by the transmission factory during production.

As a temporary fix, the factory installed a sealing bolt in that hole and it's proven effective. That casting issue has since been resolved, and later castings don't have that issue. So, the sealing bolt is no longer needed.

If you order a reman A/T and its serial number is **higher** than what's listed in this chart, don't worry about a missing sealing bolt. That A/T has a case that doesn't need it, so it doesn't come with one.
