Where's the Sealing Bolt in That Reman 9-Speed A/T?

2016–17 MDX and 2015–17 TLX

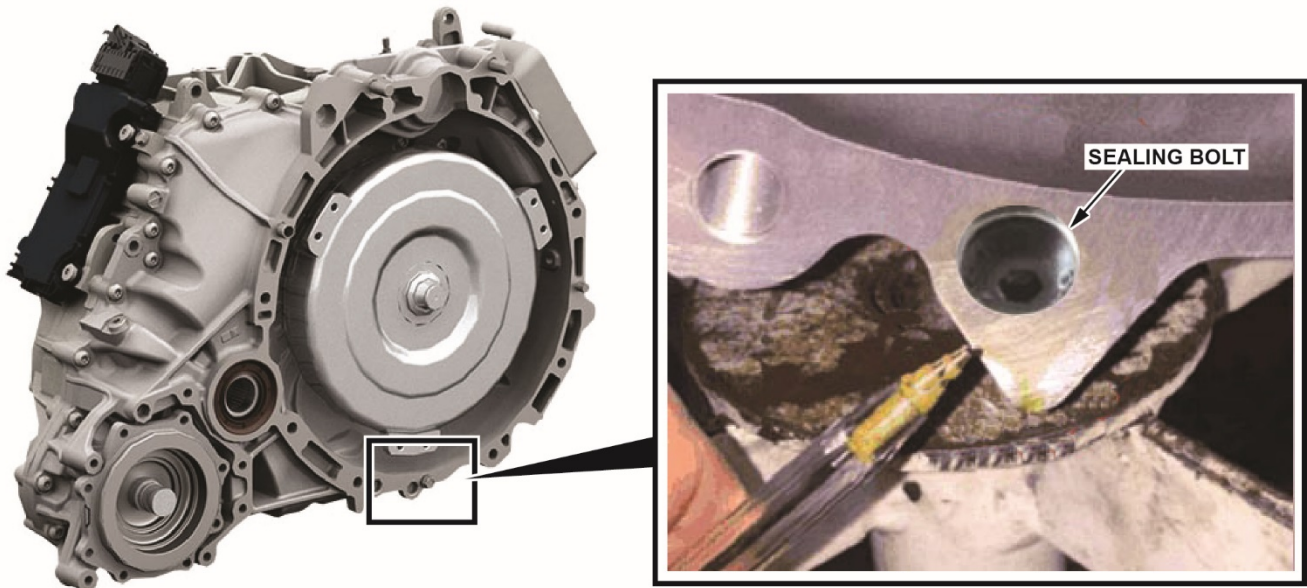
Because of a transmission case casting flaw, the inside of the torque converter bracket bolt hole in some 9-speed A/Ts is porous enough that ATF could leak from the hole. This flaw was found by the transmission factory during production.

As a temporary fix, the factory installed a sealing bolt in that hole and it's proven effective. That casting issue has since been resolved. Later castings don't have that issue, so there's no need for the sealing bolt.

If you order a reman A/T and its serial number is **higher** than what's listed in this chart, don't worry about a missing sealing bolt. That A/T has a case that doesn't need it, so it doesn't come with one.
