**HYUNDAI**NEW THINKING.
NEW POSSIBILITIES.**Technical Service Bulletin**

17-01-053

SANTA FE (NC)**SUBJECT:**SANTA FE (NC) FRONT CABIN WATER INTRUSION
(SERVICE CAMPAIGN T2G)*** IMPORTANT******* Dealer Stock and Retail Vehicles *****

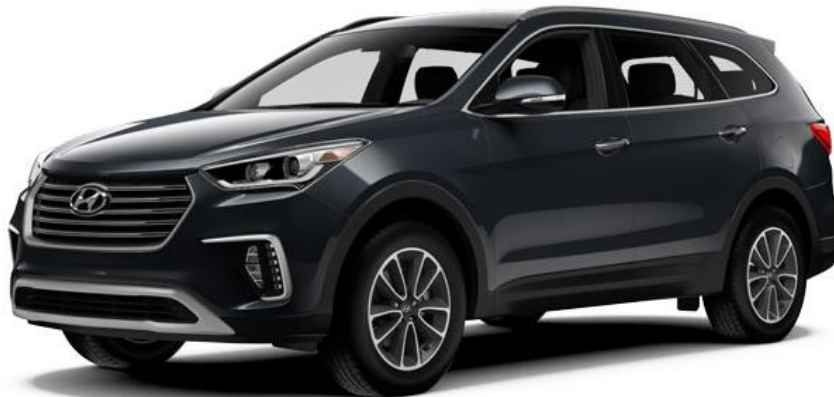
Description: On certain 2017 Santa Fe (NC) vehicles, the body seam sealant on the front side members may not have been correctly applied during vehicle assembly resulting in potential water intrusion into the floorboard of the vehicle.

This bulletin describes the procedure to repair the seam on the front side members and add sealant in the appropriate locations.

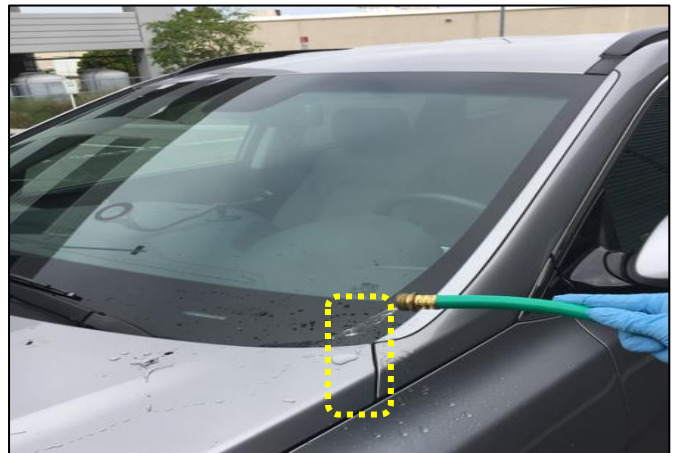
6. Using a hose, spray water directly on the panel opening between the hood, lower pillar and fender for approximately 30 seconds.

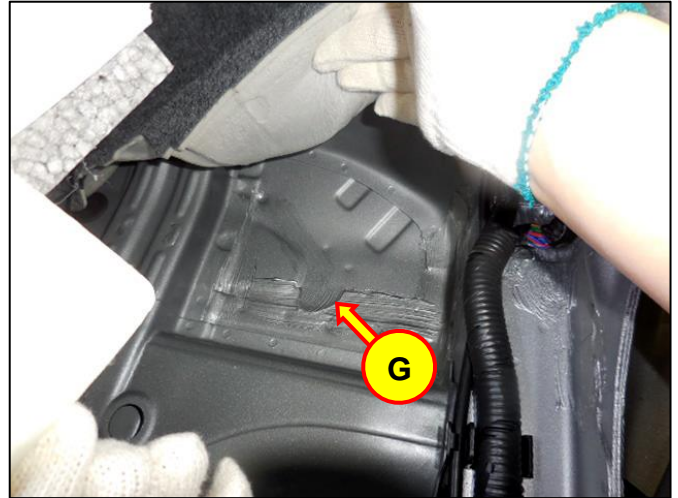
7. Check for water intrusion onto the front floor groove (G). Wait for 2~3 minutes after spraying the water.

If water is detected on the floorboard or the isolation pad, follow the seam sealant rework procedure as described below.

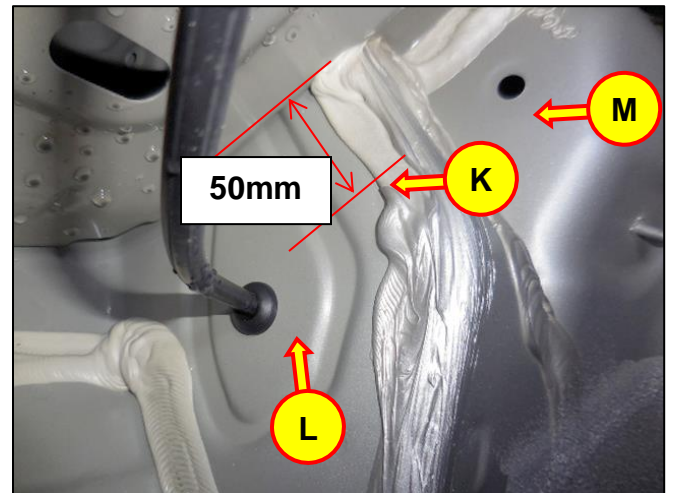
5. Check the sealant (K) on the weld seam on the fender apron upper (L) and front member side (M).
