MODEL
2017MY
Sorento (UMa)
Optima (JFa)

131 (Rev 1, 7/21/2017)

TECHNICAL SERVICE BULLETIN

SERVICE ACTION: VOLTAGE REGULATOR
PERFORMANCE ENHANCEMENT (SA278)

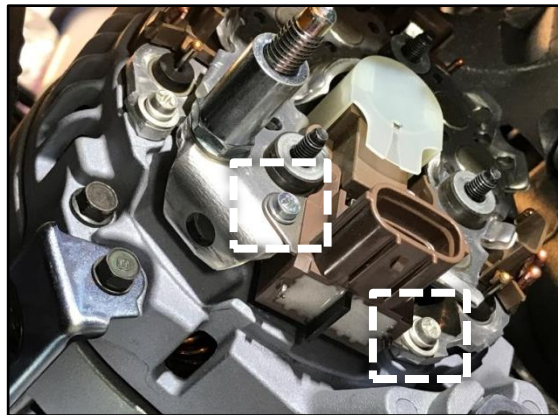
Voltage Regulator Screws

This bulletin provides the procedure to increase the torque on the voltage regulator screws on some 2017MY Sorento (UMa), produced from October 3, 2016 to January 24, 2017, and 2017MY Optima (JFa) vehicles, produced from October 3, 2016 to January 26, 2017, which may experience low battery voltage or a no-start condition. Follow the procedure outlined in this bulletin to increase the two (2) screws' torque on the voltage regulator. Before conducting the procedure, verify that the vehicle is included in the list of affected VINs.
