Clicking Noise From Front Wheel Area During Slow Speed Turns (F Sport 2WD)

Service Category Brake

The information contained in this bulletin supersedes SB No. L-SB-0002-14.

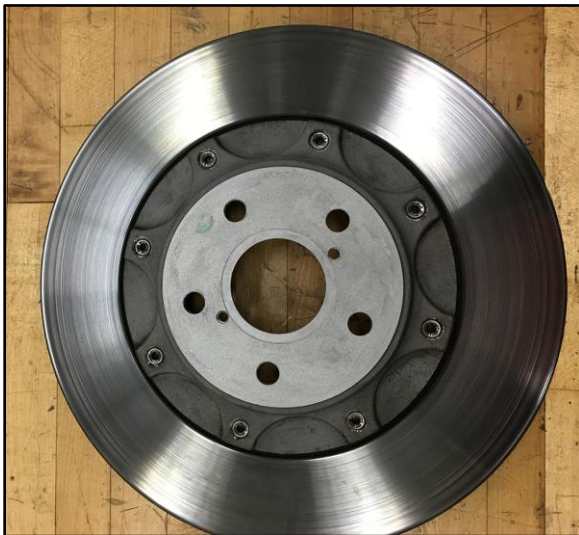
Figure 1. Before (Aluminum)

These vehicles are originally equipped with a lightweight 2-piece aluminum rotor assembly. The clicking noise that can be heard during sharp turns is a normal condition. For customers that find this objectionable, an alternative steel rotor is available. Before performing this repair, it is recommended that the visual differences of the steel rotor be reviewed with the customer.

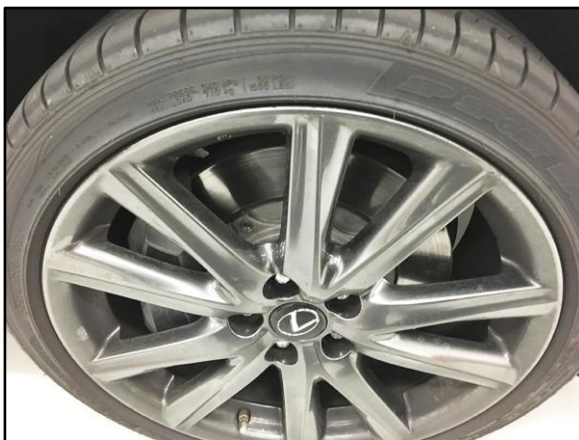
Figure 3. Before* (Aluminum)

*This picture is an example of 1 wheel type for the vehicle. Other wheel types may have slightly different results.

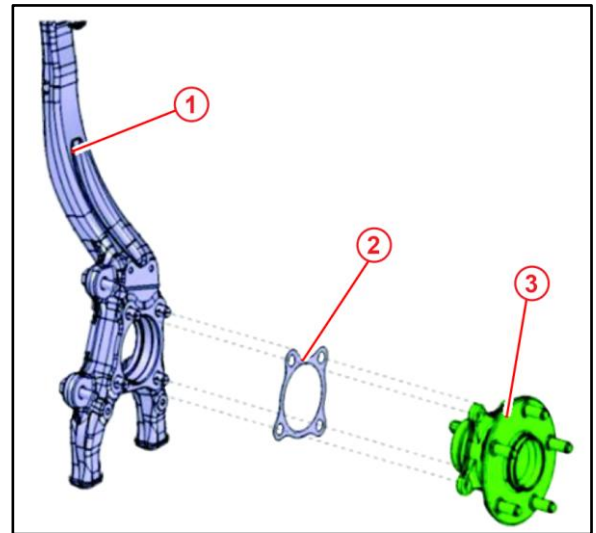
Figure 5.

1	Knuckle
2	Shim
3	Hub Bearing

- B. Install the painted brake shim between the hub and knuckle as shown.

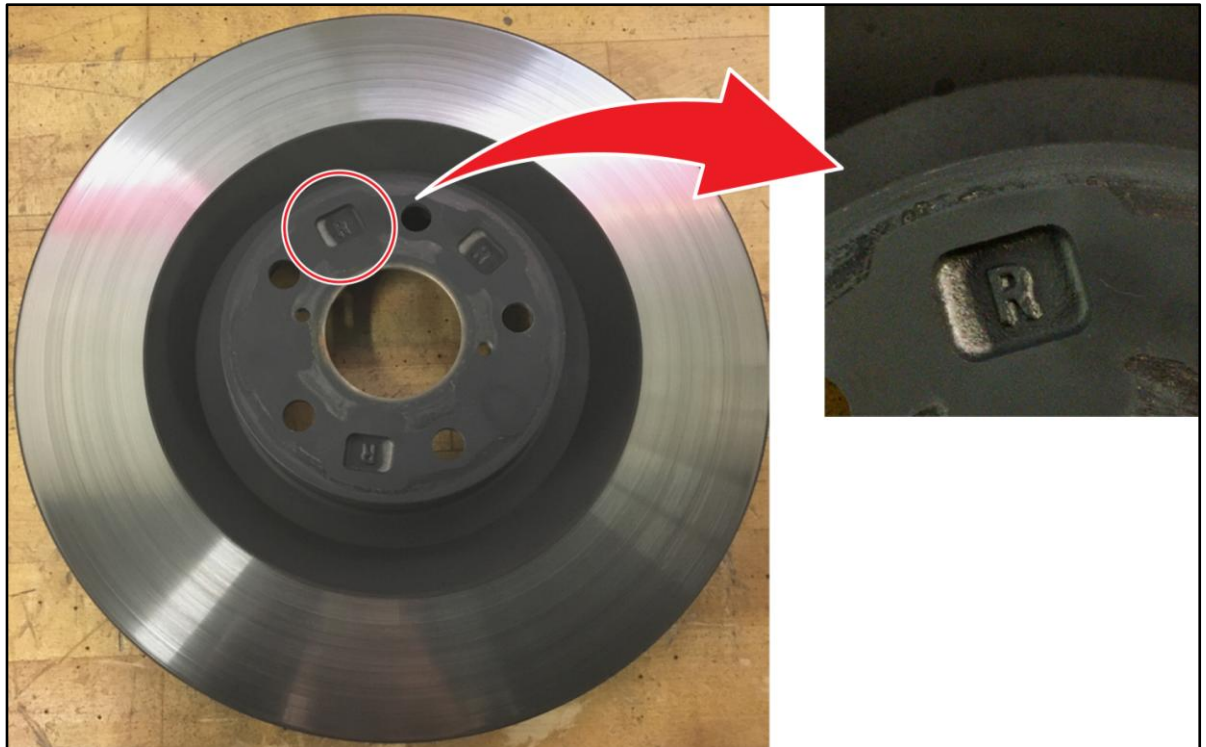
Figure 6.

NEW steel 1-piece rotors do NOT have paint marks as shown in the Repair Manual. They are marked with an “L” or an “R” to show which location to install.

C. Reinstall the hub bearing, NEW rotors and NEW brake pads.
