# Vibration at Idle in Park

**Service Category** Engine/Hybrid System

**Section** Engine Control

YEAR(S)	MODEL(S)	ADDITIONAL INFORMATION
2015 - 2017	NX200T

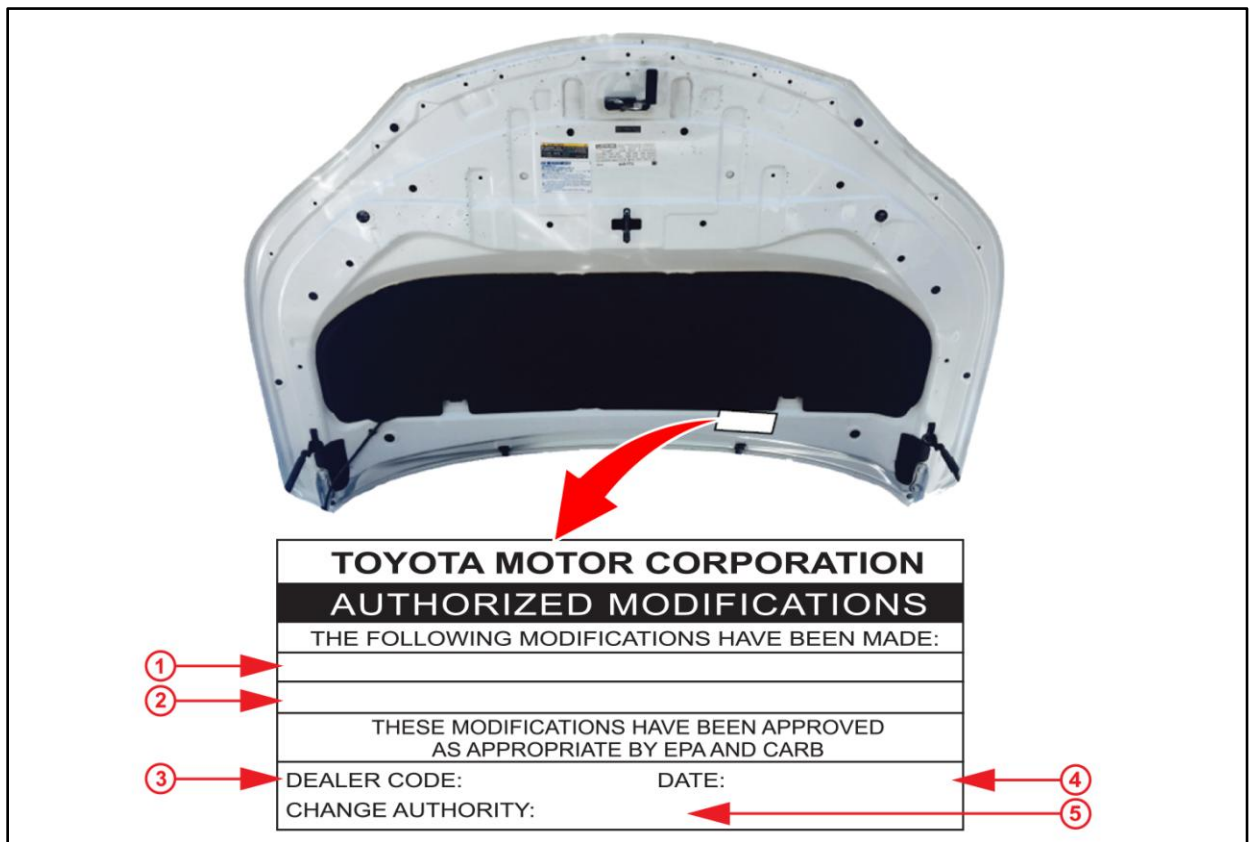
**Figure 1. Location of Authorized Modifications Label on 2015 – 2017 NX 200t**

- Check for the Authorized Modifications Label affixed to the vehicle in the location shown below. Confirm if the ECM (PCM) calibration has been updated.

- Prepare and install the Authorized Modifications Label.
  - Using a permanent marker, enter the following information on the label:
    - ECM part number [Refer to the **Parts Information** section for the **NEW PART NUMBER**]
    - Calibration ID(s) [Refer to the **Calibration Information** section for the **NEW CALIBRATION ID**]
    - Dealer Code
    - Repair Date
    - Change Authority [**This bulletin number**]
  - Install the Authorized Modifications Label to the vehicle at the location shown in Figure 1. The Authorized Modifications Label is available through the MDC, P/N 00451-00001-LBL.
- Verify the vibration condition is no longer present.
